BRUNSWICK STEAM ELECTRIC PLANT, UNIT NO. 1
DOCKET NO. 50-325 / LICENSE NO. DPR-71
PERFORMANCE OF NONDESTRUCTIVE EXAMINATION OF FEEDWATER
NOZZLES AND SAFE ENDS DURING THE B109R1 REFUELING OUTAGE

BRUNSWICK STEAM ELECTRIC PLANT, UNIT 1 NRC DOCKET NO. 50-325 OPERATING LICENSE NO. DPR-71 UNIT 1 NONDESTRUCTIVE EXAMINATION RESULTS FEEDWATER NOZZLES AND SAFE ENDS

DESCRIPTION OF TITLE: Evaluation of Unit 1 Feedwater Spargers

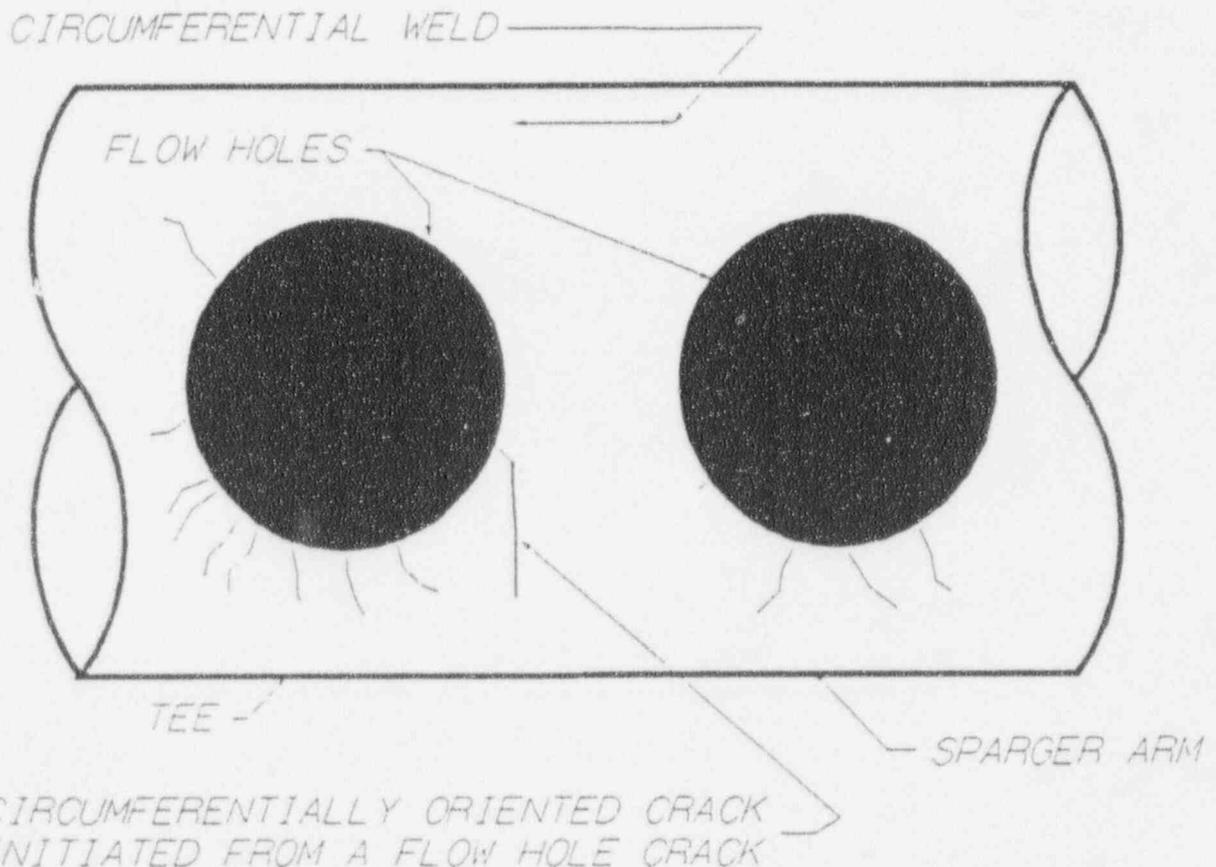
Figure 1 - Typical Circumferentially Oriented Crack

- 2.2.1 Table 1 summarizes the non-destructive examination results of the eight welds connecting the sparger arms to the tee. Six of the sparger-arm-to-tee welds had circumferentially oriented LP indications on the outside diameter surface. The longest indication was 2.25" long on the left side of the 135° azimuth tee. Based upon the previous Unit 2 examination, it was assumed that all of the outside diameter LP indications represented through-wall cracks; therefore, these six welds were subsequently UT examined

for the entire 360° circumference to determine the indication length on the inside diameter surface. The longest indication on the inside diameter surface was also the left side of the 135° azimuth tee and was 2.5" long. There were no LP indications on the sparger tee outlet to thermal sleeve welds.

Figure 1 shows the orientation of the circumferential cracking, which is the same as in the previously examined Unit 2, i.e., all of the cracks are on the flow hole side of the sparger. The cracks are growing downward following the heat affected zone of the circumferential weld.

growth rate predicted by GE in Ref. 3 is 3.16" per operating cycle for a similar indication. The maximum predicted length of a crack before structural failure would occur was 14.1".) The longest existing crack found in Unit 1 was 2.5 inches, thus, there is a total margin of 11.6" of additional crack growth (14.1" minus 2.5") before structural failure of the joint is predicted. Based upon Ref. 3, the longest Unit 1 flaw would be approximately 5.7" (2.5" plus 3.2") at the end of the next cycle. It is therefore acceptable to operate for an additional cycle with the existing feedwater spargers. The longest existing crack will not reach critical flaw size in the next operating cycle.
