SUBJECT: Calvert Cliffs Nuclear Power Plant  
Unit No. 2; Docket No. 50-318; License No. DPR 69  
Licensee Event Report 94-003  
Reactor Shutdown for Leak From Fatigue Crack in Safety Injection Tank Line

TITLE (4)  
**Reactor Shutdown for Leak From Fatigue Crack in Safety Injection Tank Line**

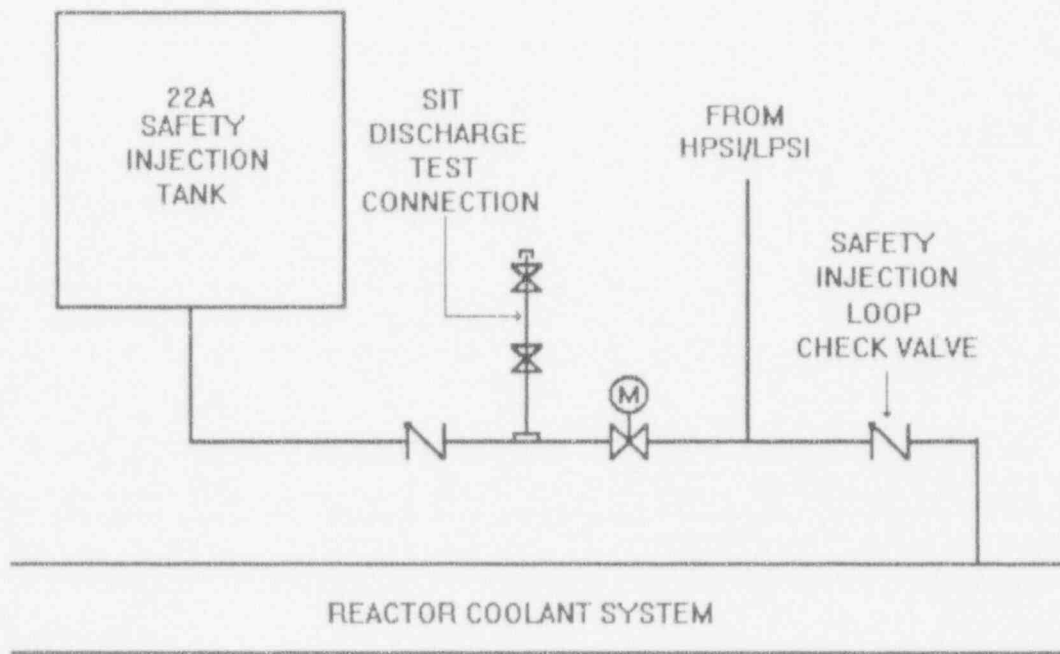
FIGURE 1

The SIT discharge test connection consists of a 3/4 inch segment of austenitic stainless steel schedule 160 pipe running from the SIT discharge line and socket welded to a 3/4 inch to 1 inch reducer attached to a 1 inch globe valve. The crack was located in this socket weld (see Figure 2). The line is isolated from the Reactor Coolant loop by the Safety Injection Loop Check Valve (see Figure 1).

22A SAFETY INJECTION TANK DISCHARGE LINE

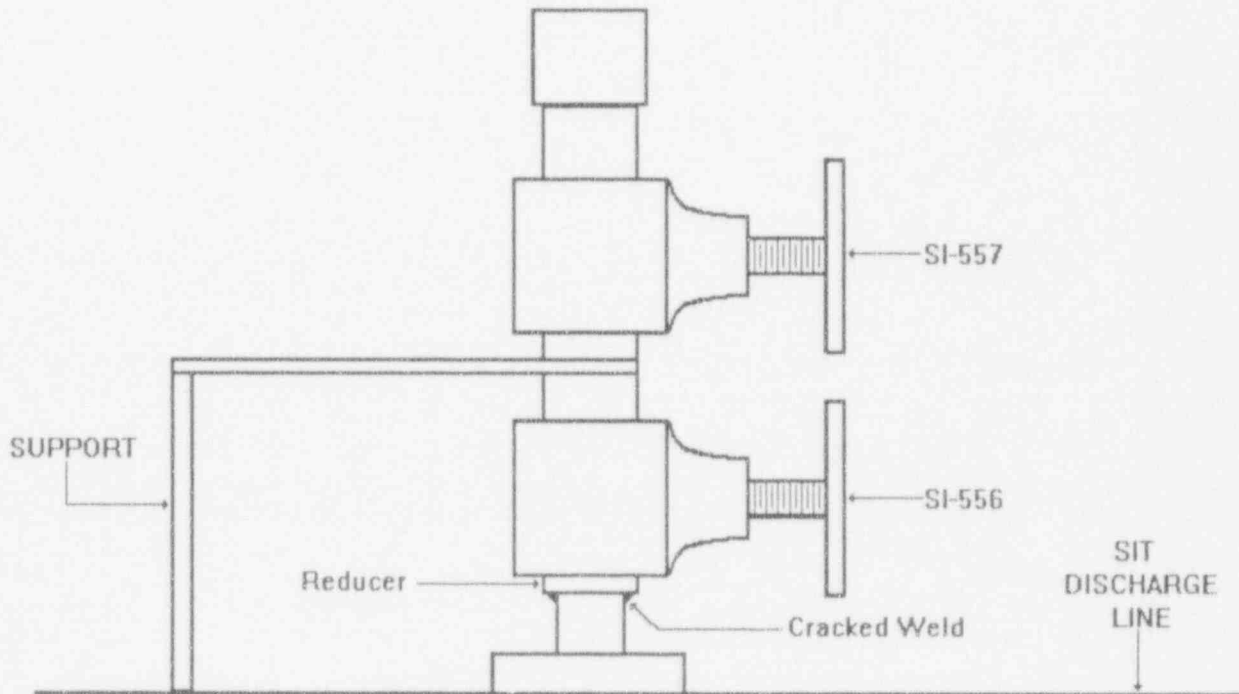
FIGURE 2

On July 7, 1994, 22A Safety Injection Tank (SIT) outleakage increased noticeably. At about the same time frame, an increase in containment sump discharge frequency was noted indicating increased leakage to containment. On July 11, 1994, an operator entered containment to determine why the 22A SIT leakage rate had increased to approximately 20 gallons per hour (0.33 gpm). Upon arriving in the vicinity of the 22A SIT outlet Motor Operated Valve, the operator discovered an active leak from the inlet weld on a 3/4 inch to 1 inch reducer for vent valve 2-SI-556 on the 22A SIT discharge test connection (see Figure 1). He noted boric acid buildup around the leak and estimated that the leak was spraying a mist about two to three feet outward for about a 150 degree circumference around the pipe.

Metallurgical analysis of the cracked weld concluded that this was a high cycle fatigue failure. Visual examination of the fracture surface under low power magnification revealed faint clamshell marks indicative of fatigue. Vibration measurements were taken on the 22A SIT discharge test connection and compared to the other three SIT test connections in Unit 2. Vibration levels on the cracked line were 2-3 times higher than those on the similar lines. Engineering analysis indicates that, although the design and installation of the test connection fully met applicable code requirements, the configuration introduced a high potential for harmonic oscillation to occur, coinciding with the excitation frequency of the RCS. This would create a higher driving stress sufficient to account for the high cycle fatigue. Although vibration measurements were taken prior to repair of the test connection, these were not sufficient to confirm or deny harmonic oscillation. The vulnerability of the line to harmonic oscillation was not realized until after the measurements had been taken.

The 22A SIT discharge test connection was removed during the Spring 1993 Unit 2 Refueling Outage to allow for the replacement of the 22A SIT Outlet Check Valve. After the check valve was replaced, the line was rewelded in place. The placement of the support was slightly modified (it was within specified tolerances) at this time. It is suspected that these changes resulted in harmonic oscillation causing high cycle fatigue failure.

22A SAFETY INJECTION TANK DISCHARGE TEST CONNECTION

- A. The support for 22A SIT discharge test connection was redesigned and installed to reduce levels of vibration to an acceptable level.

Measurements following the modification confirmed that vibration was reduced and verified not to be in the harmonic region.
