(7-77)	LICENSEE EVENT REPORT Update Report: Previous Report Date: 2-21-83
	CONTROL BLOCK:
	N   C   B   E   P   1   1   0
CON'T	REPORT LO 0 5 0 - 0 3 2 5 0 0 1 2 3 8 3 8 0 2 2 8 8 3 9 SOURCE 60 61 DOCKET NUMBER 68 69 EVENT DATE 74 75 REPORT DATE 80
02	EVENT DESCRIPTION AND PROBABLE CONSEQUENCES (10) While performing routine surveillance during an extended refueling outage, the control
03	operator noticed that one fuel bundle was located around each of the following with-
04	drawn control rods: 22-15, 34-23, 34-27, and 26-43. This event did not affect the
05	health or safety of the public.
06	L
07	L
08	Technical Specifications 3.9.10.2, 6.9.1.9b
09 78	SYSTEM CAUSE CAUSE COMPONENT CODE COMPONENT CODE SUBCODE SUBCO
	17 LER/RO EVENT YEAR REPORT NO. CODE TYPE NO.   17 NUMBER 8 3 0 0 7 0 3 1 1
	$\begin{array}{c ccccccccccccccccccccccccccccccccccc$
1101	CAUSE DESCRIPTION AND CORRECTIVE ACTIONS (27)
	cells with withdrawn control rods. The procedure did not define responsibility for

### Facility: Unit No. 1

#### Event Date: January 23, 1983

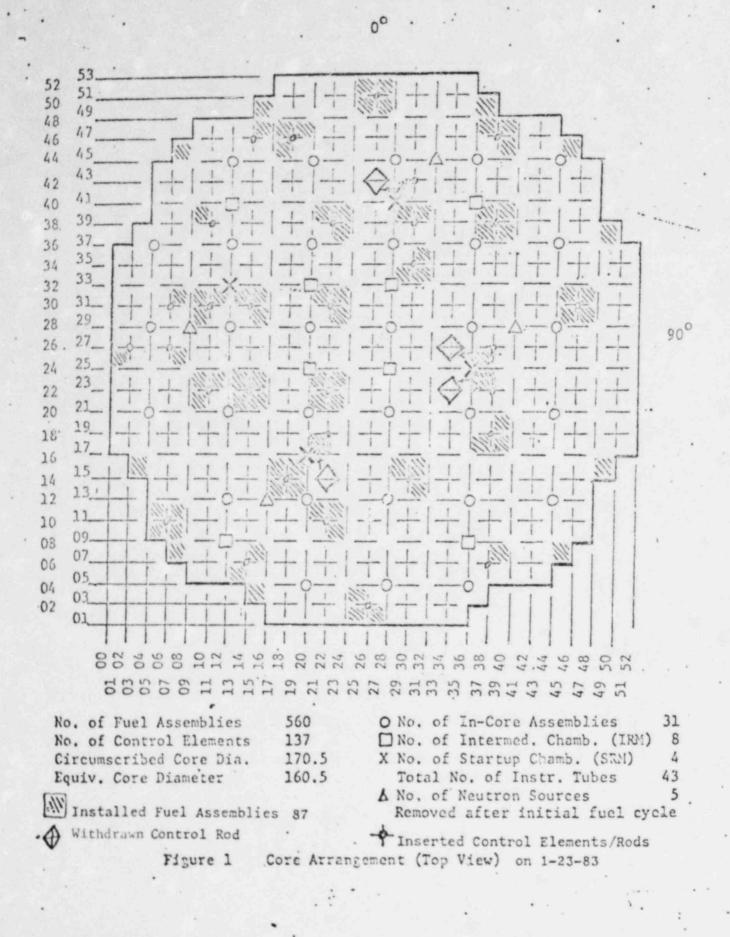
The control rod drive units for rods 22-19, 30-43, 38-23, and 38-27 were scheduled to be rebuilt following the completion of all other drive rebuilds when the fuel bundle in each cell would be moved to cells with fully inserted rods. Due to a problem encountered with uncoupling several drive units to be rebuilt, it was decided to work the four drives with fuel bundles. A fuel shuffle sequence had been prepared for relocating those four fuel bundles based on the remaining rod being inserted. At approximately 0300 on January 23, 1983, the fuel bundles were relocated in the core around withdrawn control rods 22-15, 26-43, 34-23, and 34-27. While performing surveillance requirements to assure that all withdrawn control rods had no fuel in the cell (4.9.10.2.1e) at 1245 on January 23, 1983, the fuel shuffle error was identified.

NOTE:

Arrows denote locations where fuel assemblies were moved to cells with control rods withdrawn.

The withdrawn control rods around which the four fuel bundles were placed were inserted within one hour. The delay in inserting these rods occurred because they were under clearance when the problem was identified. A verification was also performed on core fuel location and that all control rods with fuel in their cells were inserted.
