FLORIDA POWER CORPORATION
CRYSTAL RIVER UNIT 3
TENDON SURVEILLANCE PROGRAM

ENGINEERING EVALUATION REPORT
FOR THE
FIFTH TENDON SURVEILLANCE
INSPECTION PERIOD

Originated By: Michael Marcellus
Reviewed By: Dale D. Krause
Report Date: 20 JUNE 1994

Gilbert/Commonwealth
Reading, Pa.

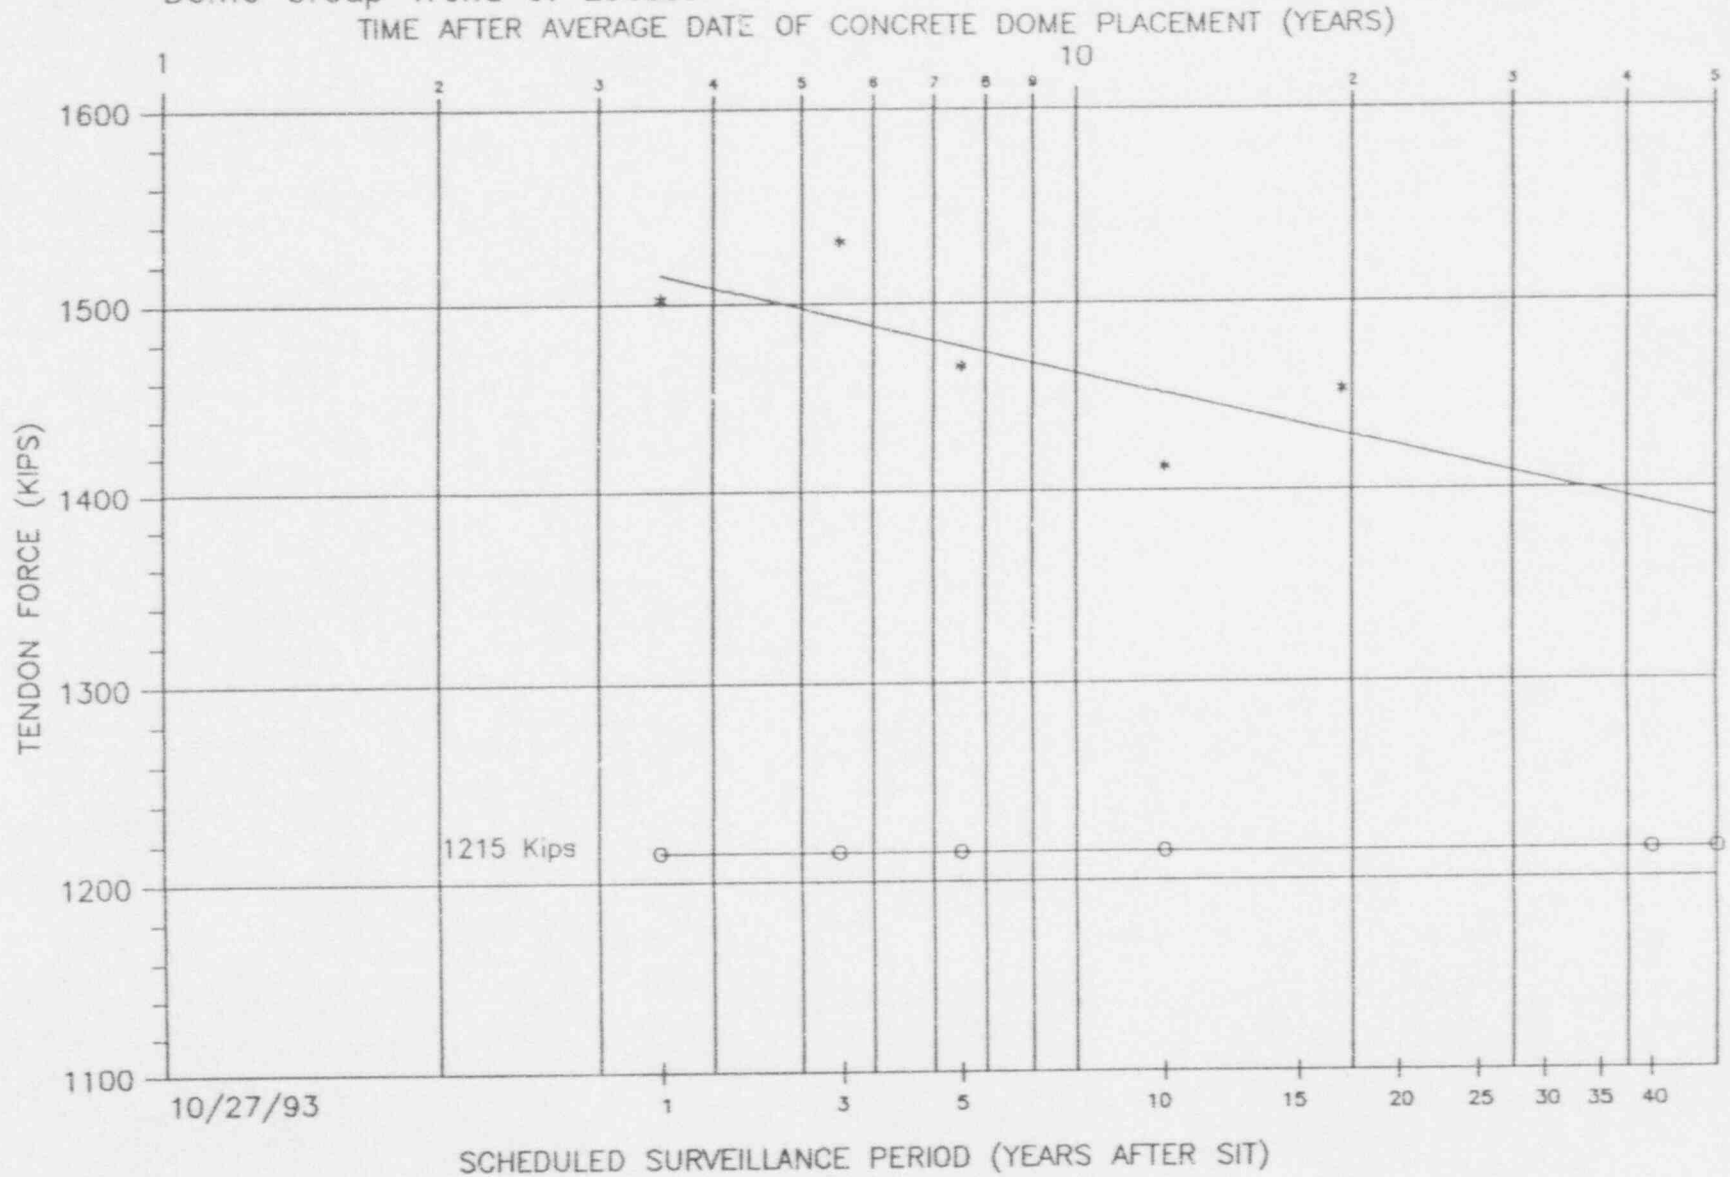
FIGURE 6.1

The data in Table 6.1 reflects an overall positive condition of the dome tendon group. Columns 7 and 8 compare measured liftoffs versus RG and applicable TS lower limits. The calculated percentages are all positive numbers indicating that measured liftoffs were above their RG and TS lower limits. Therefore, in addition to the minimum required average prestress value for the dome group being met, individual dome tendons were found to meet current Technical Specification and RG 1.35 acceptance criteria.

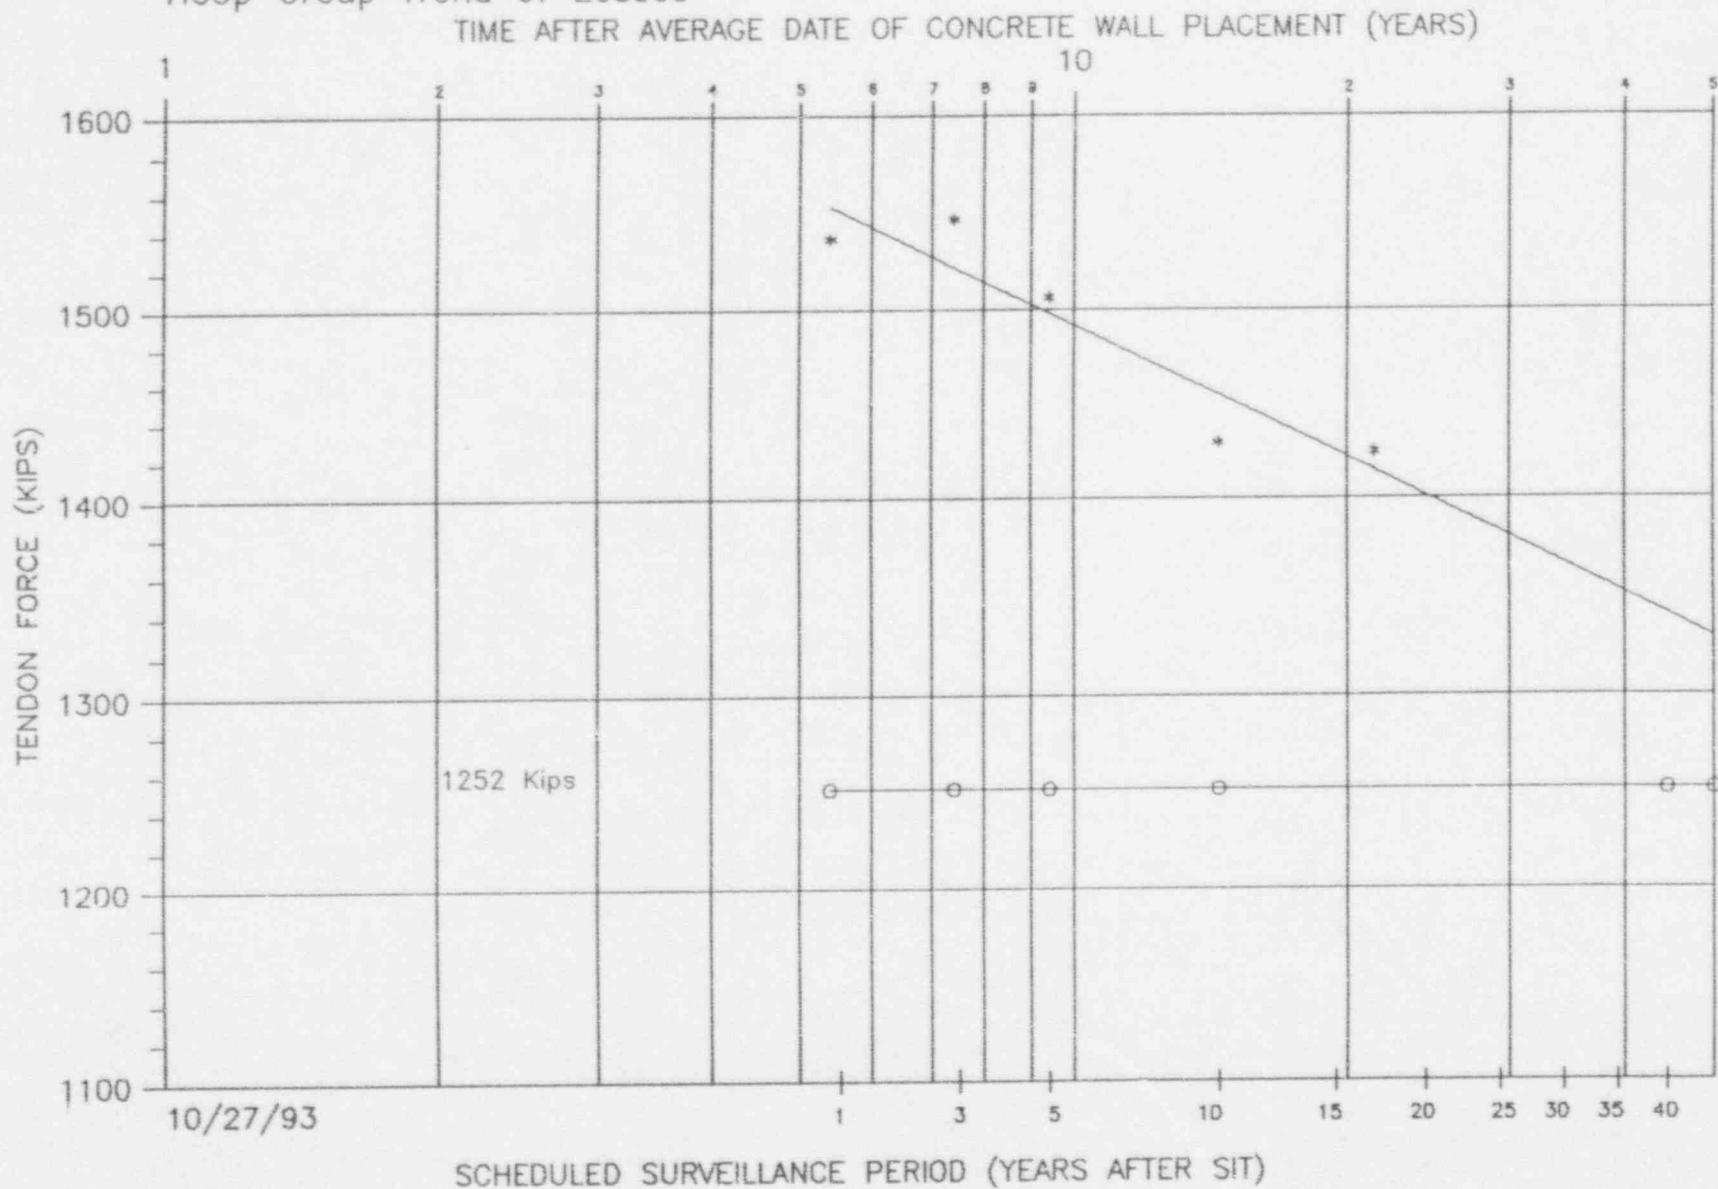
FIGURE 6.2

Figure 6.2 shows the plot of the regression line representing the overall trend of losses for the hoop tendons since the first surveillance. The data points have good correlation and the projected trend line at the end of the forty year plant life is above the minimum required prestress level of 1252 kips. The low prestress condition of two hoop tendons is reflected in the average for the current surveillance, and is therefore accounted for in this projection.

Data in Table 6.2 reflects an overall positive condition of the hoop tendon group. A review of the measured liftoffs versus the TS lower limit shows that all hoop tendons have exceeded the Technical Specification lower limit. In fact, tendon 46H29 from this surveillance is the lowest hoop tendon shown with a 4.1% margin over the TS limit.

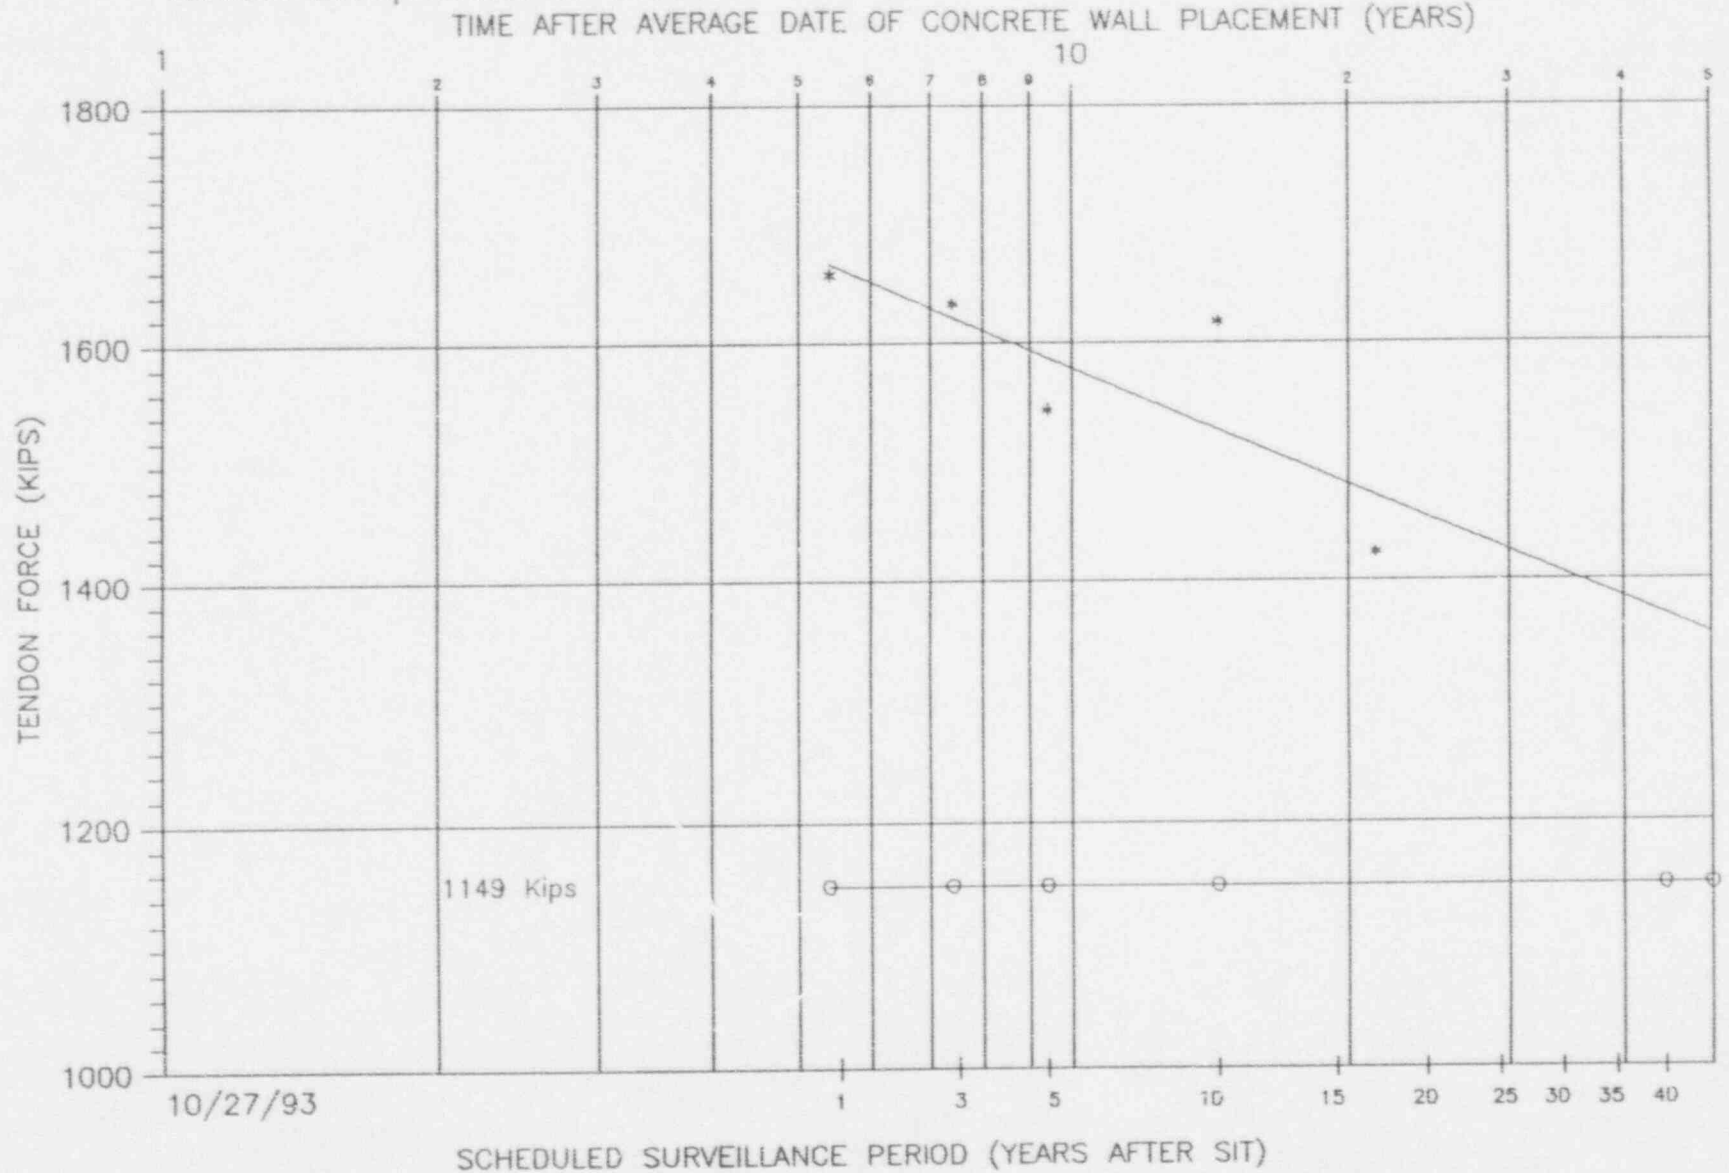
FIGURE 6.3

Data in Table 6.3 reflects an overall positive condition of the vertical tendon group. Measured liftoffs, when compared to the lower limit of the TS, show that all values are positive (Columns 7 and 8). This indicates that the none were below the TS limit. When the same comparison is made against the lower limit of the Reg. Guide, only one tendon shows as negative. This tendon was 12V1, as inspected in the third surveillance period. A closer examination of the data indicates that the same tendon was inspected again in the fourth surveillance with results indicating that the same tendon was 5.6% above the 95% Base limit. The G/C fourth surveillance report (Reference 7.) reported this as an error from the third surveillance. Therefore, it can be concluded that all vertical tendons meet the current Reg. Guide acceptance criteria.
