LICENSEE: BALTIMORE GAS & ELECTRIC COMPANY (BG&E)

FACILITY: Calvert Cliffs Units 1 and 2

SUBJECT: SUMMARY OF A FEBRUARY 24, 1983 MEETING HELD WITH BG&E TO DISCUSS RECENT PROBLEMS WITH THE CALVERT CLIFFS ENGINEERED SAFETY FEATURES ACTUATION SYSTEM (ESFAS).

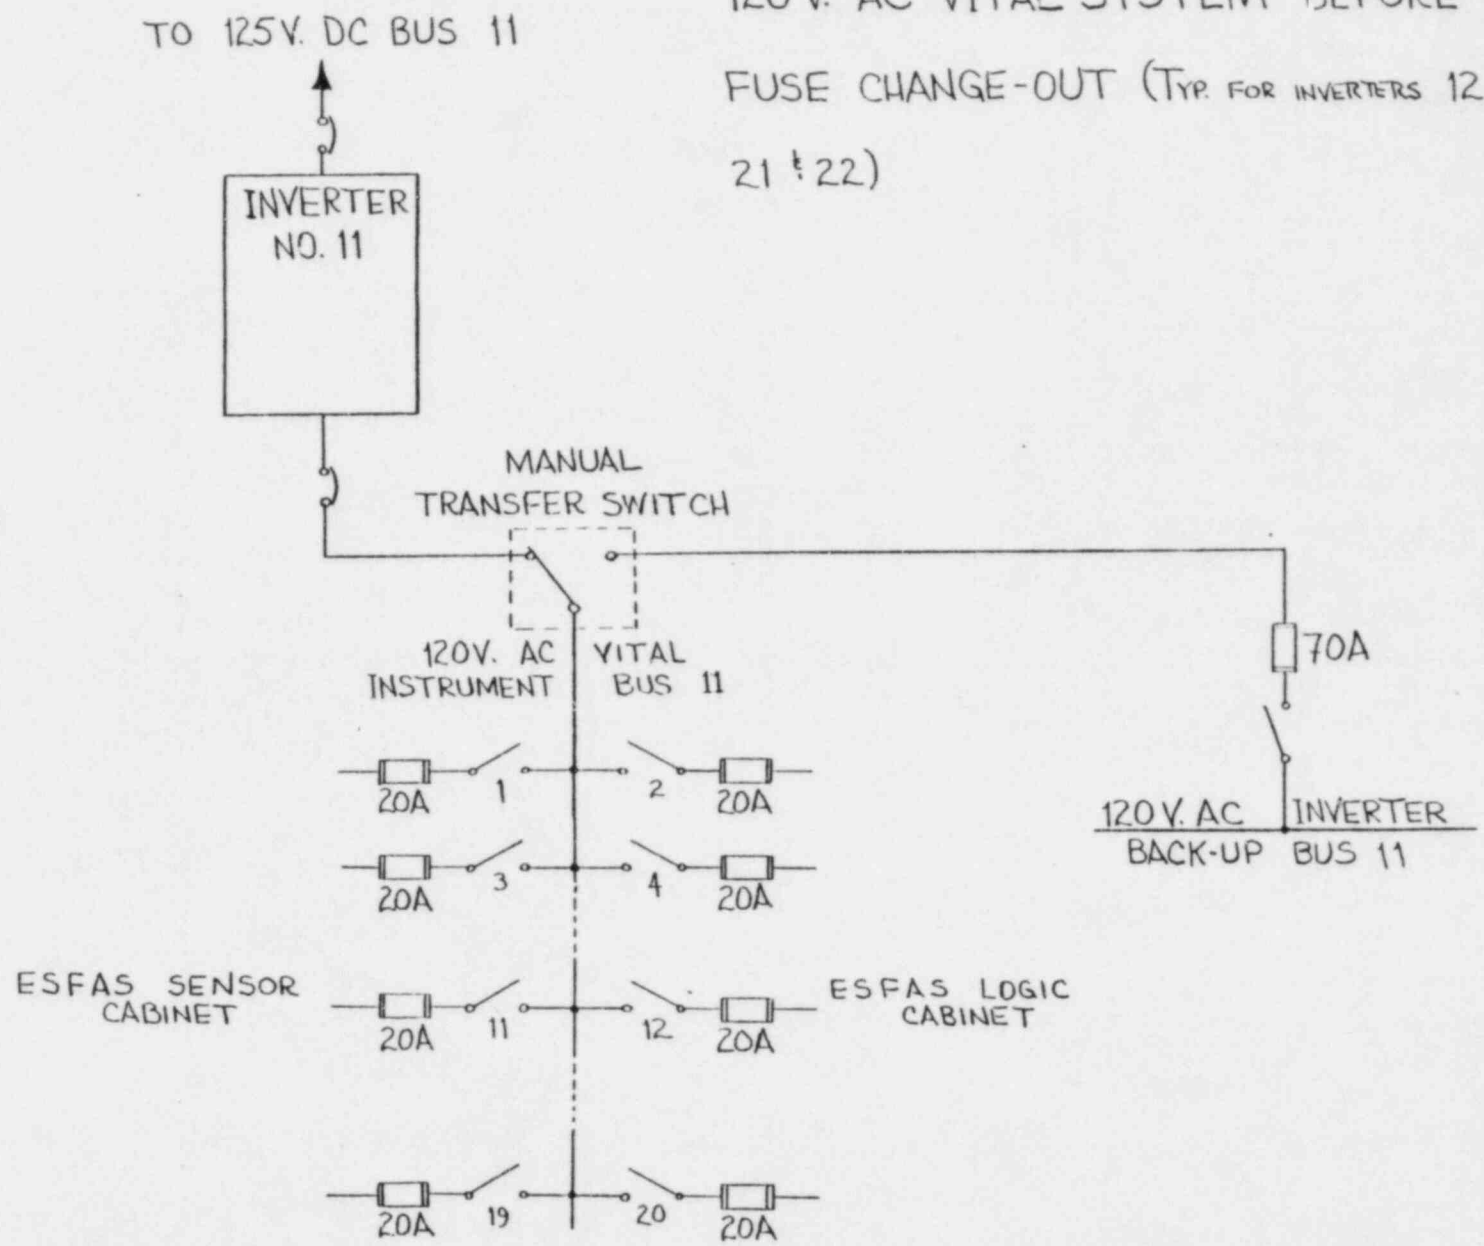
120 V. AC VITAL SYSTEM BEFORE  
FUSE CHANGE-OUT (TYP. FOR INVERTERS 12,  
21 & 22)

PROBLEMS / SYMPTOMS

1. BLOWING DC INPUT FUSE TO INVERTER BUT NOT OUTPUT FUSES ON LOAD WHERE FAULT OCCURS.
2. INVERTER PROTECTED FROM FAULT CURRENTS BY CURRENT LIMIT FEATURE.
3. UNNECESSARY ESFAS ACTUATION.

PROPOSED SOLUTION

1. FOLLOW MANUFACTURER'S RECOMMENDATIONS TO USE PROPER FUSE TYPE AND SIZE.
2. REMOVE CURRENT LIMIT FEATURE FROM INVERTER.

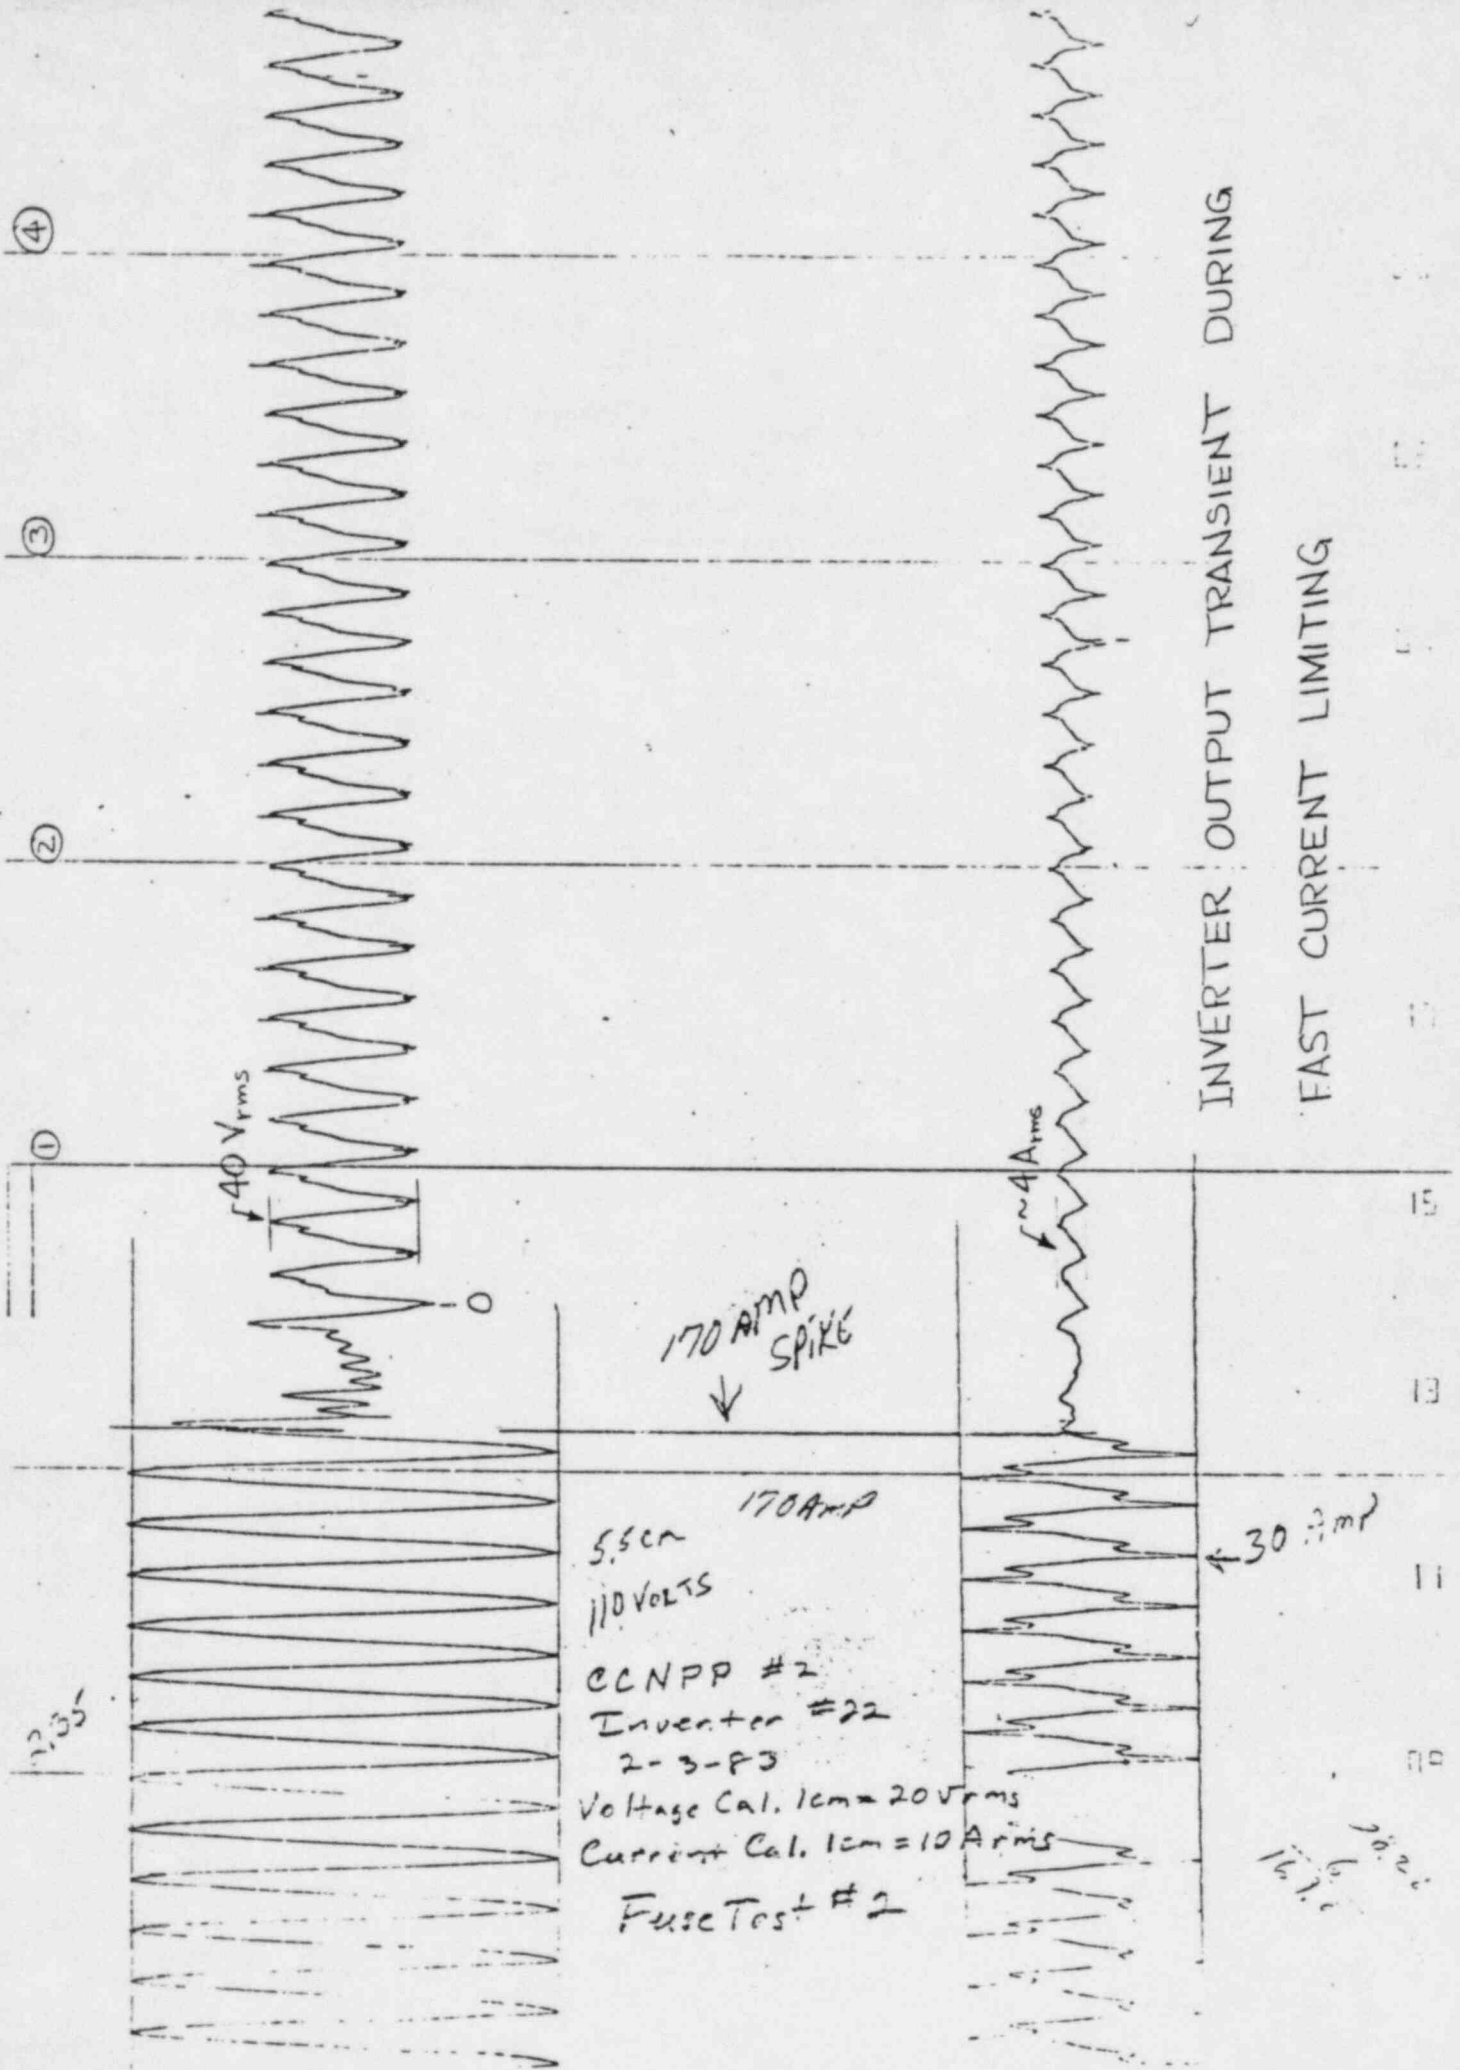
7

40 Vrms

170 AMP SPIKE

INVERTER OUTPUT TRANSIENT DURING

FAST CURRENT LIMITING

5.5cm 170 AMP  
 110 VOLTS  
 CCNPP #2  
 Inverter #22  
 2-3-P3  
 Voltage Cal. 1cm = 20 Vrms  
 Current Cal. 1cm = 10 Arms  
 Fuse Test #2

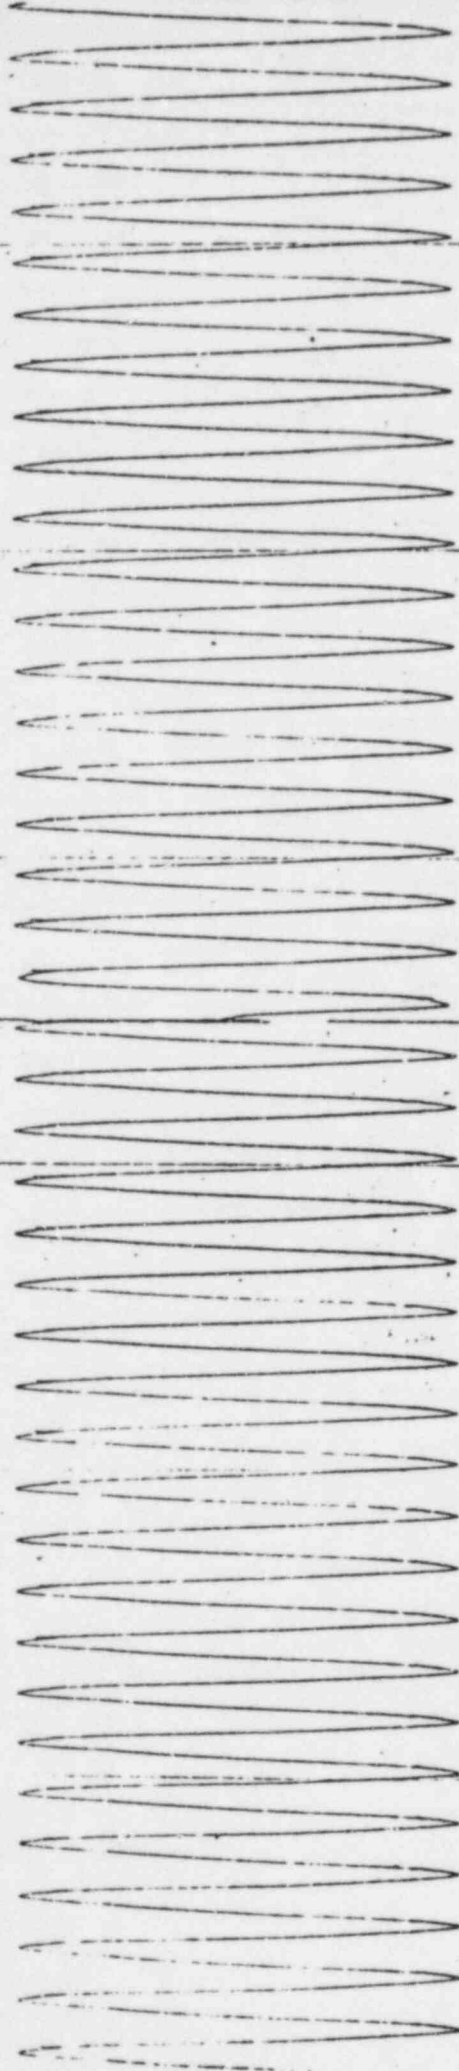
INVERTER RESPONSE TO SHORT CIRCUIT WITHOUT CURRENT LIMITING.

15 Amp  
#5 FUSE

↑  
235 Amp  
SPIKE

CCNPP #2  
Inverter #22  
2-3-83 11:35AM  
Volt. Cal. 1cm = 20Vrms  
Cur. Cal. 1cm = 10Arms  
Fuse Test #5

1. REMOVE CL FEATURE - ALLOWS FAULT TO CLEAR (VIA LOAD FUSES) AND PREVENTS VOLTAGE DROP.
2. MEET MANUFACTURER'S RECOMMENDATION FOR PROPER FUSING.
3. ESFAS POWER SUPPLIES WILL NOT SEE VOLTAGE DROP IF FAULT OCCURS.
