1994 Annual Prelicensing Inspection of the Salt Lake City (South Clive), Utah, UMTRA Project Disposal Site

July 1994

Prepared for
U.S. Department of Energy

Prepared by
RUST Geotech Inc.
Under DOE Contract No. DE-AC04-86ID12584
U.S. Department of Energy
Grand Junction Projects Office
Grand Junction, Colorado

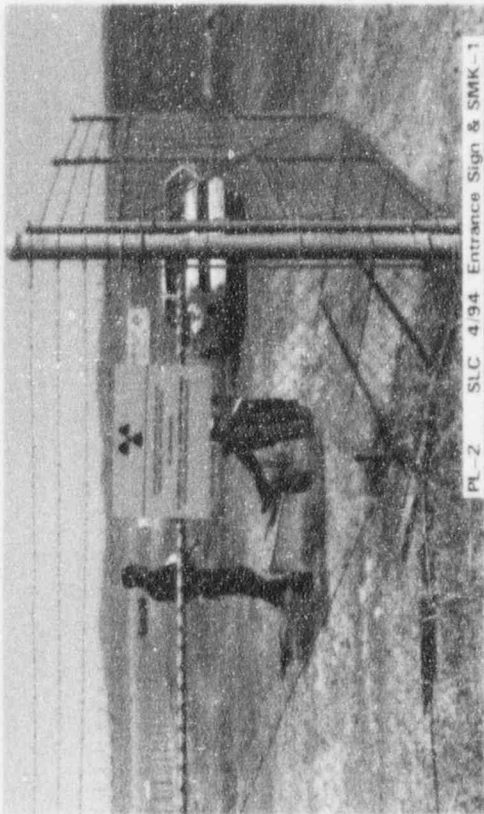
The entrance gate and entrance sign, which is designated on Plate 1 by an "E," are in excellent condition (PL-1 and PL-2, respectively). A stop sign, which is on the site security fence just south of the entrance gate (PL-1), has been damaged by four bullet holes from a large-caliber rifle.

PL-2 SLC 4/94 Entrance Sign & SMK-1

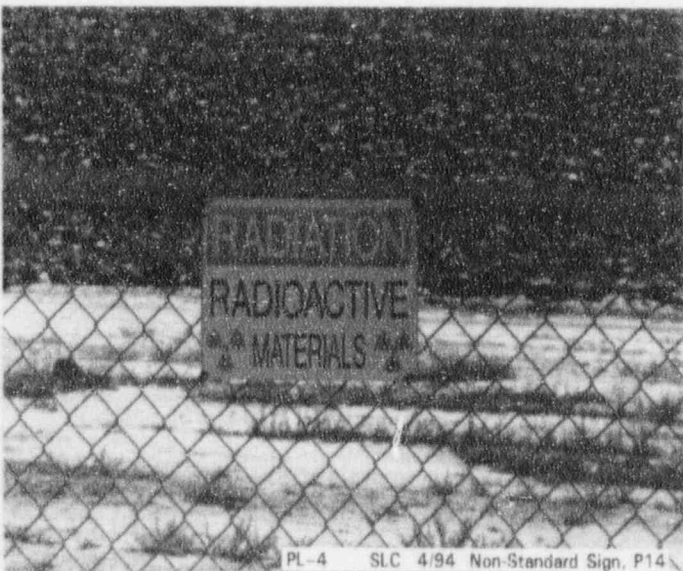
PL-4 SLC 4/94 Non-Standard Sign, P14

Recommendation: During the 1995 inspection, replace the three perimeter signs on the north security fence with perimeter signs that meet current UMTRA Project specifications (DOE 1992b). Also, on the south security fence, move existing perimeter sign, P7, about 100 feet westward and install a new perimeter sign about 200 feet from the southeast corner.

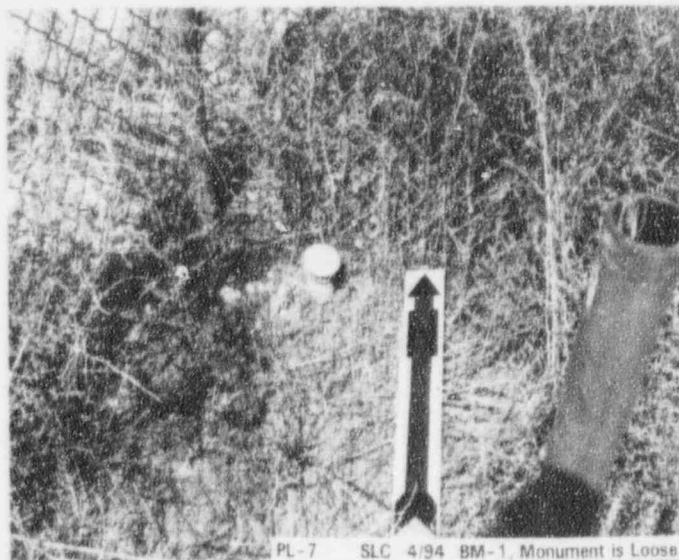
Four boundary monuments are set at the corners of the rectangle-shaped site, BM-1 through BM-4 (PL-7 through PL-10, respectively). The monuments are in excellent condition except for BM-1, which is loose. Damage to this monument may have occurred during installation of the adjacent fence by Envirocare. Although loose in the ground, BM-1 appears to be in the correct location, and no repair is recommended.

PL-7 SLC 4/94 BM-1, Monument is Loose

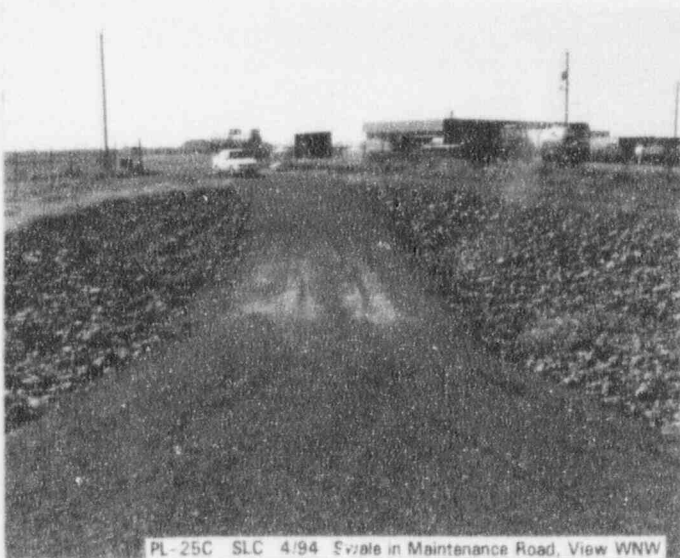
PL-25C SLC 4/94 Swale in Maintenance Road, View WNW

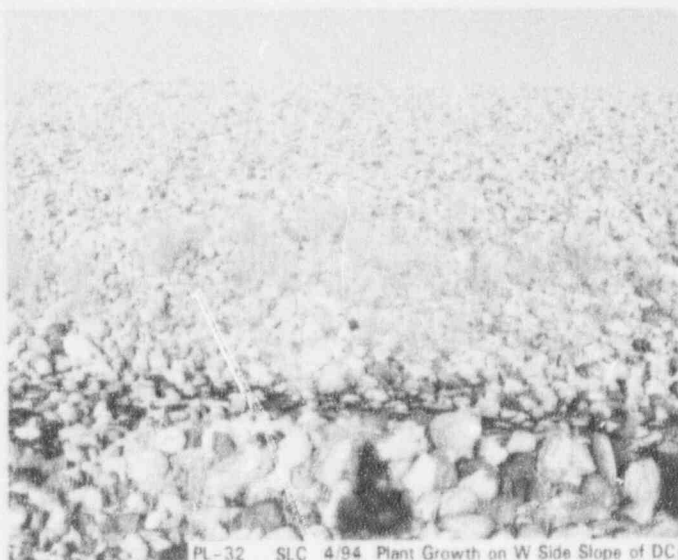
Plant growth occurs in small areas and as scattered individual plants on the east and west side slopes (Plate 1). Plants were the same types as seen on top of the disposal cell, and they were all dead remains of growth during one or more previous years. The amount of plant growth on the side slopes is greater than noted during previous seasons. The largest areas of plant growth on the east and west side slopes (PL-31 and PL-32, respectively) are in the lower parts of the side slope and are near or adjacent (PL-32) to ponded water in a toe drain. The ponded water probably enhances plant growth through a wicking process that transfers moisture laterally into the lower parts of the side slopes. The elimination of ponded water in the toe drains would likely decrease the amount of plant growth on the side slopes.

PL-32 SLC 4/94 Plant Growth on W Side Slope of DC

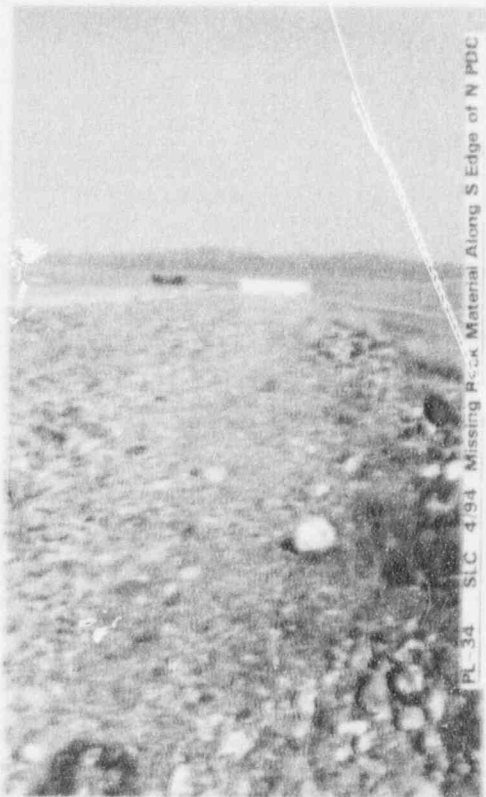
As reported from previous inspections, rock material is missing from the south side of the north perimeter diversion channel for a distance of about 100 yards (PL-34). This issue was discussed with the UMTRA Project Site Manager during the inspection. The GJPO understands that the Site Manager will ask the RAC to evaluate the missing rocks problem. On the basis of site design criteria, the RAC will recommend either that the problem be corrected or that the present condition be accepted.

3. Erosion is occurring across the maintenance road near the southwest corner of the base of the disposal cell. (See pages 10-11.)
4. Rock material is missing from a section about 100 yards long in the south side of the north perimeter diversion channel. (See page 11.)

PL-34 SLC 4/94 Missing Rock Material Along S Edge of N PDC

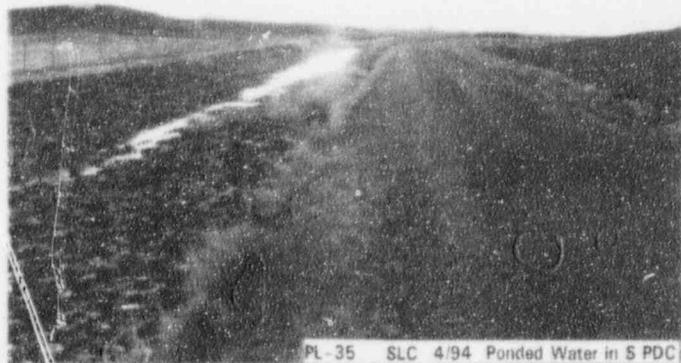
PL-35 SLC 4/94 Ponded Water in S PDC

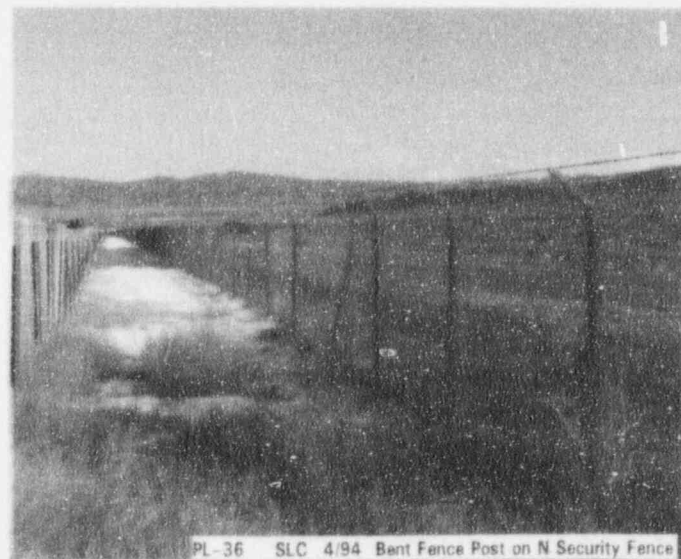
100 to 114 feet on the south, and 96 feet on the west (Plate 1). Minor damage in the form of bent fence posts has occurred to the security fence in the north (PL-36), east, and south (Plate 1) fence lines. No additional fence post damage has occurred since the 1993 inspection, and the damage does not threaten the integrity of the security fence.

PL-36 SLC 4/94 Bent Fence Post on N Security Fence

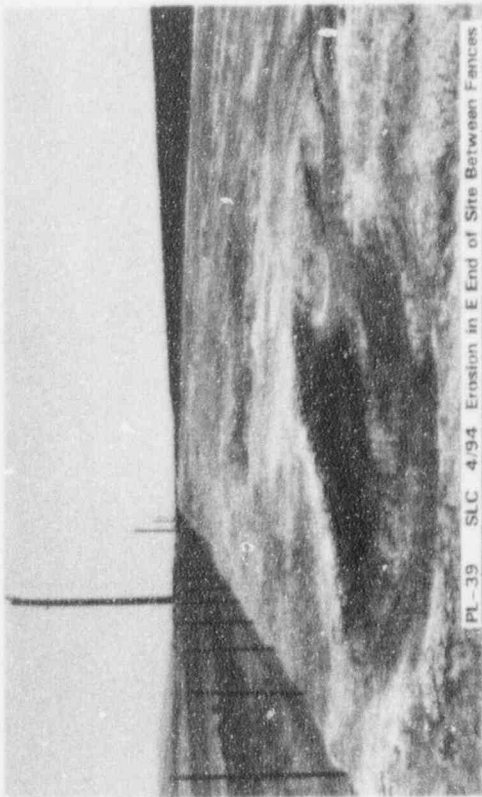
PL-39 SLC 4/94 Erosion in E End of Site Between Fences

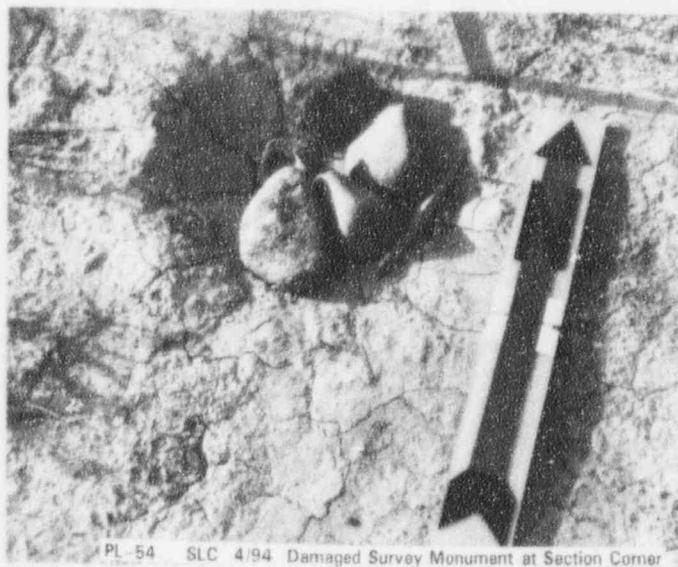
PL 54 SLC 4/94 Damaged Survey Monument at Section Corner
