PRESENT STATUS AND PROJECTED FUTURE PROGRESSION OF STEAM-  
GENERATOR TUBE CORROSION/DEGRADATION AT POINT  
BEACH UNIT NO. 1, WISCONSIN ELECTRIC  
POWER COMPANY, TWO CREEKS,  
WISCONSIN

James R. Myers, Ph.D., P.E.  
JRM Associates  
Consulting Corrosion/Metallurgical Engineers  
4198 Merlyn Drive  
Franklin, Ohio 45005

Public Service Commission  
State of Wisconsin  
4802 Sheboygan Avenue  
Madison, Wisconsin 53707

June 8, 1983

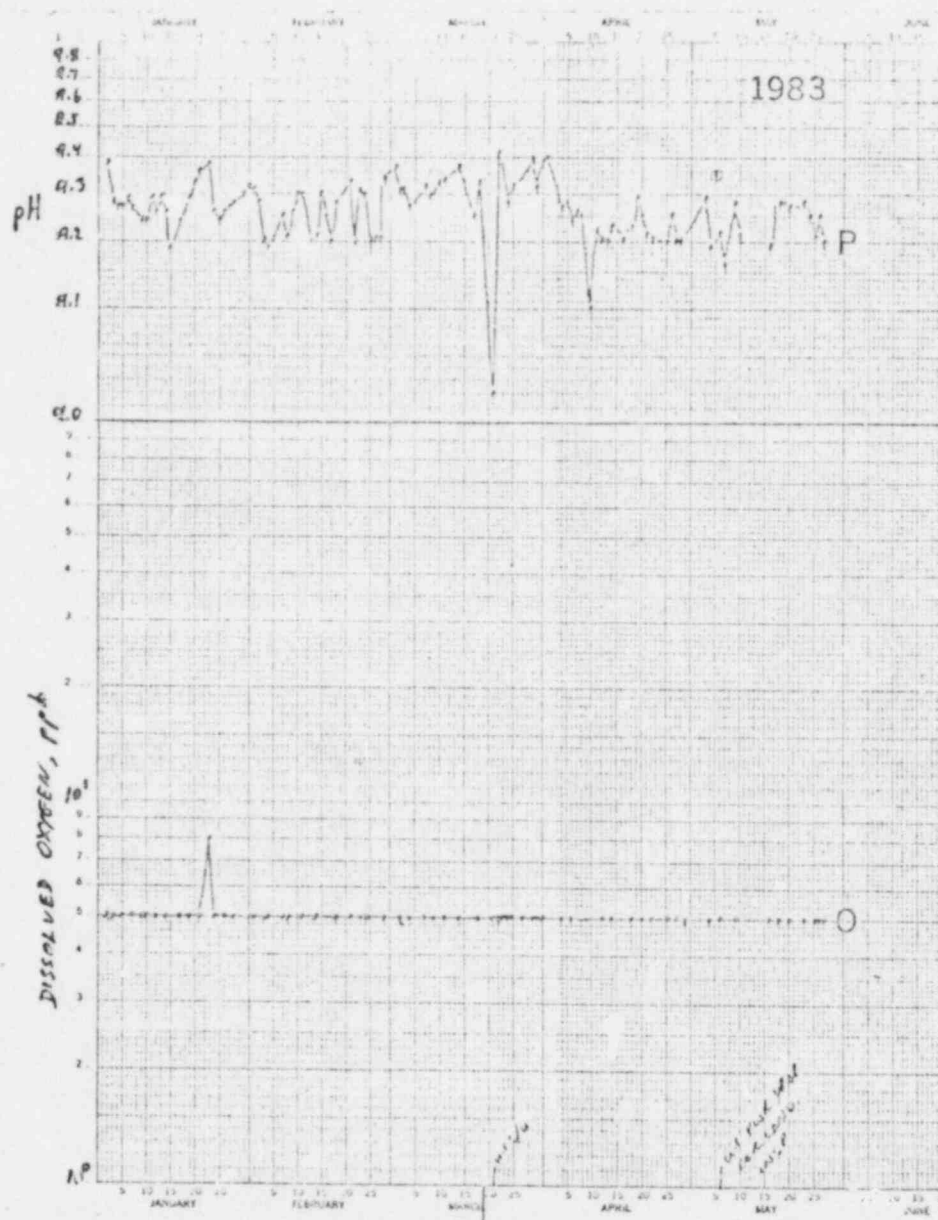
Exactly how well WEPCO personnel have controlled the feedwater chemistry at Point Beach Unit No. 1 can be seen by examining the data in Figures 7 and 8 which are reproductions of actual WEPCO logs for 1983. Excluding the to-be-expected transient conditions, the feedwater during 1983 contained less than 5 ppb (the lower limit of the detection equipment) dissolved oxygen, 7 to 12 ppb residual hydrazine, and 0.5 to 0.7 ppm ammonia; it had a pH of 9.2 to 9.4 and a conductivity of 4.2 to 5.4 micromhos/cm<sup>3</sup>. Examination of the 1982 data revealed that the feedwater normally contained less than 5 ppb dissolved oxygen, 0.5 to 0.7 ppm ammonia, and 7 to 15 ppb hydrazine; it had a pH of 9.2 to 9.3 and a conductivity of 4.2 to 5.2 micromhos/cm<sup>3</sup>. Similar feedwater data ranges are available for the 1978-1981 time period.

Figure 7 - pH (P) and dissolved oxygen (O) data for the feedwater at Point Beach Unit No. 1 during 1983.

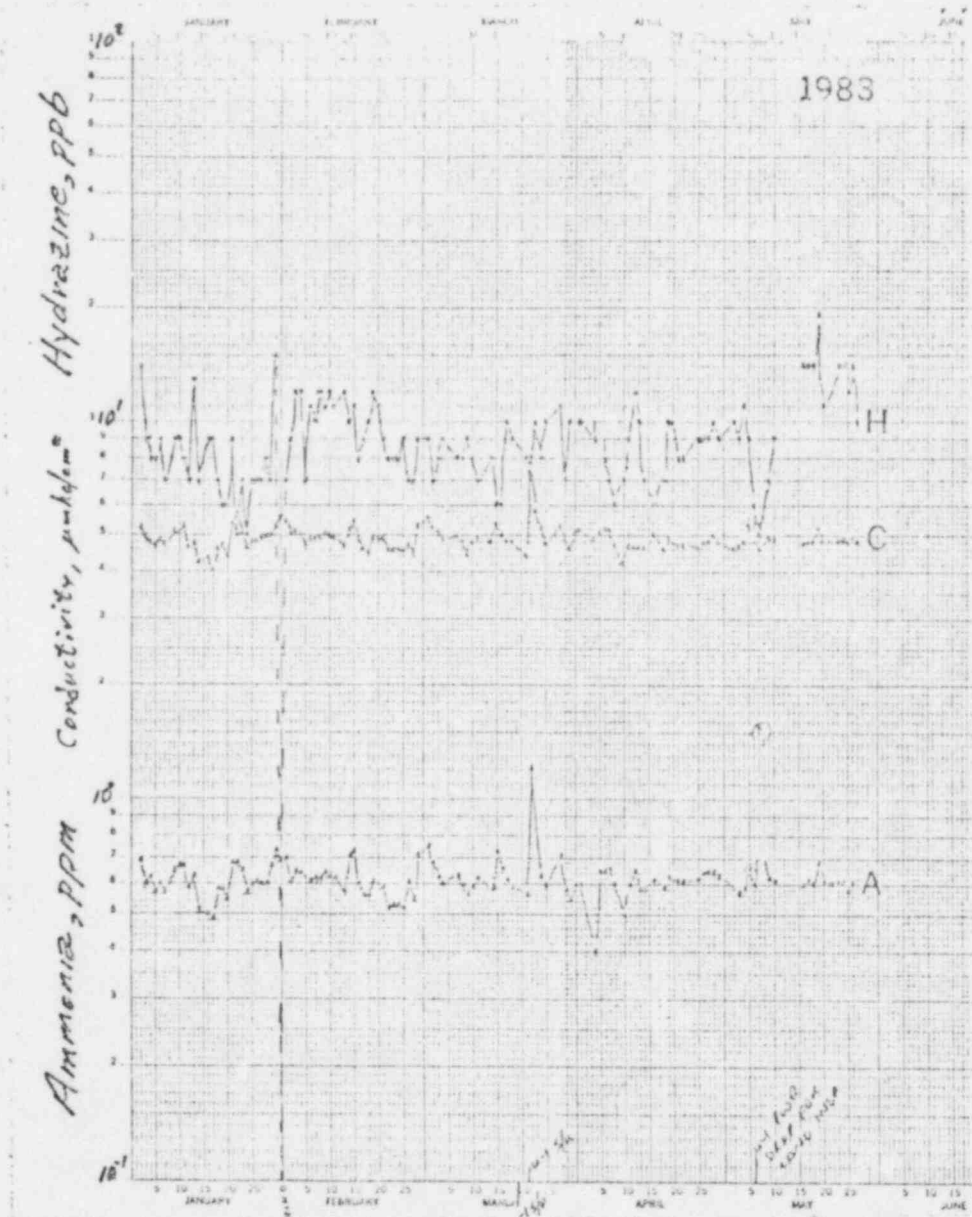
Figure 8 - Conductivity (C), residual hydrazine (H), and ammonia (A) data for the feedwater at Point Beach Unit No. 1 during 1983.

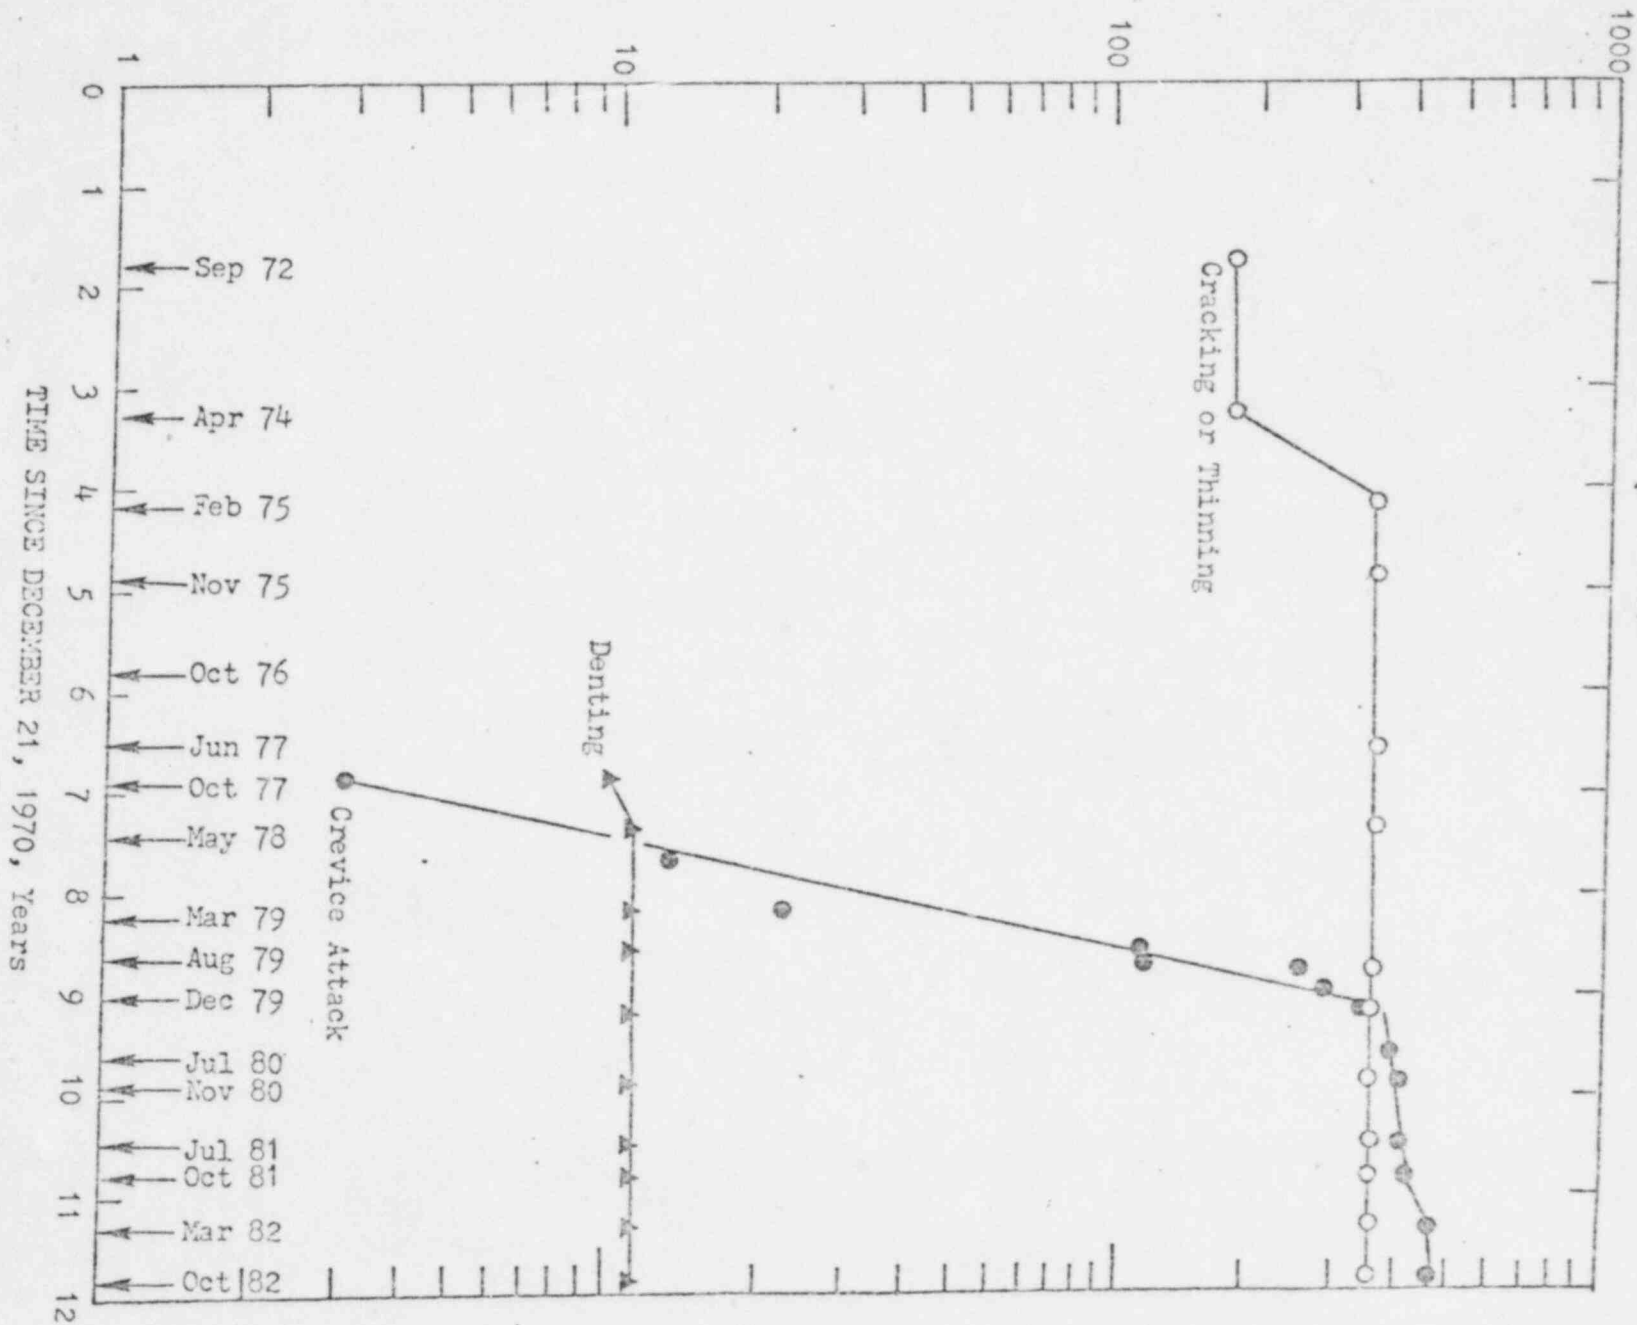
Examination of the Steam Generator Tube Plugging History for Point Beach Unit No. 1 (see Appendix) reveals that the only anticipated, corrosion-related reason for the future plugging of tubes in the existing steam generators would be intergranular/stress corrosion in the tube-tubesheet crevices. The other corrosion-related tube degradation phenomena have been effectively mitigated (Figure 9). Analysis of the intergranular/stress corrosion (crevice) data in Figure 9 between February 1980 and October 1982 provides the only means at the present time of predicting future tube plugging at Point Beach Unit No. 1. Assuming a linear extrapolation of these data on a semilogarithmic plot and allowing a correction factor for the temporary operation at a hot-leg temperature of 575 °F, it can be roughly estimated that an additional 80 to 85 tubes will require plugging during the next 2.5 years of operation (i.e., between June 1983 and December 1985); possibly another 110 to 120 tubes will require plugging between December 1985 and December 1990. It must be emphasized that these predictions are based upon continued operation at 77% of full power with a hot-leg temperature of 557 °F.

Figure 9 - History of Steam Generator Tube Plugging at Point Beach Unit No. 1. Only intergranular/stress corrosion in the tube-tubesheet crevices is a problem of major concern at the present time.
