MONTICELLO NUCLEAR GENERATING PLANT
Docket No. 50-263 License No. DPR-22

Initial (30 day) Response to NRC Generic Letter 94-03, "Intergranular Stress Corrosion Cracking of Core Shrouds in Boiling Water Reactors"

Core Shroud Inspection Plan for the Monticello Nuclear Generating Plant

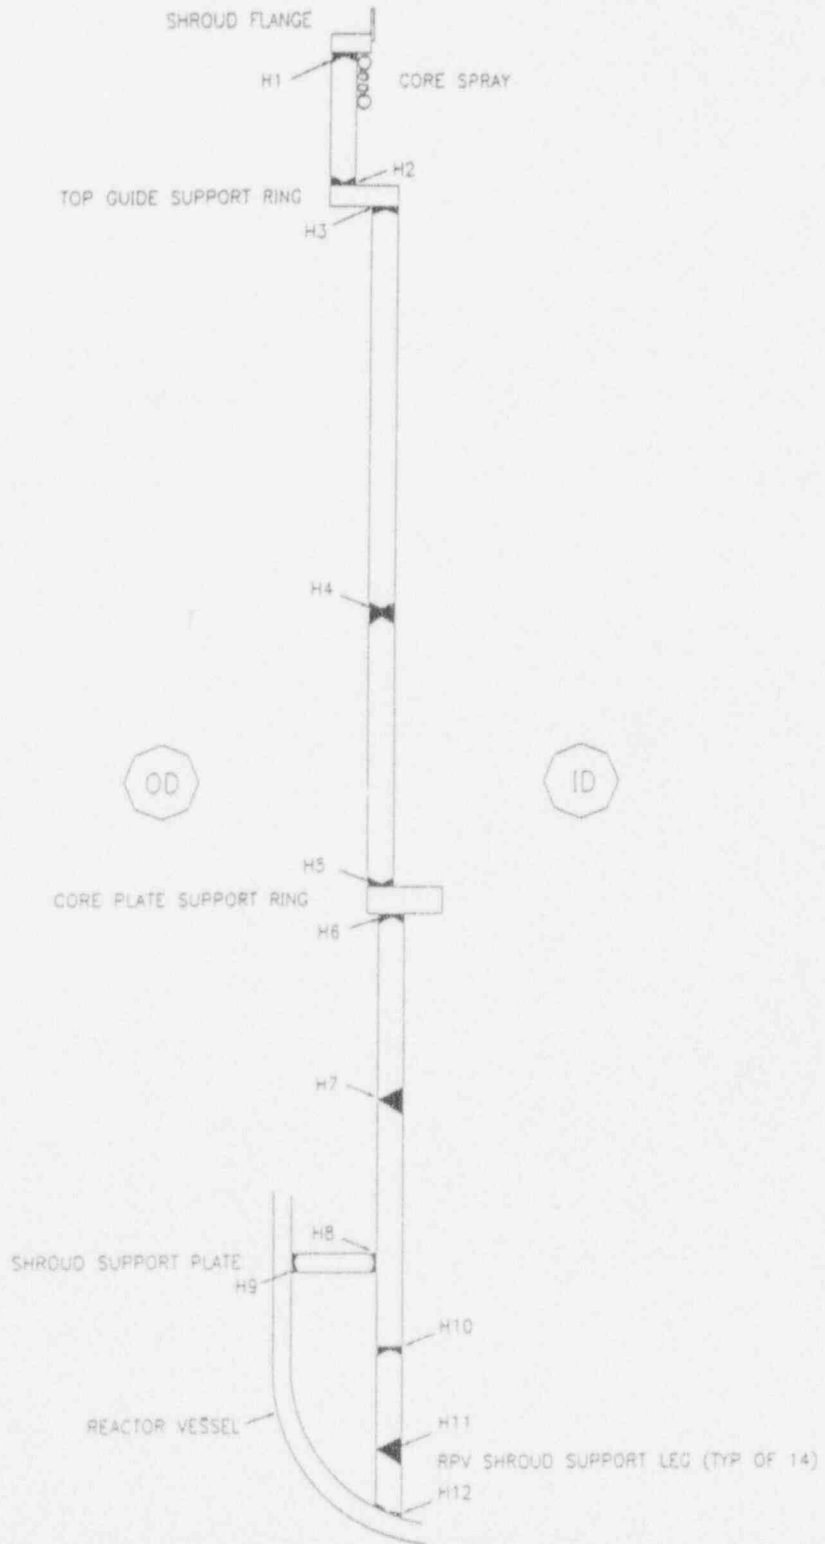
Refer to Figure A-1 of this attachment for weld identification locations.

Monticello Core Shroud Cross Section
Core Shroud Weld Locations and Weld Identification
