PACIFIC AIR PRODUCTS CO.

Regarding: Docket #99900769/83-01

Regarding: Texas Utilities Generating Co.
Comanche Peak Steam Electric Station
Gibbs & Hill Project 2323
Spec. 2323-M5-84
PAPCo Job # 5800

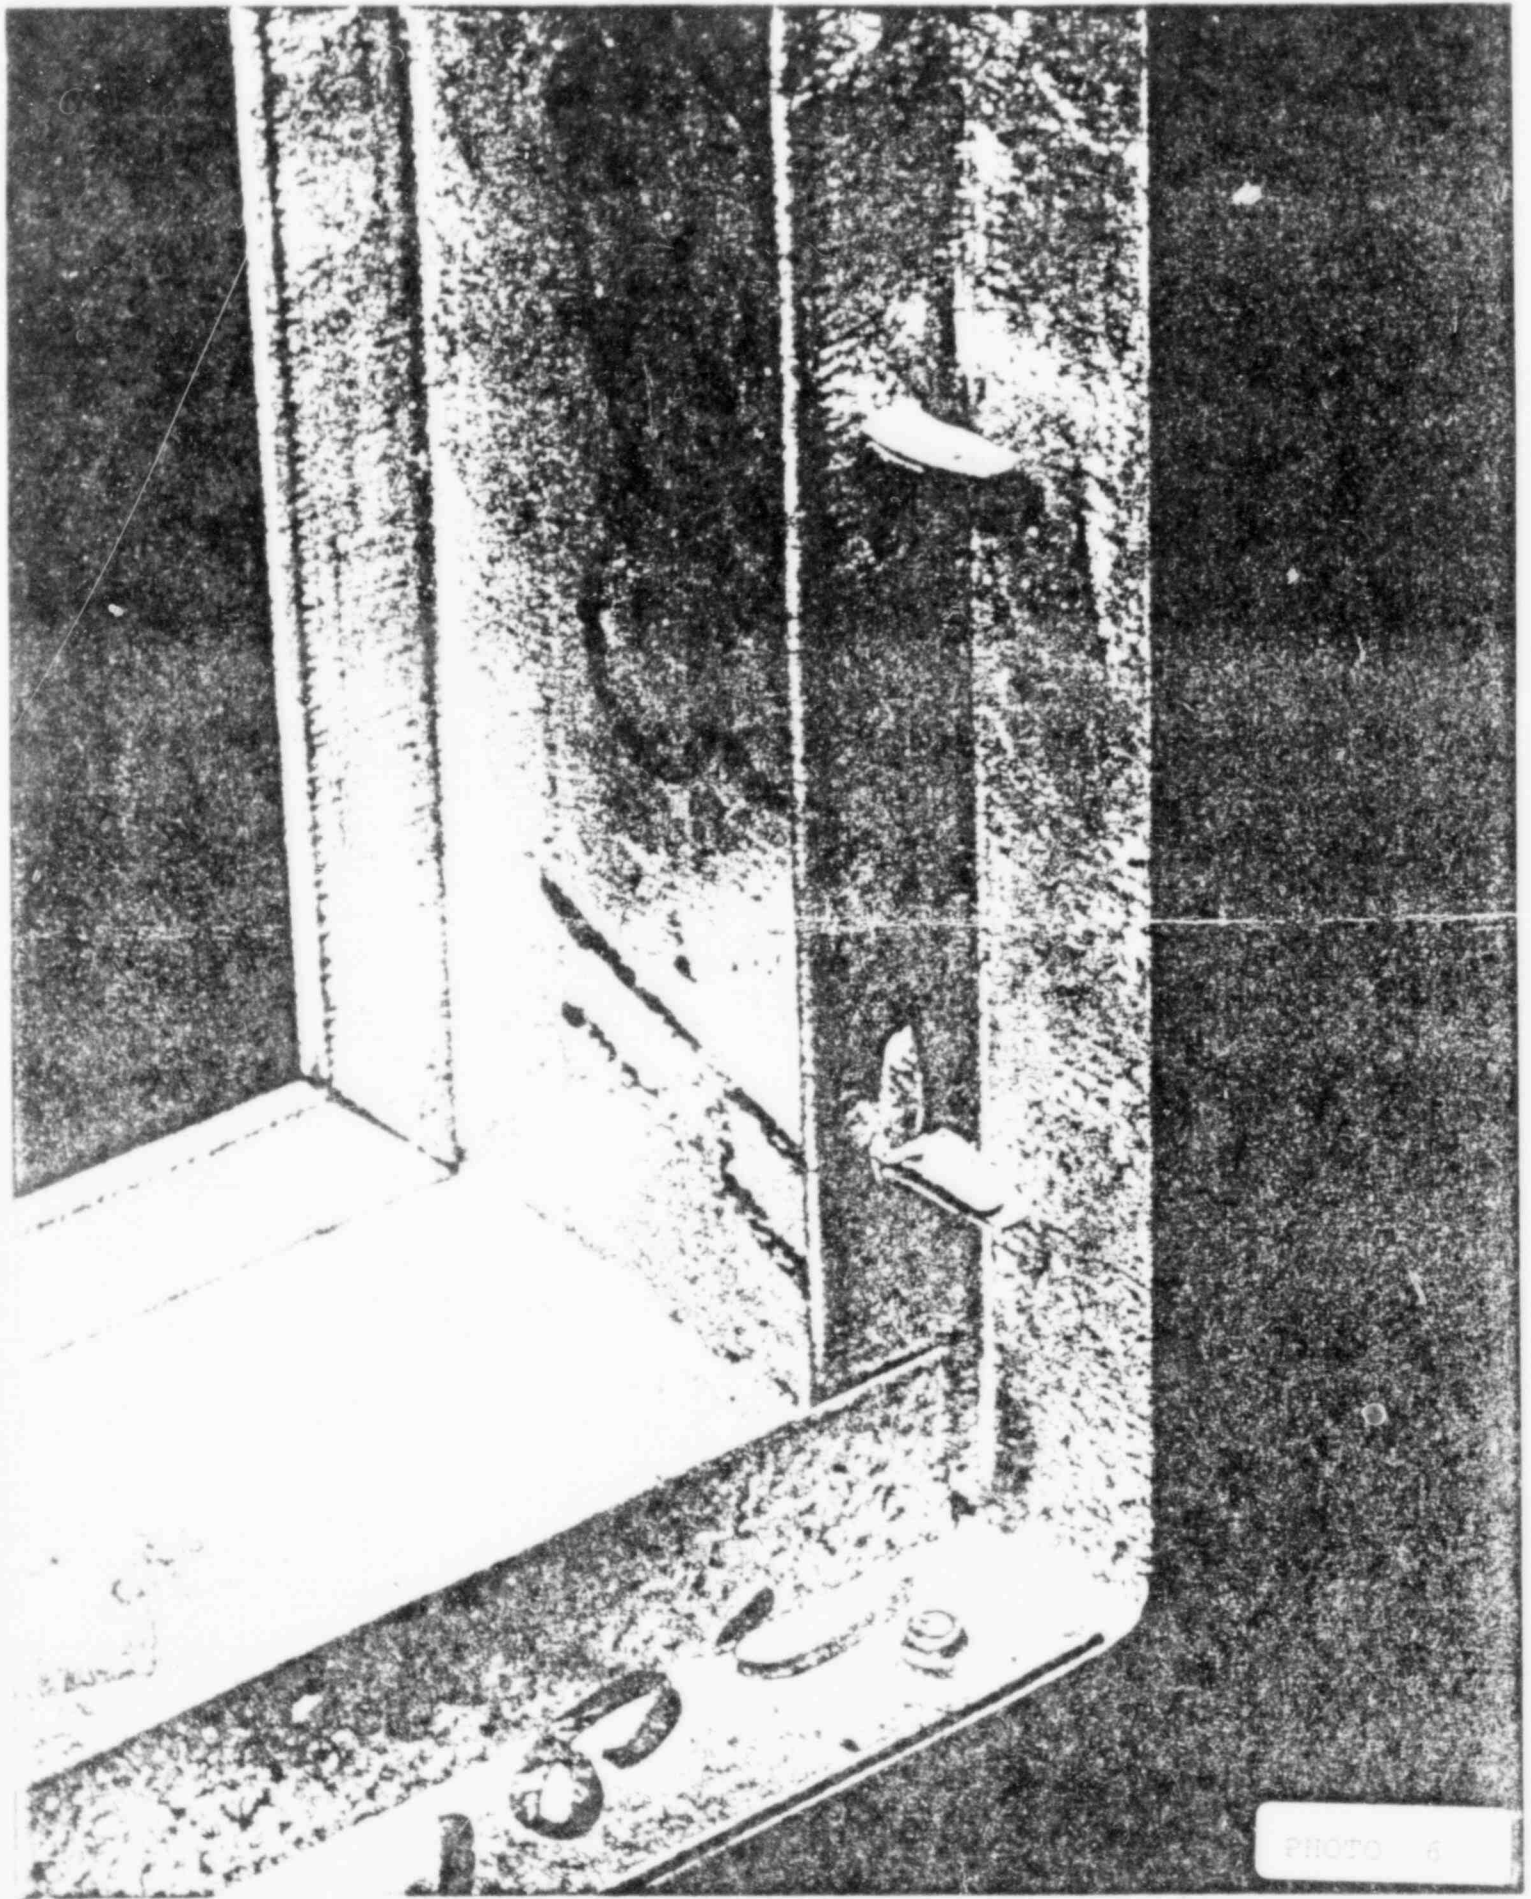
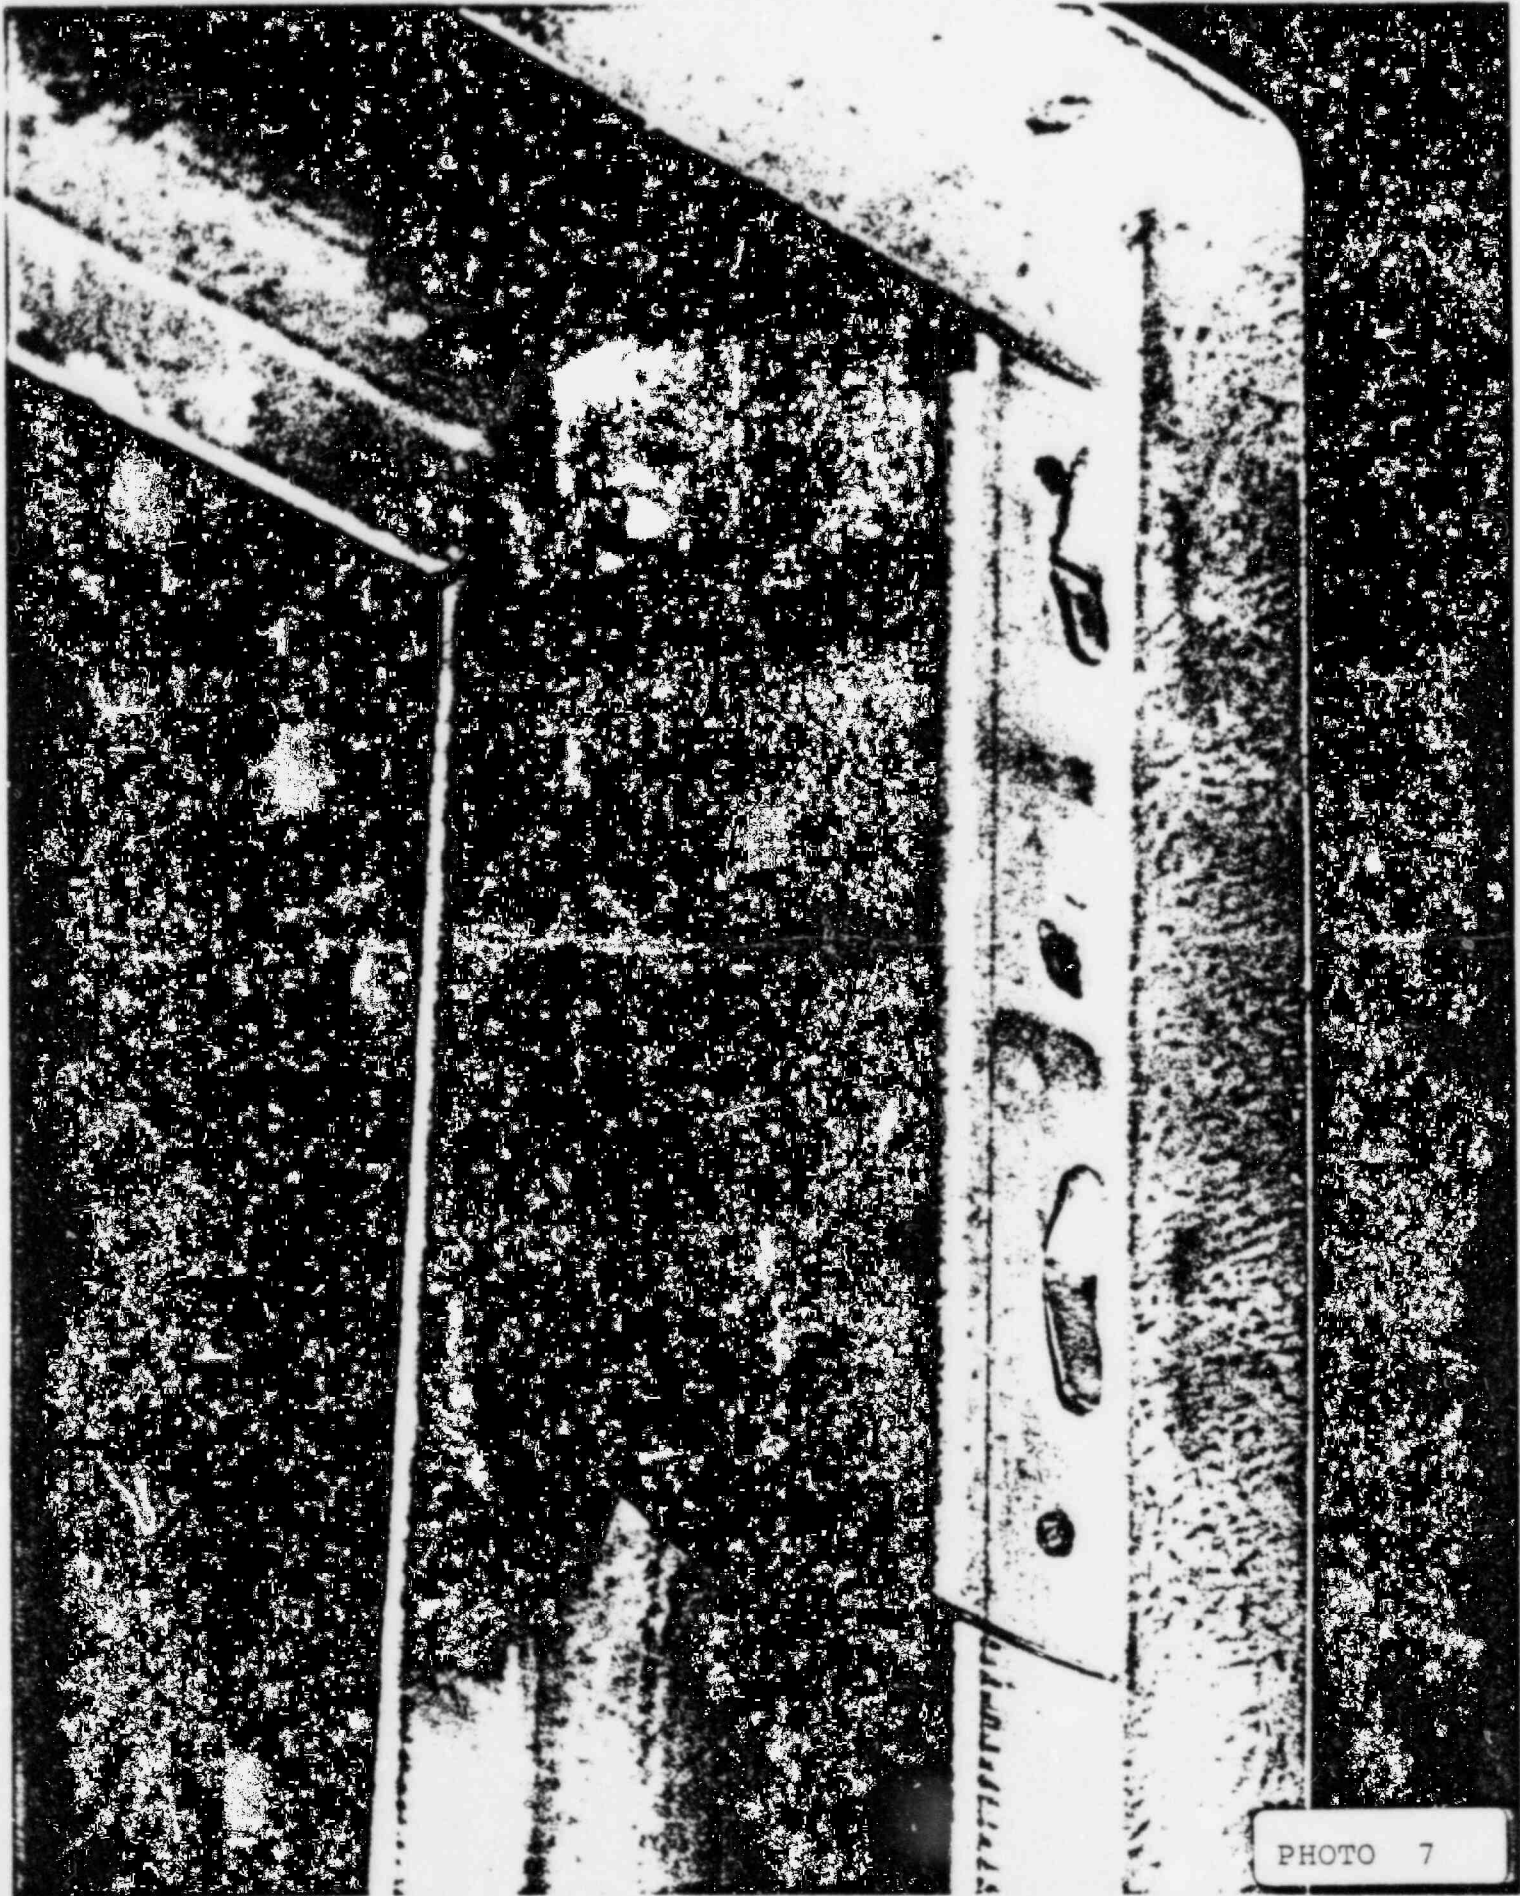
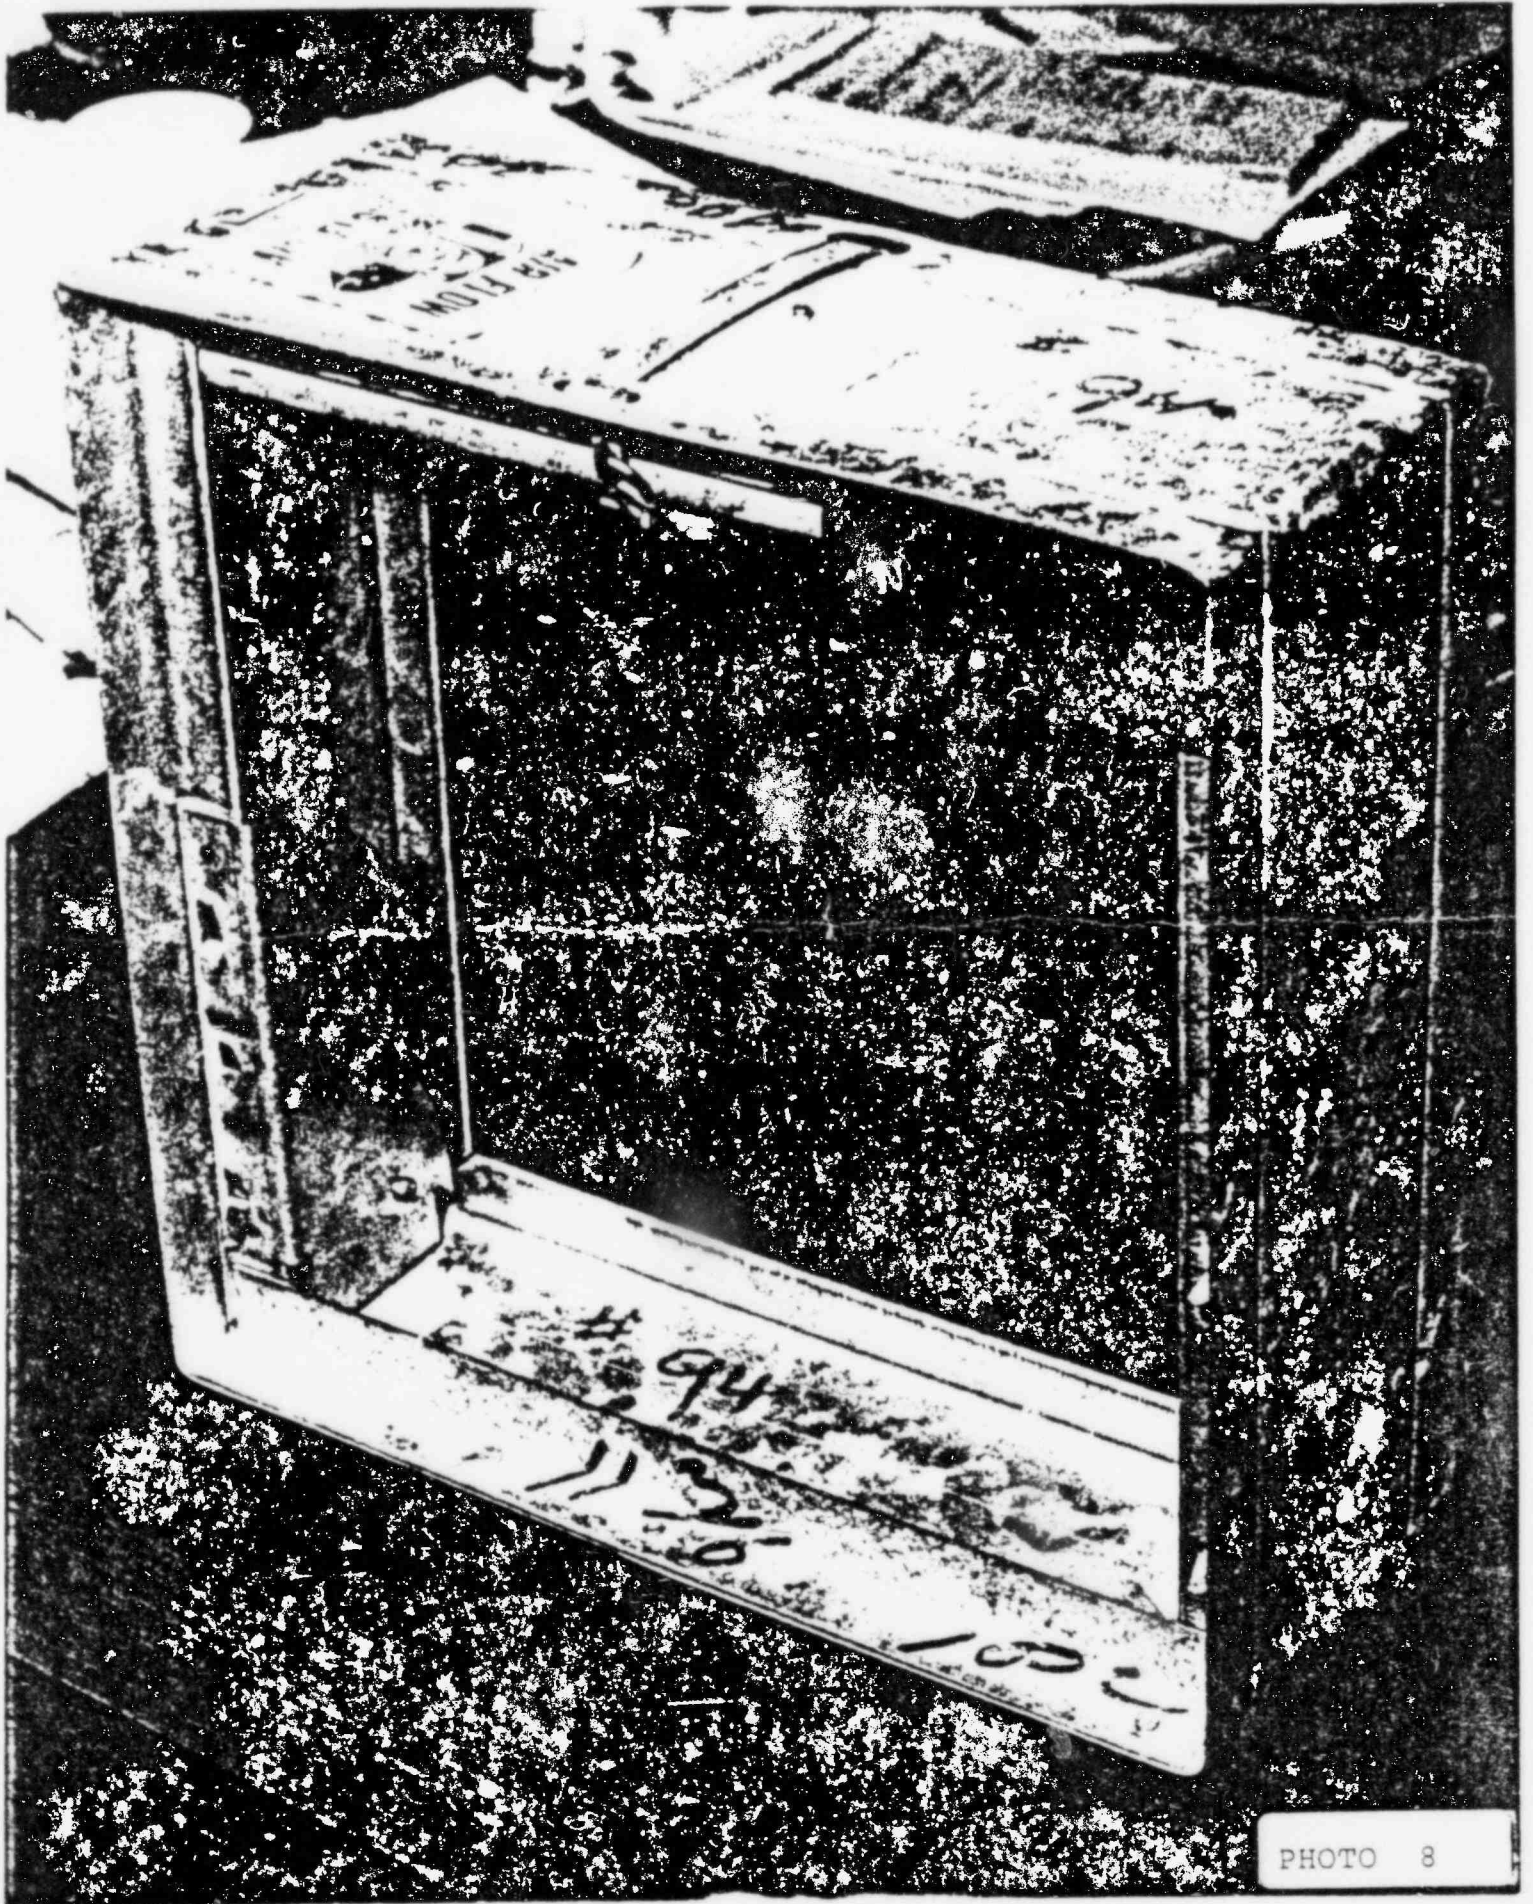
In my opinion, the method for attaching the blade lock assembly is adequate for the intended purpose (See Photo No. 6, 7, & 8).

I believe that some of the dampers on the site were affected by "Monday morning syndrome" and the factory assembler bent the tabs that hold the blade locking clip to the damper frame backwards (or not at all).

EXAMPLE: If the two tabs are bent down toward the bottom of the damper, the blade striking the damper would not loosen the clip but the action of opening the damper would.

If the two tabs were bent up towards the top of the damper, the blade striking the blade locking clip would loosen and probably dislodge the blade locking clip. If the top clip was bent up and the bottom clip bent down, the blade clip should be secure. This is the factory recommendation and field proven method.

SOLUTION: The fire dampers on the site should be inspected to determine that all blade locking clip tabs are properly secured.

If the blade locking clips are improperly secured, then the blade locking clip should either be secured in the proper manner or the blade locking clip should be pop riveted in place per the procedure furnished by Air Balance Company.
