Maine Yankee

Subject: Maine Yankee Licensee Event Report 94-016, Emergency Feedwater
Isolation Valve Leakage

TITLE (4)
Emergency Feedwater Isolation Valve Leakage

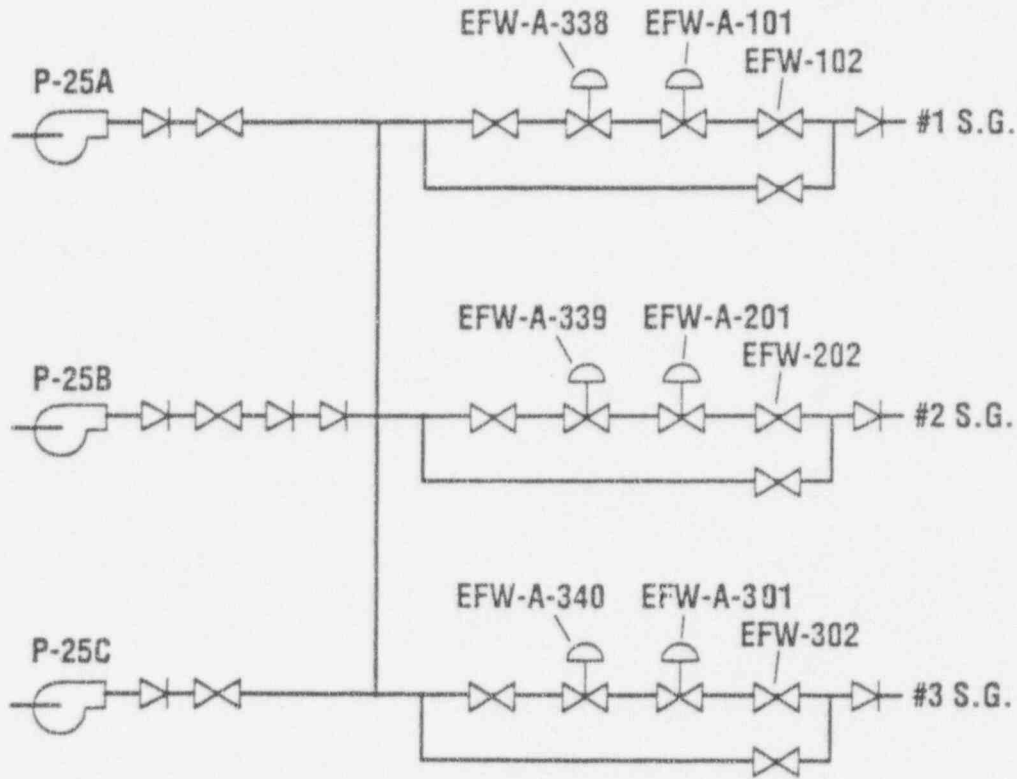
Attachment A

On August 10, 1994 comprehensive testing was performed on the Emergency Feedwater isolation and regulating valves for all three Steam Generators using precision test equipment. These tests revealed leakrates for various individual valves and combinations of valves from 0 to 36 GPM per Steam Generator (See Attachment A). Safety Analysis sensitivity studies conducted in parallel with these tests established the following revised acceptance criteria:

SG	Valve(s) Closed	As Found 08/04/94	Test Results 08/10/94	As Left 08/11/94
1	EFW-A-101	75 GPM	36 GPM	0 GPM
	EFW-A-338	400 GPM	20 GPM	24 GPM
	EFW-A-101 & 338	-	15 GPM	0 GPM
	EFW-A-101, 338 & EFW-102	-	0 GPM	0 GPM
2	EFW-A-201	-	0 GPM	0 GPM
	EFW-A-339	-	17 GPM	17 GPM
	EFW-A 201 & 339	-	0 GPM	0 GPM
	EFW-A-201, 339 & EFW-202	-	0 GPM	0 GPM
3	EFW-A-301	-	0 GPM	0 GPM
	EFW-A-340	-	36 GPM	23 GPM
	EFW-A-301 & 340	-	4 GPM	0 GPM
	EFW-A-301, 340 & EFW-302	-	0 GPM	0 GPM

In order to meet the revised acceptance criteria, EFW-A-101 was adjusted to reduce leakage past EFW-A-101 & 338 to zero GPM and administrative controls were implemented to ensure termination of any potential future leakage to a ruptured Steam Generator within 30 minutes using manual isolation valves (V).
