UNITED STATES  
NUCLEAR REGULATORY COMMISSION  
WASHINGTON, D. C. 20555

SAFETY EVALUATION REPORT BY THE OFFICE OF NUCLEAR REACTOR REGULATION  
CONCERNING  
THE CONTROL ROD DRIVE TRIP BREAKERS  
AT  
ARKANSAS NUCLEAR ONE, UNIT NO. 1  
DOCKET NO. 50-313

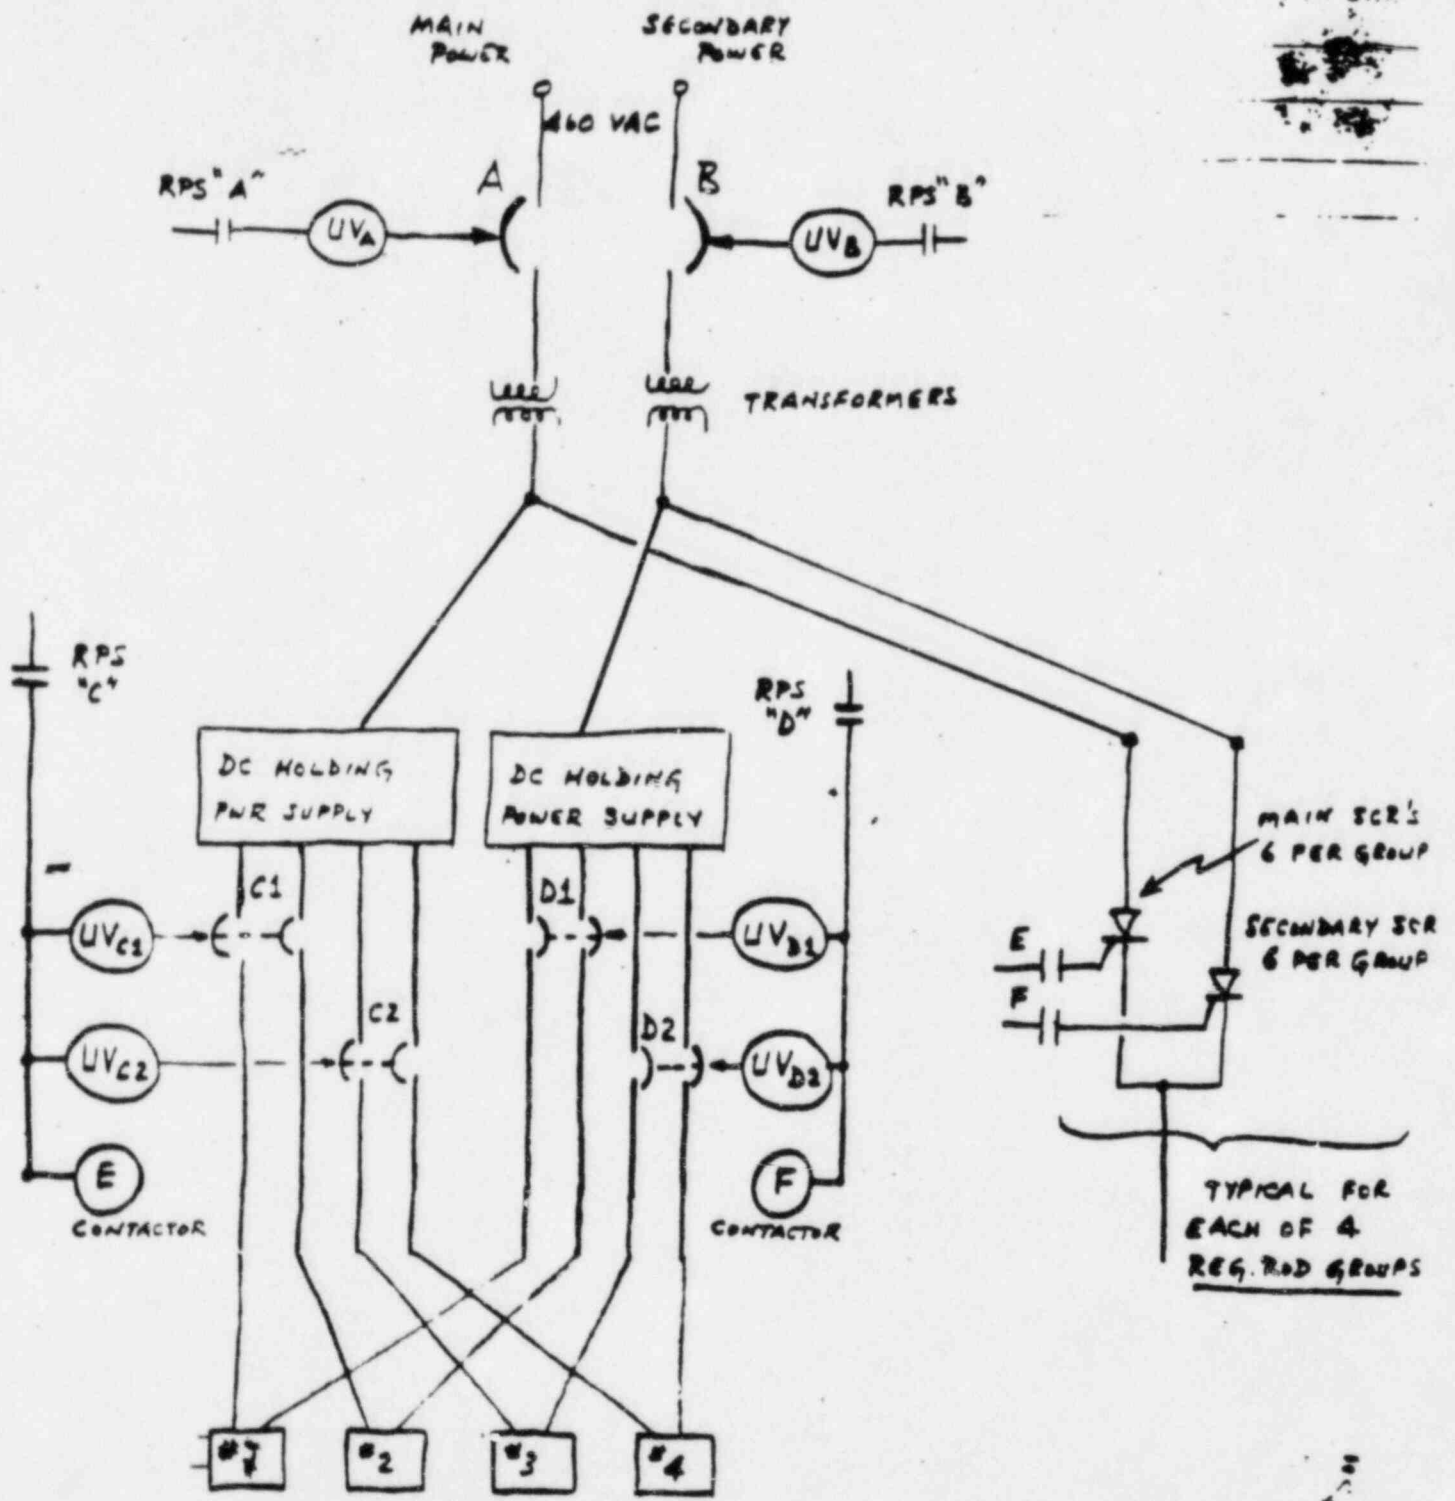
FIGURE 1

The configuration of the trip breakers and other devices used at ANO-1 to interrupt power to the control rods is shown in Figure 1. This configuration is a (1-out-of-2) X 2 logical arrangement. The combination of the Protection Channels and the breaker/contactors configuration provides an overall logic of (1-out-of-2) X 2 for reactor trip.

When a reactor trip occurs, three distinct power interruptions take place as shown in Figure 1. First, the two ac feed breakers (that provide power to all rods) are opened. Second, the dc breaker to each group of safety rods is tripped. Third, the contactors open which are indirectly in the gate circuits of the SCR's, causing the SCR's to stop conducting.

- SAFETY ROD GROUPS  
 (ONG "C" BREAKER AND ONE "D" BREAKER)  
 MUST OPEN TO TRIP EACH ROD GROUP

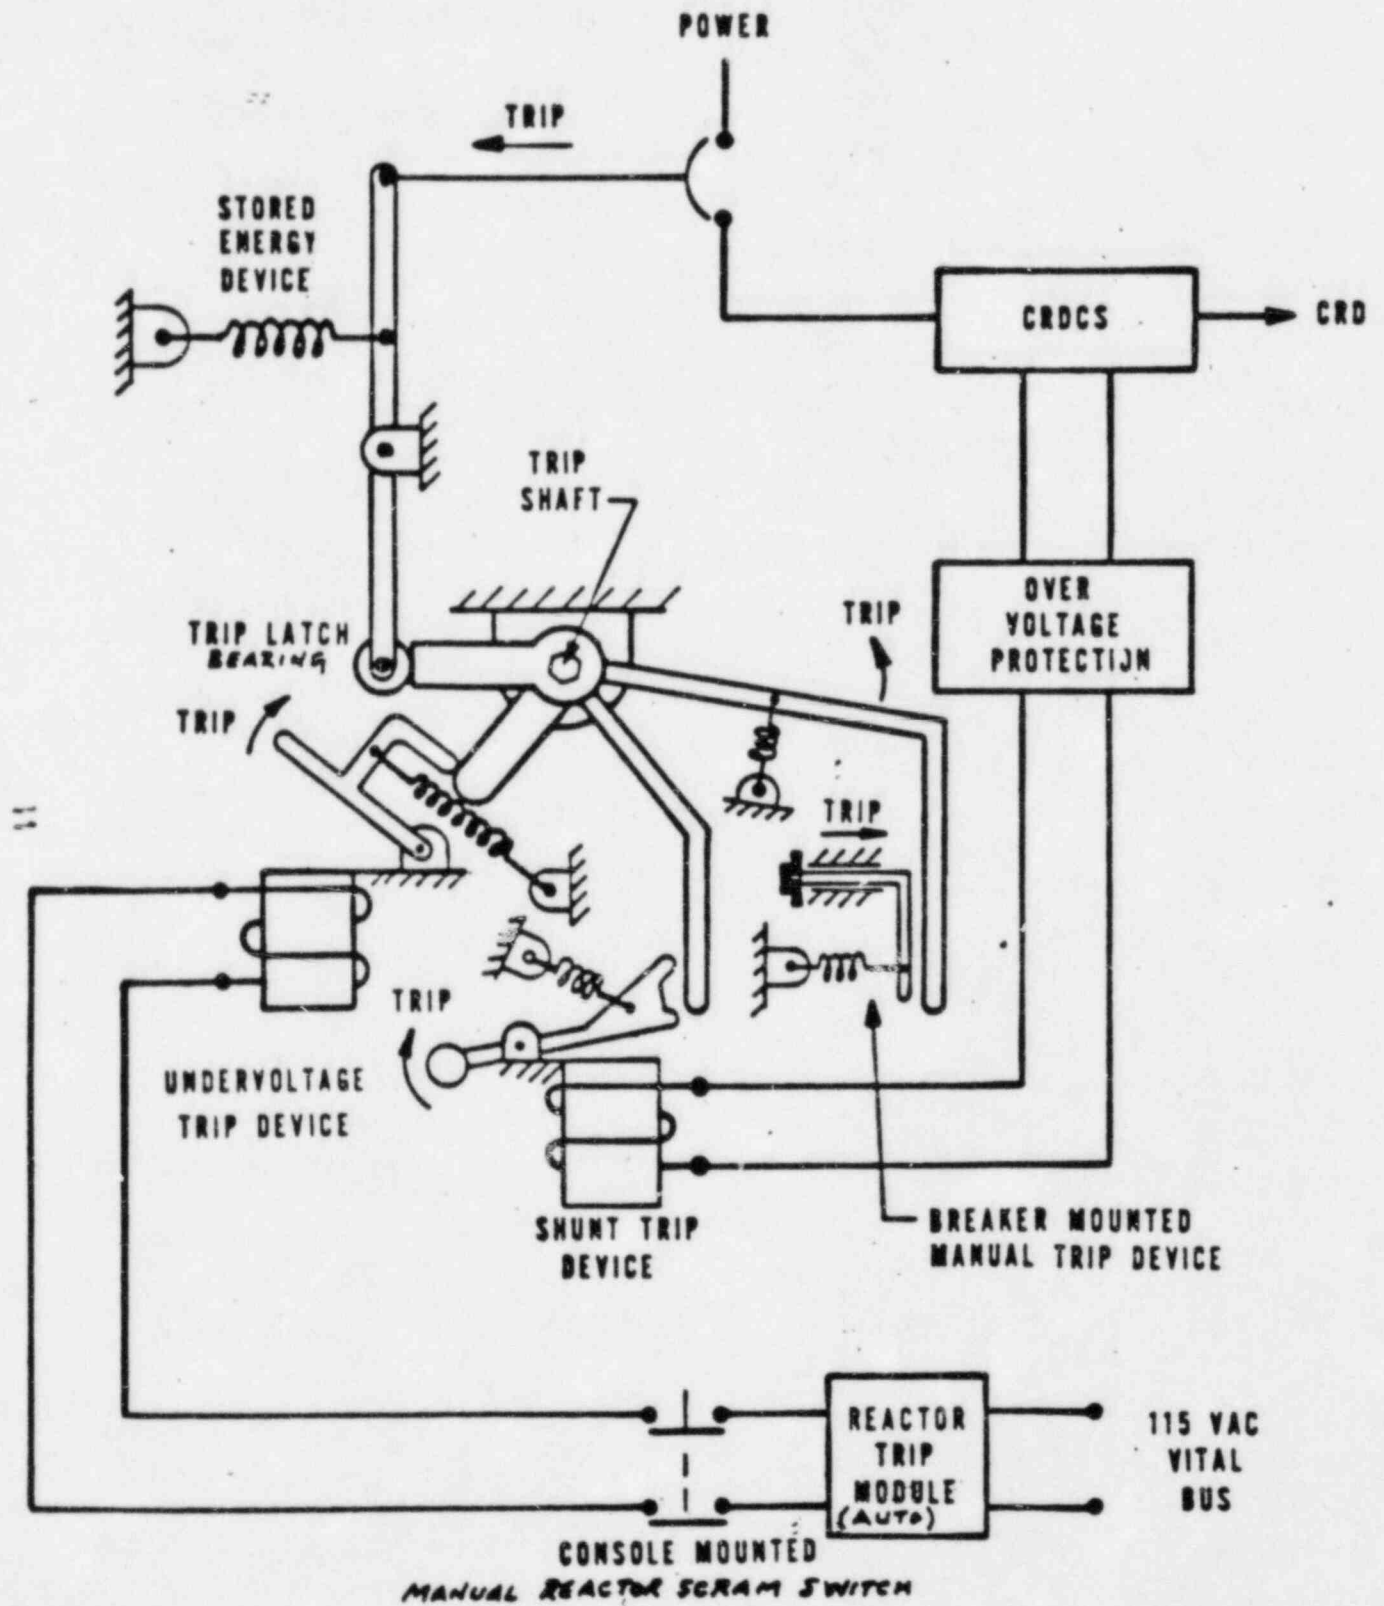
**FIGURE 2**

# GE AK-2 TYPE Reactor Trip Breaker

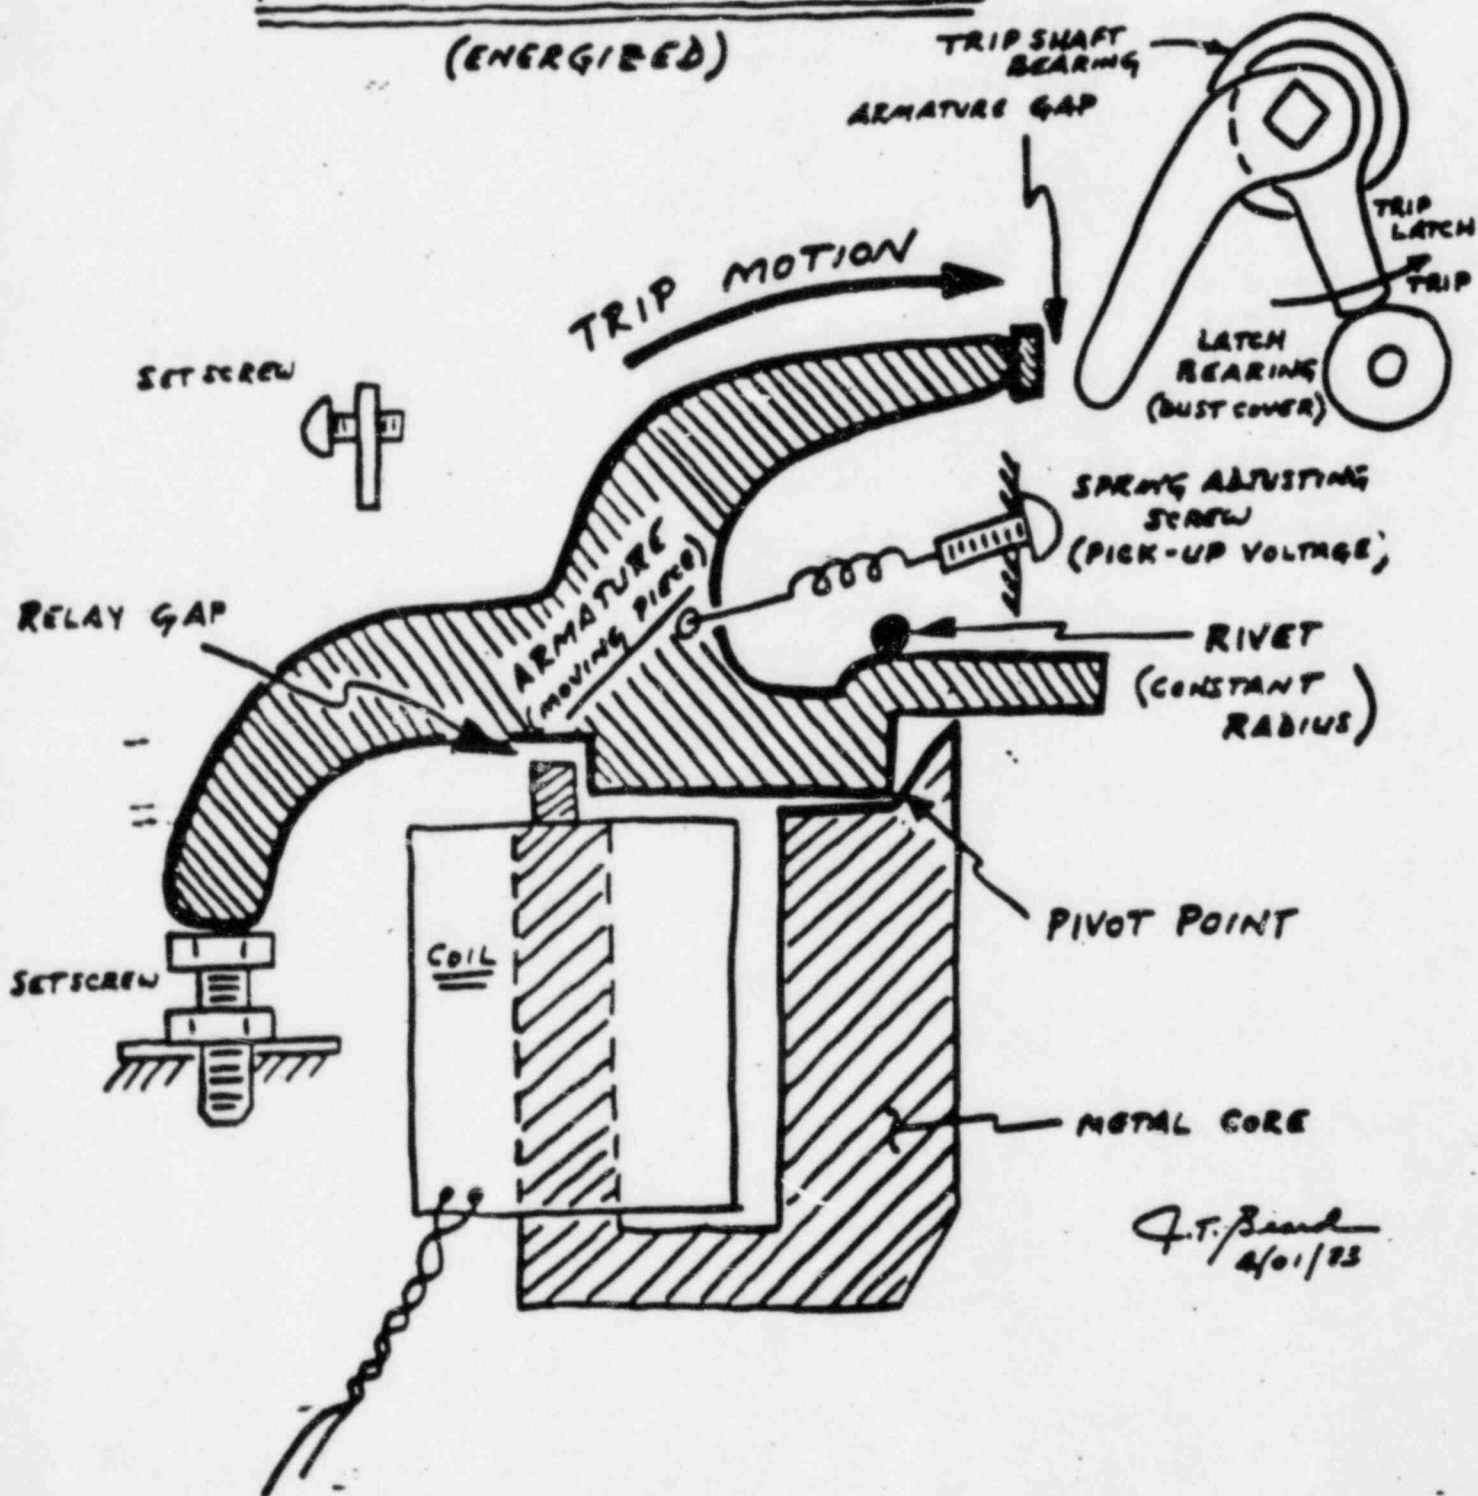
FIGURE 3

Based on the above, the staff concludes that the most likely causes of the failure to trip are (a) lack of lubrication of the breaker trip shaft bearings and the precision trip latch bearing, and (b) the undervoltage coil pickup voltage setting being less than that recommended by the vendor.

Figure 3 is a detail representation of the UV trip device. It shows various adjustments including the spring tension used to set the device pickup voltage. This figure also shows the trip shaft bearings and the precision latch bearing.

# GE AK-2 UV TRIP DEVICE
