UNITED STATES OF AMERICA  
NUCLEAR REGULATORY COMMISSION<sup>26</sup>

AFFIDAVIT OF ROBERT H. TURNER

PROJECT P.V.N.G.S. Evaporation Pond (7-54) SHEET 1 of 1CONTACTS Dick McGregor - APSKen Euge & Bill DuBois - Ertec WesternIMPORTANT ACTIONS TAKEN:

INSPECTION OF DAM CONSTRUCTIONPROJECT P.V.N.G.S. Evaporation Pond (7-54)

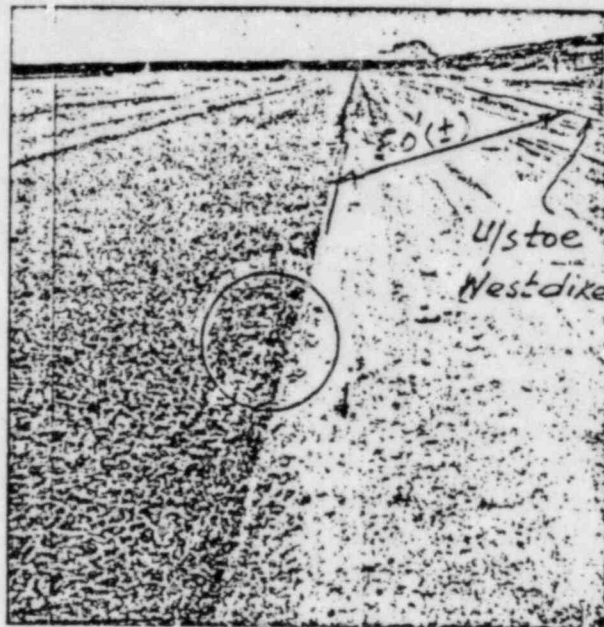
First layer of pond lining  
at bottom starting near  
the u/s toe of the west  
dike. View looking south.  
Notice gravel sticking out  
of the lining material  
and the surface  
irregularities.

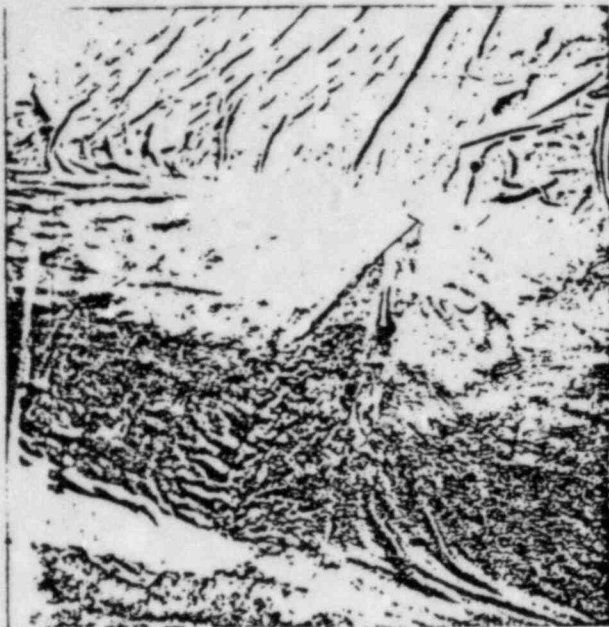
1. The liner appears to be sound and sturdy and quite satisfactory.
2. The jointing of the different sections and the 3 ft. overlap is in accordance with the specifications.
3. The rupture in the lining material noticed at few locations is patched up with sufficient overlap.
4. Termination of the liner at the downstream toe is not completed.
5. There are some questions about the contractor's methods of terminating the upper end of the liner on the upstream end of the crest. The construction drawings (which were reviewed and approved with the understanding that the liner will be placed according to the manufacturer's specifications) call for 12" deep trench, whereas the manufacturer's specifications require a minimum of 18" deep trench.

Notice rupture in the hypalon liner near the u/s toe. Location: South dike, near southwest corner, Station 27+00.

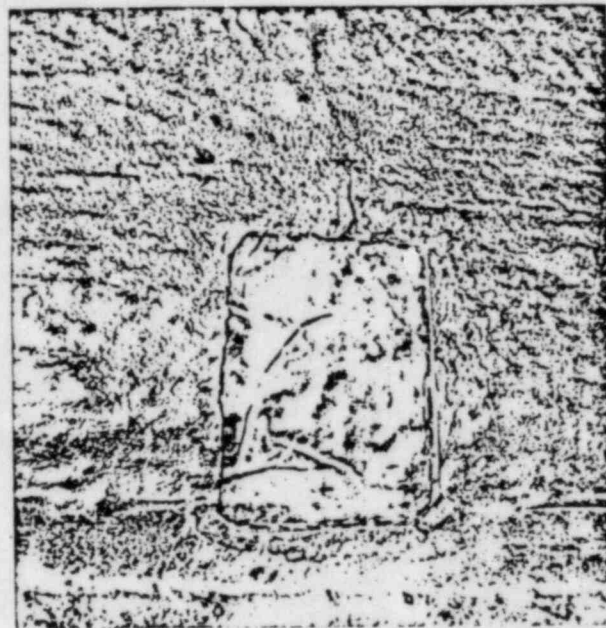
Similar rupture in the liner patched up. Location: Approx. 150 feet west of Station 27+00, near southwest corner.

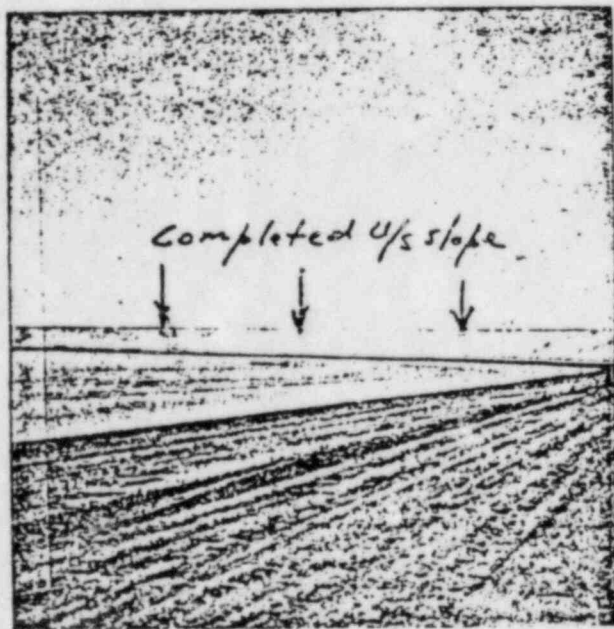
Hypalon liner placed on the upstream slope of the south dike at the southwest corner. View from West Dike.

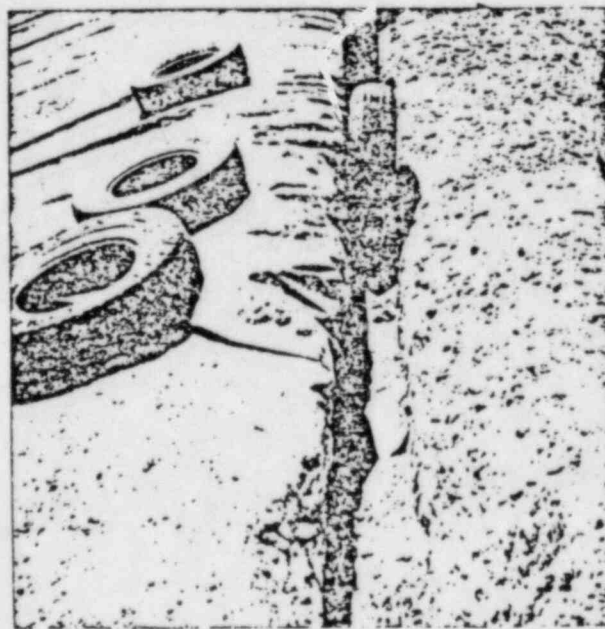
In my opinion, the trench depth giving a soil cover of 12" is not sufficient to prevent movement or the downward drag of the liner due to settlement, wave action and the hydrostatic forces.

The hypalon liner being terminated on the upstream side of the crest. Trench dimensions: 12" w x 12" d.

I discussed this with Dick McGregor at the site and Joe Kanovich (both of APS) after my return to the office and asked them to look into the matter before it is too late. To insure sufficient anchorage we would require that the manufacturer's specifications of the 18" minimum trench depth be followed. Further, the contractor is presently backfilling the trench without compaction. I suggested, 6" layers of uncompacted thickness should be hand tamped with proper care taken to protect the liner from damage. Joe Kanovich told me he will discuss these points with Goodrich and Bechtel staff and call me back.
