Beaver Valley Power Station, Unit No. 1  
Docket No. 50-334, License No. DPR-66  
LER 91-011-00

LER 91-011-00, 10 CFR 50.73.a.2.vii.c, "Failure of Safeguards Pit Ventilation Isolation Damper".

Failure of Safeguards Pit Ventilation Isolation Damper

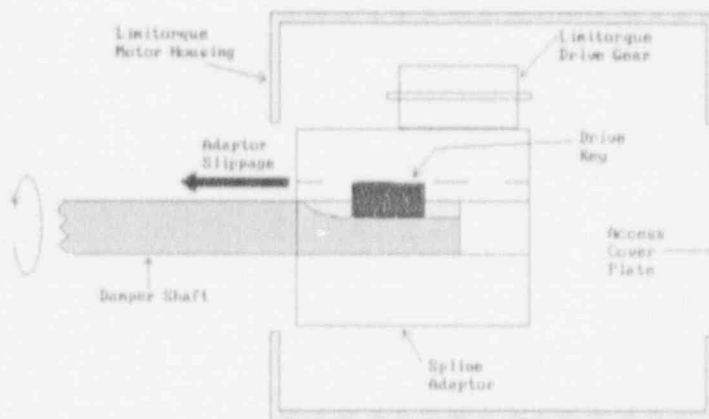
Figure 1

On 4/8/91, Maintenance was inspecting the train A Safeguards Pit Ventilation Isolation Damper VS-D-4-11A, manufactured by Shan-Rod, model number 4320. During this inspection, it was discovered that the spline adaptor keyed onto the damper shaft had moved along the shaft towards the damper. This movement was sufficient to allow the adaptor to disengage from the motor operator drive gear. With the adaptor not engaged to the drive gear, the damper position could not be changed by the motor. (Figure 1 shows the adaptor fully engaged to the drive gear.) The series train B damper was tested and verified to be functioning properly. During a Containment Isolation Phase B, these dampers isolate the normal ventilation flow to the Safeguards area valve pit. Although this does not provide a direct containment isolation function, this does decrease the potential for airborne activity in the Safeguards area during accident conditions coincident with leakage in the valve pit.

Typical Shan-Rod Spline Adaptor

This event appears to be due to a design deficiency involving the Shan-Rod damper shaft adaptor. Keying the adaptor to the shaft does not prevent the adaptor from sliding along the shaft during operation.

- 1) The adaptor for the train A Safeguards Pit Isolation Damper was adjusted to be fully engaged to the motor operator drive gear.
- 2) The station is currently inspecting all Shan-Rod dampers to determine if they have experienced adaptor slippage.
- 3) The station has contacted the damper's manufacturer and is developing a modification to the adaptor that will prevent future movement. This modification involves installing a spacer to prevent the spline adaptor from sliding along the shaft. See figure 2 for proposed modification. Either this or a similar modification will be installed on all Shan-Rod dampers at the station.

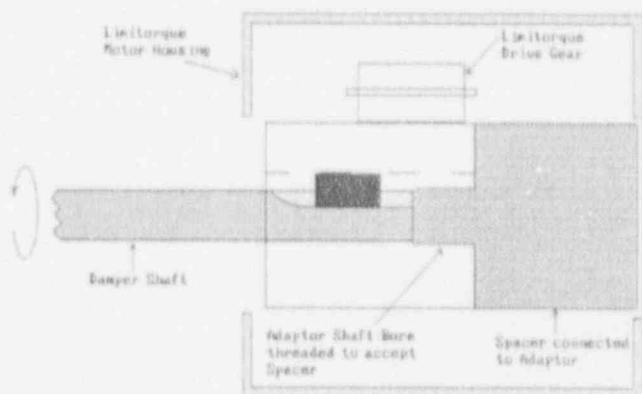
Figure 2

Modified Spline Adaptor
