TOLEDO EDISON COMPANY  
DAVIS-BESSE NUCLEAR POWER STATION UNIT ONE  
SUPPLEMENTAL INFORMATION FOR LER NP-32-83-01

IDENTIFICATION OF OCCURRENCE: Current operating practice involving the Emergency Core Cooling System (ECCS) Room Coolers was less conservative than the assumptions in the Safety Analysis Report (SAR)

LER #83-012

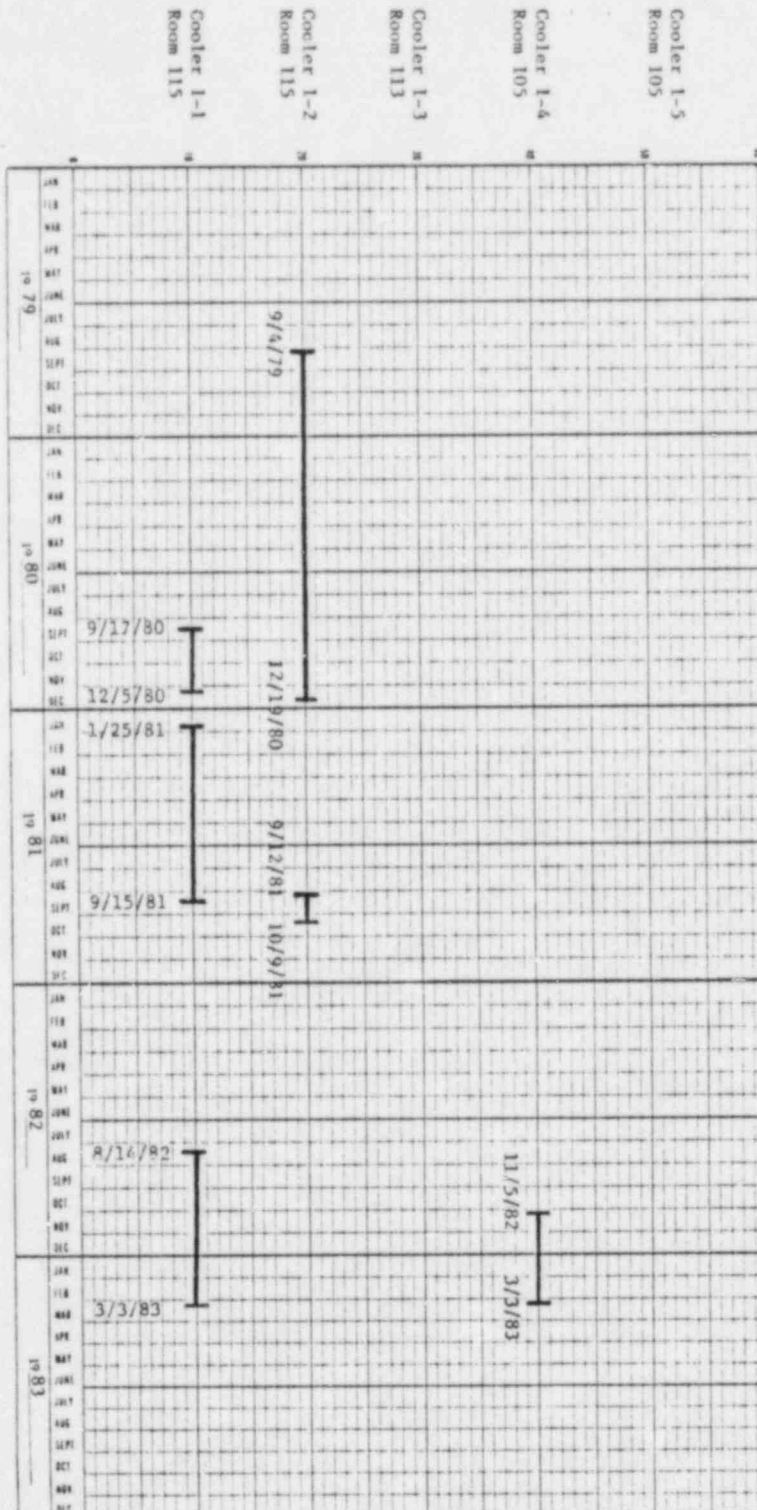
FIGURE 1: OUT OF SERVICE HISTORY FOR THE ECCS ROOM COOLERS

1 | During an investigation to determine the out of service history of the ECCS Room Coolers, it was discovered that both room coolers in Room 115 had been isolated during the time period of September 17 through December 5, 1980. This occurrence is being reported per Technical Specification 6.9.1.9.c. The complete history of when the ECCS Room Coolers have been taken out of service is shown in Figure 1.

As seen in Figure 1, there have been two time periods in which both ECCS Room Coolers in Room 115 have been taken out of service. These were:

- 1) From September 17 through December 5, 1980, and
- 2) From September 12 through September 15, 1981

During the first time period (September 17 through December 5, 1980, the unit was only at power from November 5 through December 3, 1980. The ECCS Room Coolers in Rooms 105 and 113 were in service during this time period ensuring that the ECCS train (Train 1) in Room 105 was operable. In

addition, at no time during this time period (November 5 through December 3, 1980) were there any equipment failures which would have rendered the operable ECCS train (Train 1) inoperable.

1 During the second time period (September 12 through September 15, 1981), the unit was at full power. The ECCS Room Coolers in Rooms 105 and 113 were in service, ensuring that ECCS Train 1 was operable. Again, there were no equipment failures of the ECCS Train 1 which would have rendered the operable ECCS train inoperable. This event has previously been reported in Licensee Event Report NP-33-81-70 (81-057).
