UNITED STATES
NUCLEAR REGULATORY COMMISSION
OFFICE OF INSPECTION AND ENFORCEMENT
WASHINGTON, D.C. 20555

April 1, 1979

IE Bulletin No. 79-05

NUCLEAR INCIDENT AT THREE MILE ISLAND

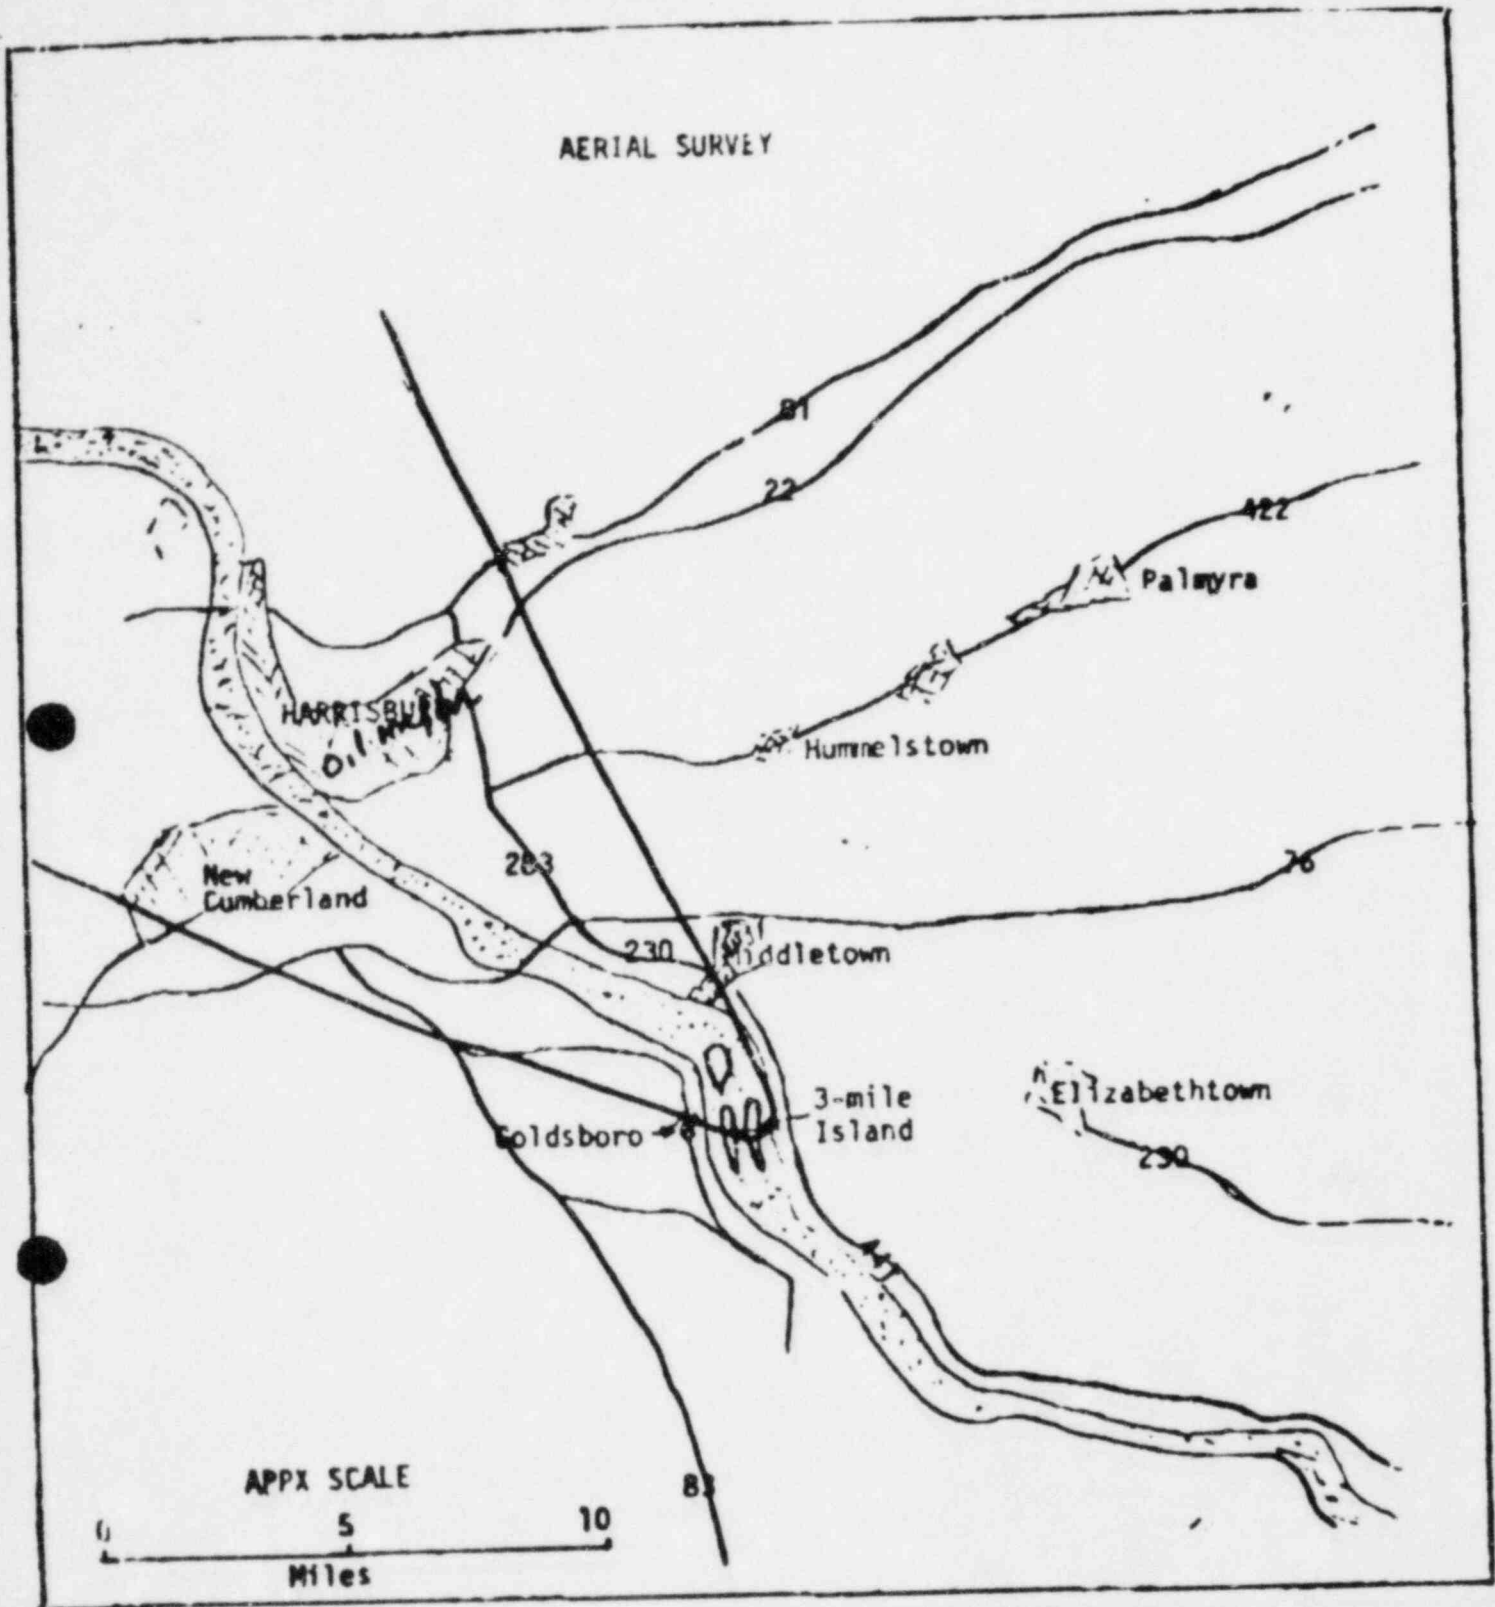
March 28, 1979 8:00 p.m.

Plume in a N to NW direction. Primarily Xe-133.
Over Harrisburg, radiation measurements in the plume showed about 0.1 mr/hr. At 10 miles from the site, the plume was about 4-5 miles wide; top of plume at about 3000 feet.

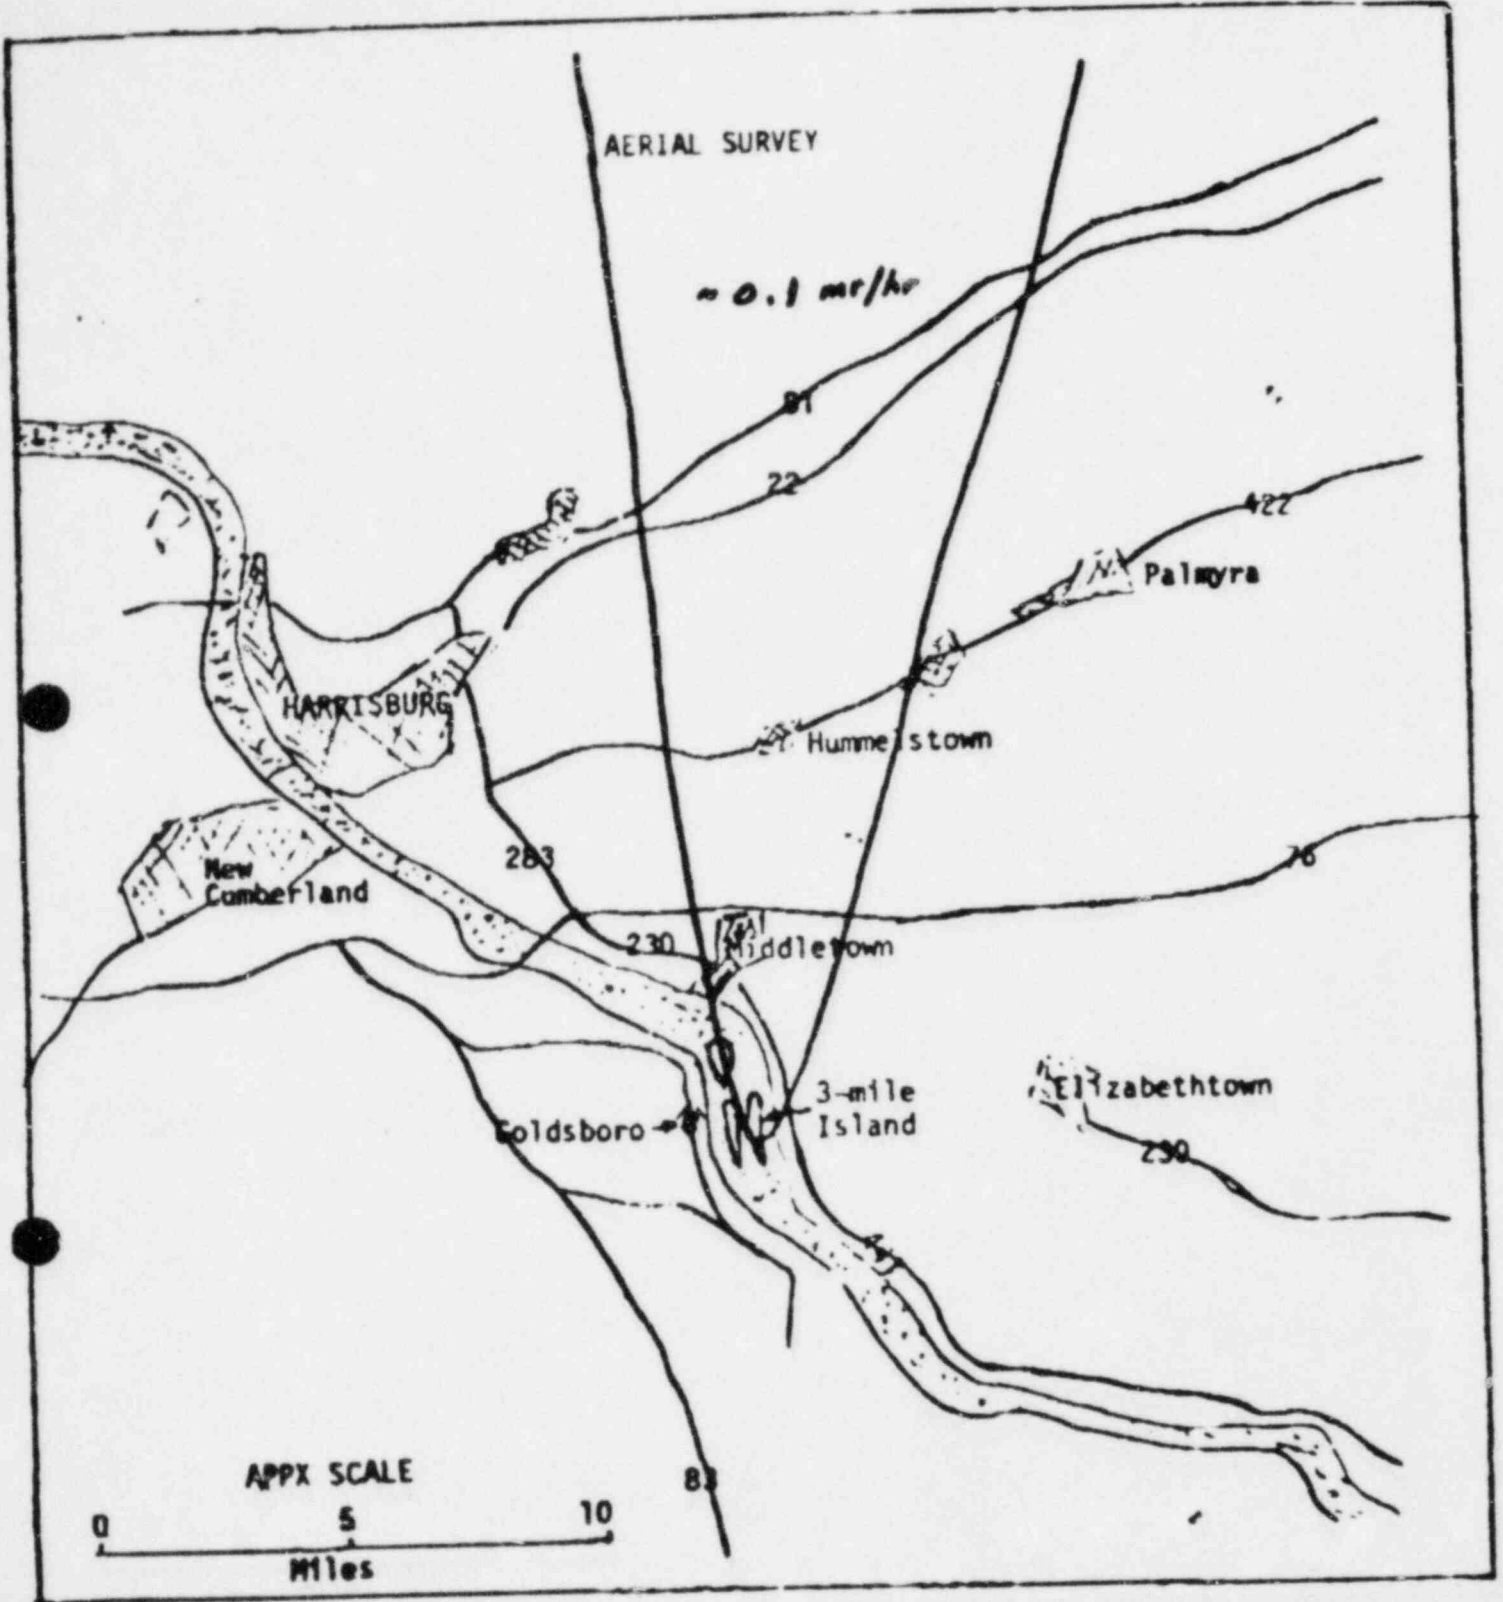
March 28, 1979 4:30 p.m.

Plume in a N to NE direction, about 30° sector.
Primarily Xe-133. At distance of about 16 miles,
radiation measurements in the plume were about 0.1 mr/hr.

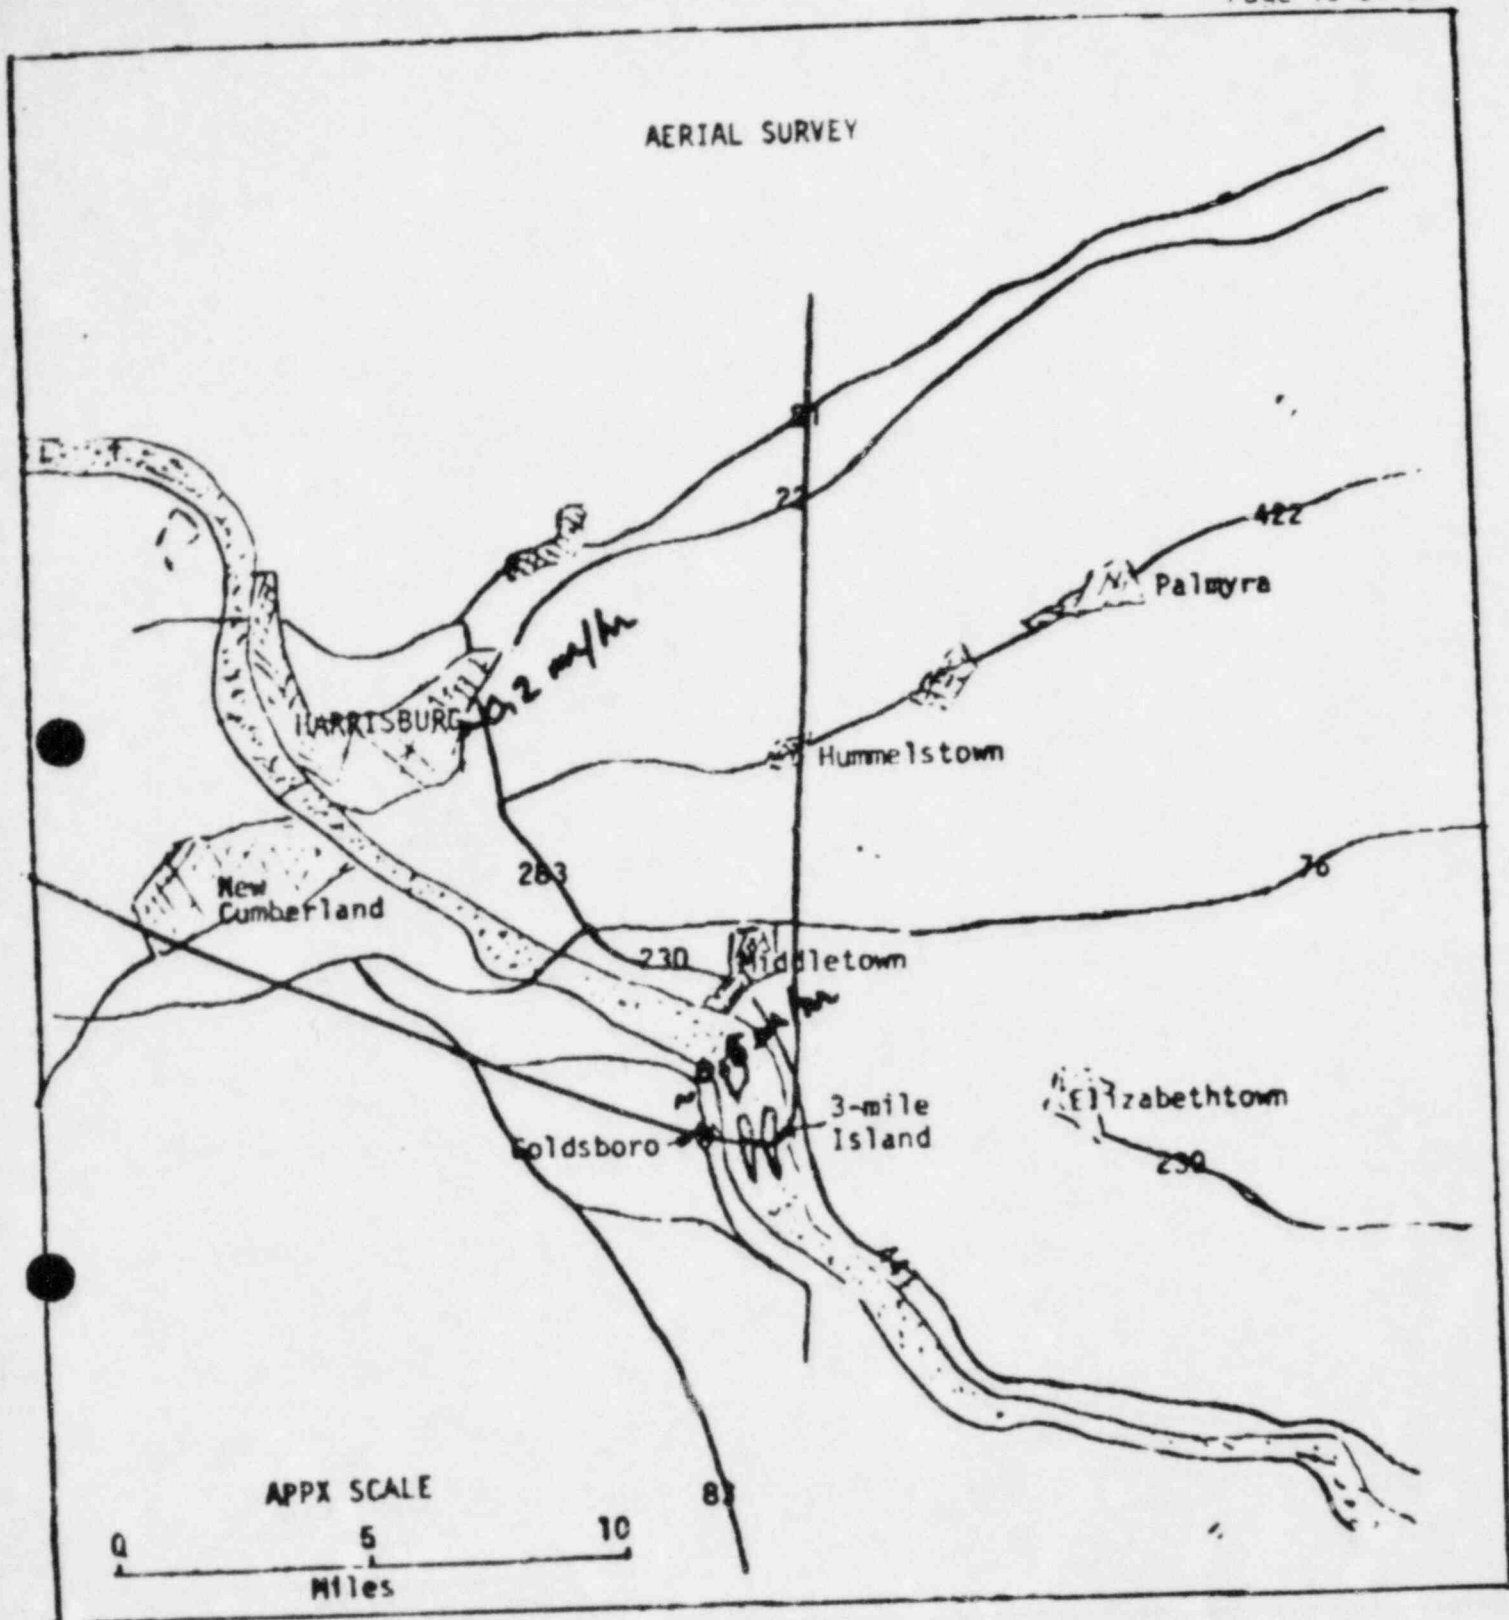
March 29, 1979 10:45 a.m.

Plume in a N to NW direction. Primarily Xe-133.
Radiation measurements in the plume at about 10 miles
from plant in centerline of plume were 0.2 mr/hr; at
1 mile from plant, about 0.5 mr/hr maximum.

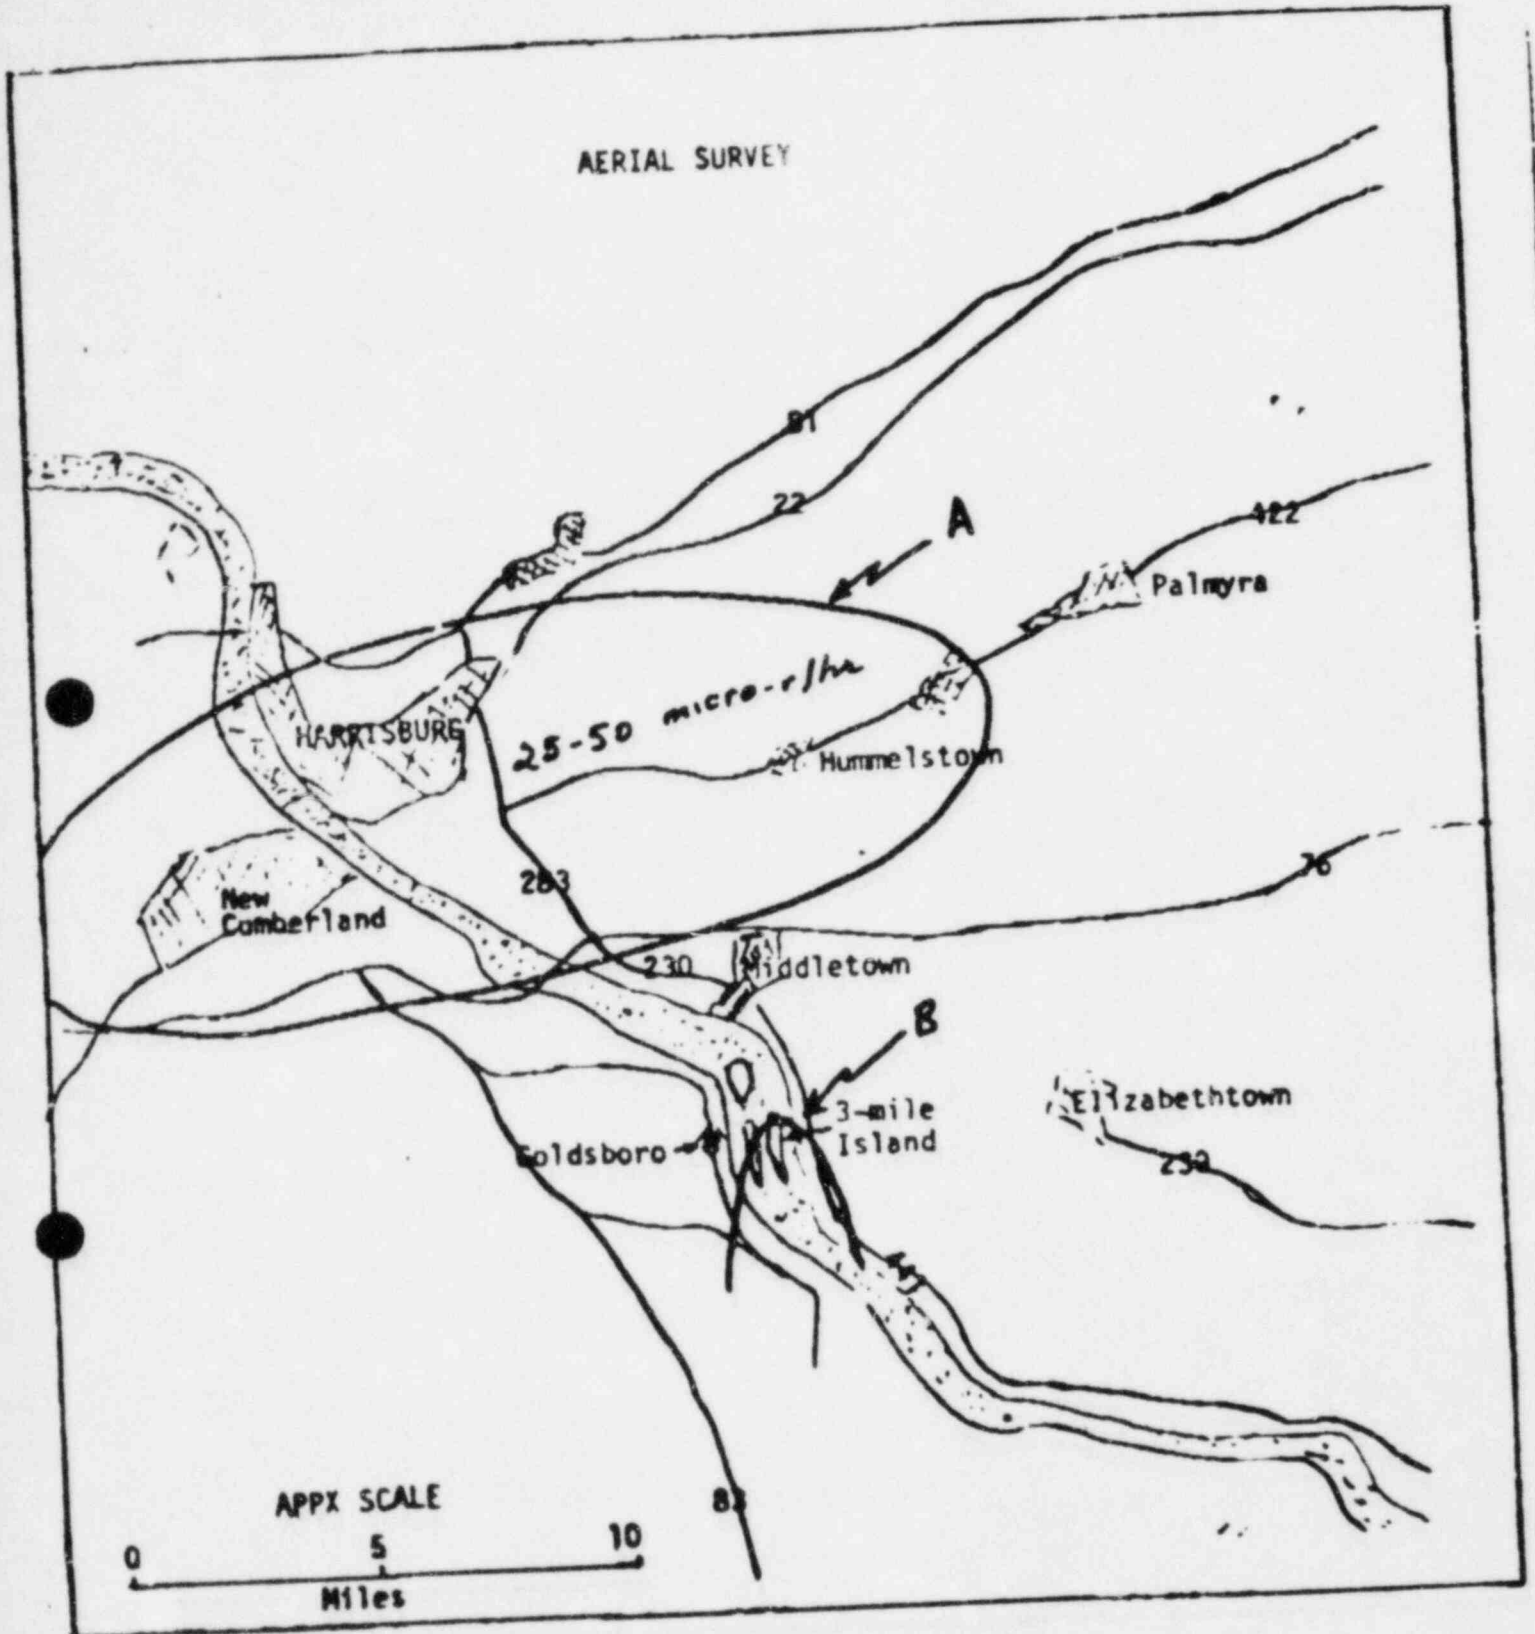
March 29, 1979 5:00 p.m.

- A** Residual cloud ($Xe-133$) N to NW between Mechanicsburg and Hershey, Pennsylvania. Radiation measurements in the cloud in the microrentgen/hour range, highest readings in cloud center.
- B** Ground level measurements on the island indicated a plume in the southerly direction. Radiation measurements at fenceline south of plant were 10 μ r/hr, and one-half mile south of fenceline, 0.5 μ r/hr.

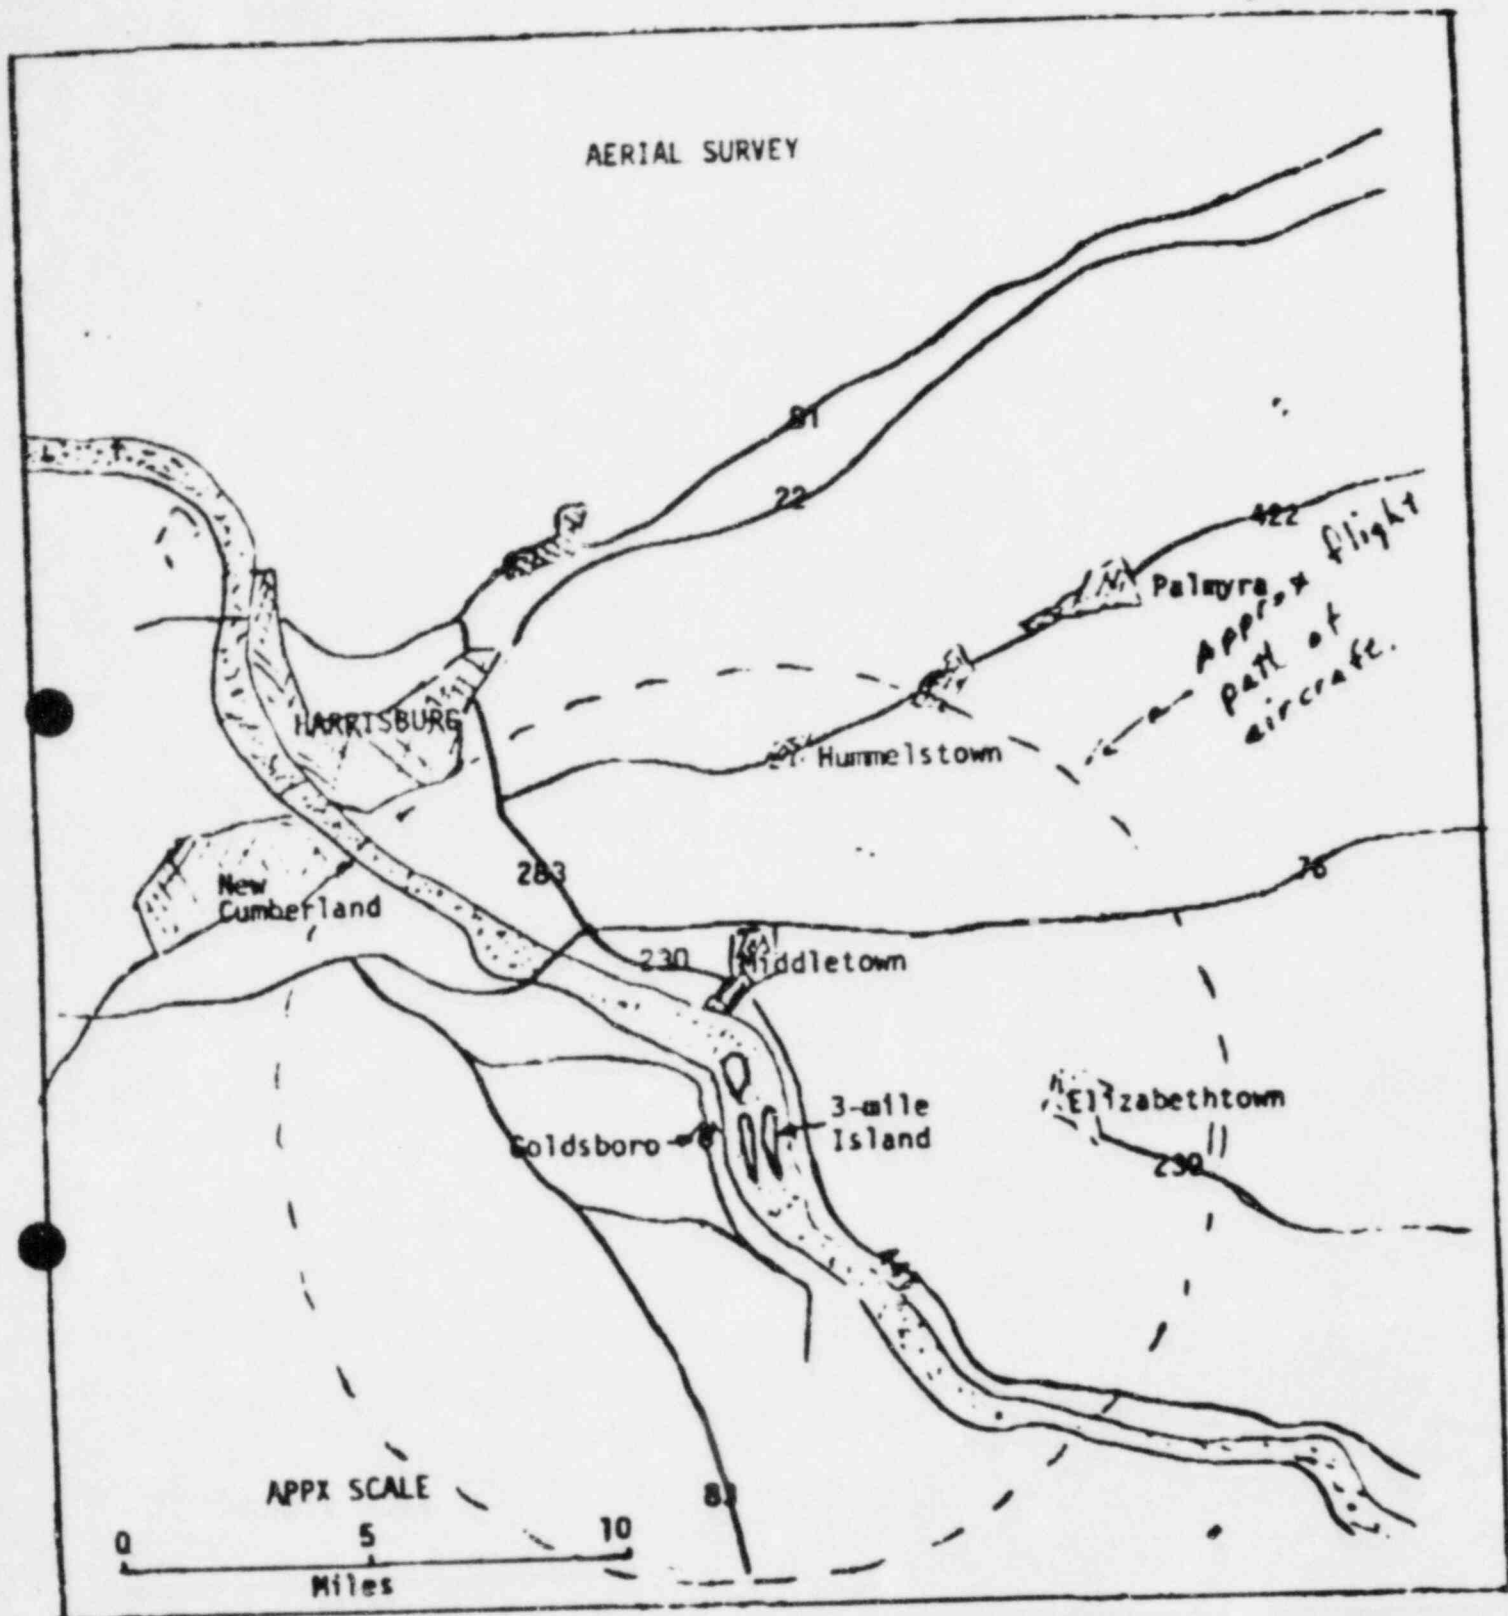
March 29, 1979 8:00 p.m.

Survey aircraft circled the site at distance of about 8 miles at altitude of 1000 feet. No detectable plume; "pockets" of residual radioactivity were detected with radiation readings in the range of 25 - 50 microrentgens/hour.

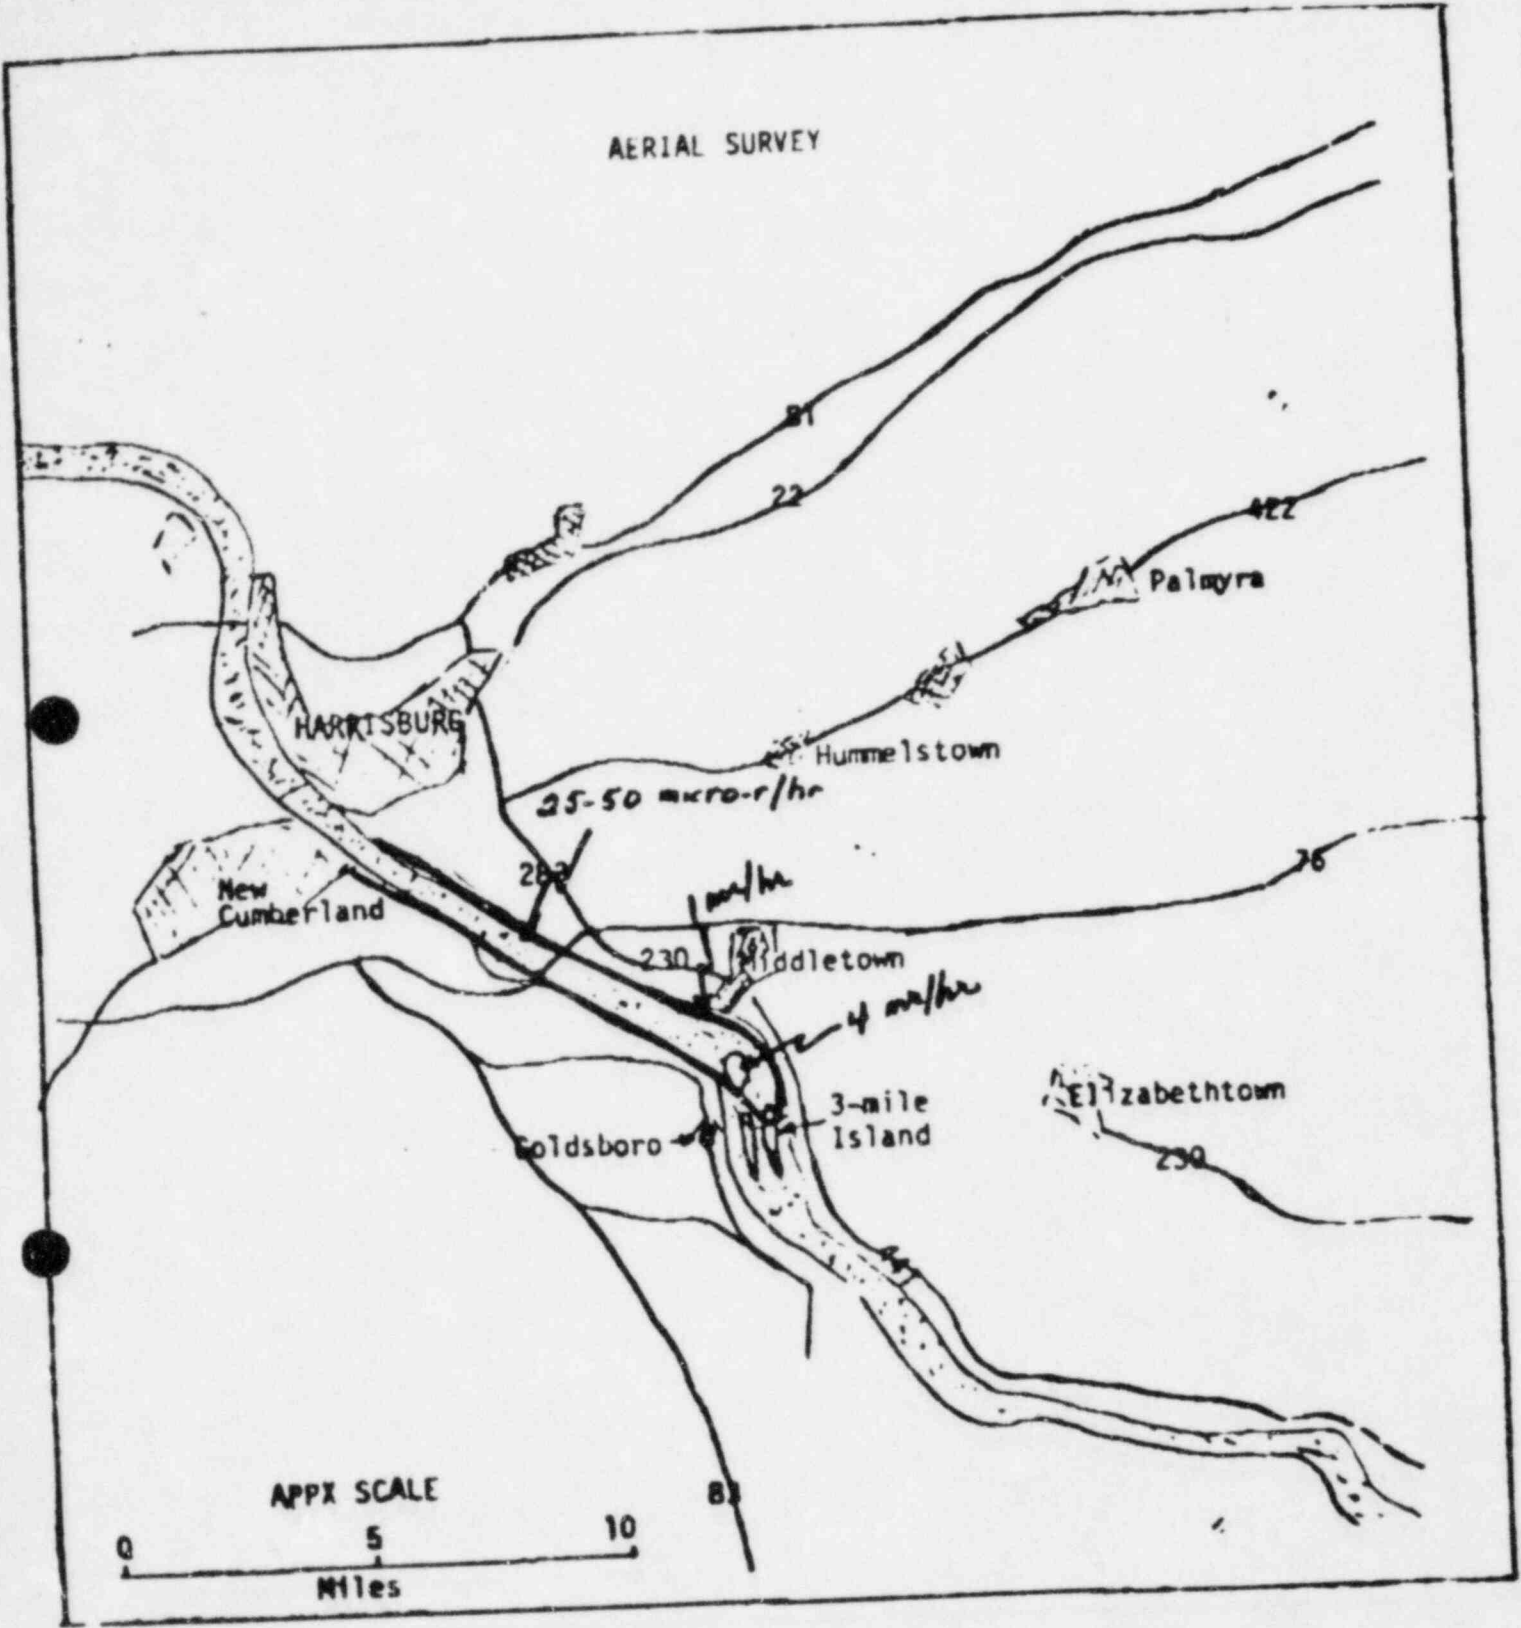
March 29, 1979 10:30 p.m.

Plume in a NW direction, width about equal to width of river. Plume touches down about 1 mile from plant at Hill Island. Radiation measurements at east shore line at Hill Island, 4 mr/hr; one mile north of Hill Island, 1 mr/hr; and at five miles from the plant, 25 - 50 micro-roentgens/hr.

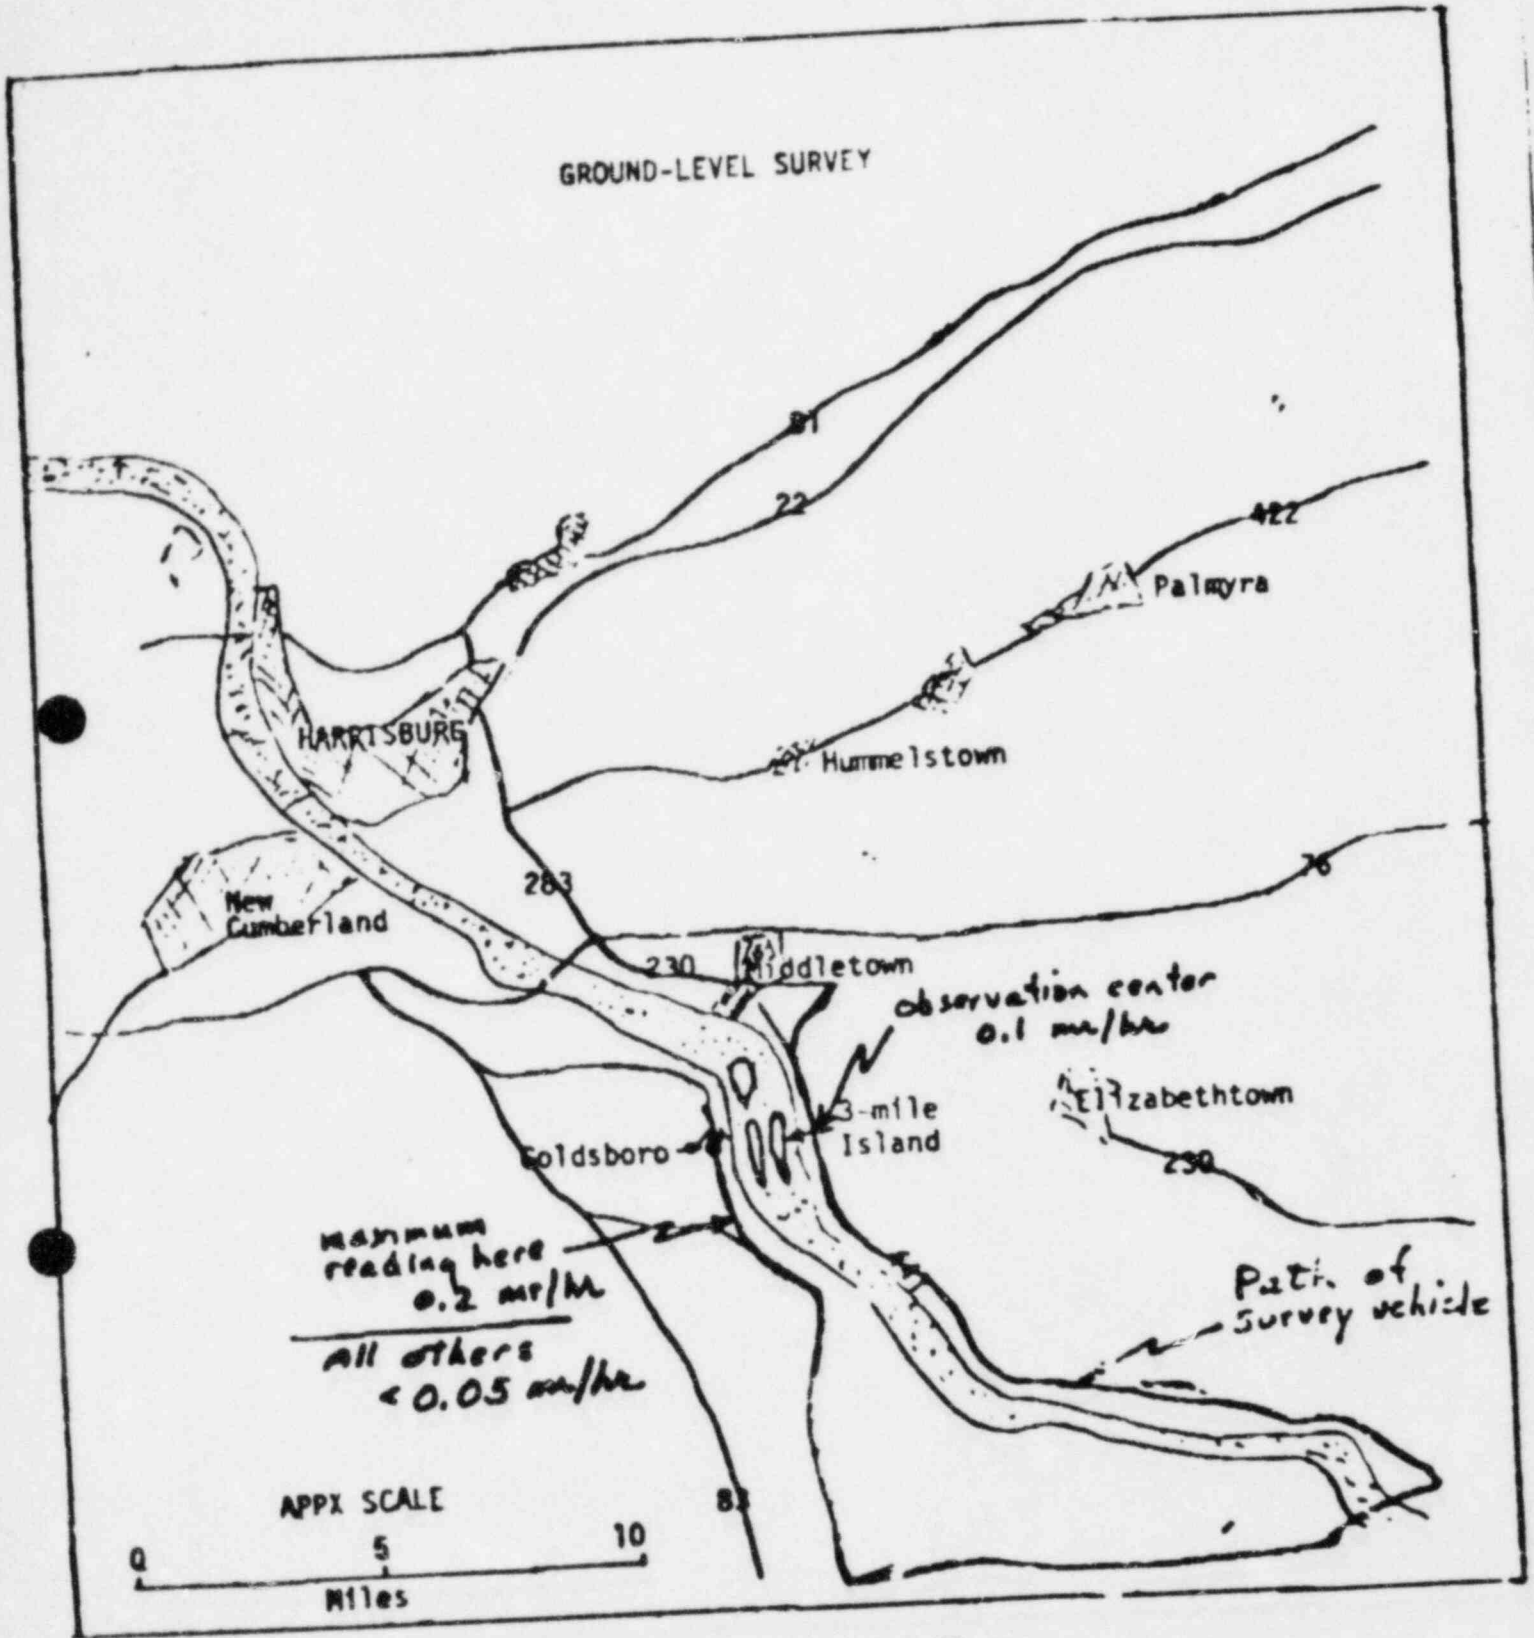
March 30, 1979 Time: approximately 4:00 a.m. - 5:30 a.m.

An NRC survey team took radiation measurements from a vehicle traveling both sides of the Susquehanna River. Radiation levels were highest near Cly, a community just south of the plant on the west side of the river. The level at Cly was about 0.2 mr/hr. With the exception of the reading of 0.1 mr/hr at the Observation Center, the remainder of the readings on the route were less than 0.05 m/hr.

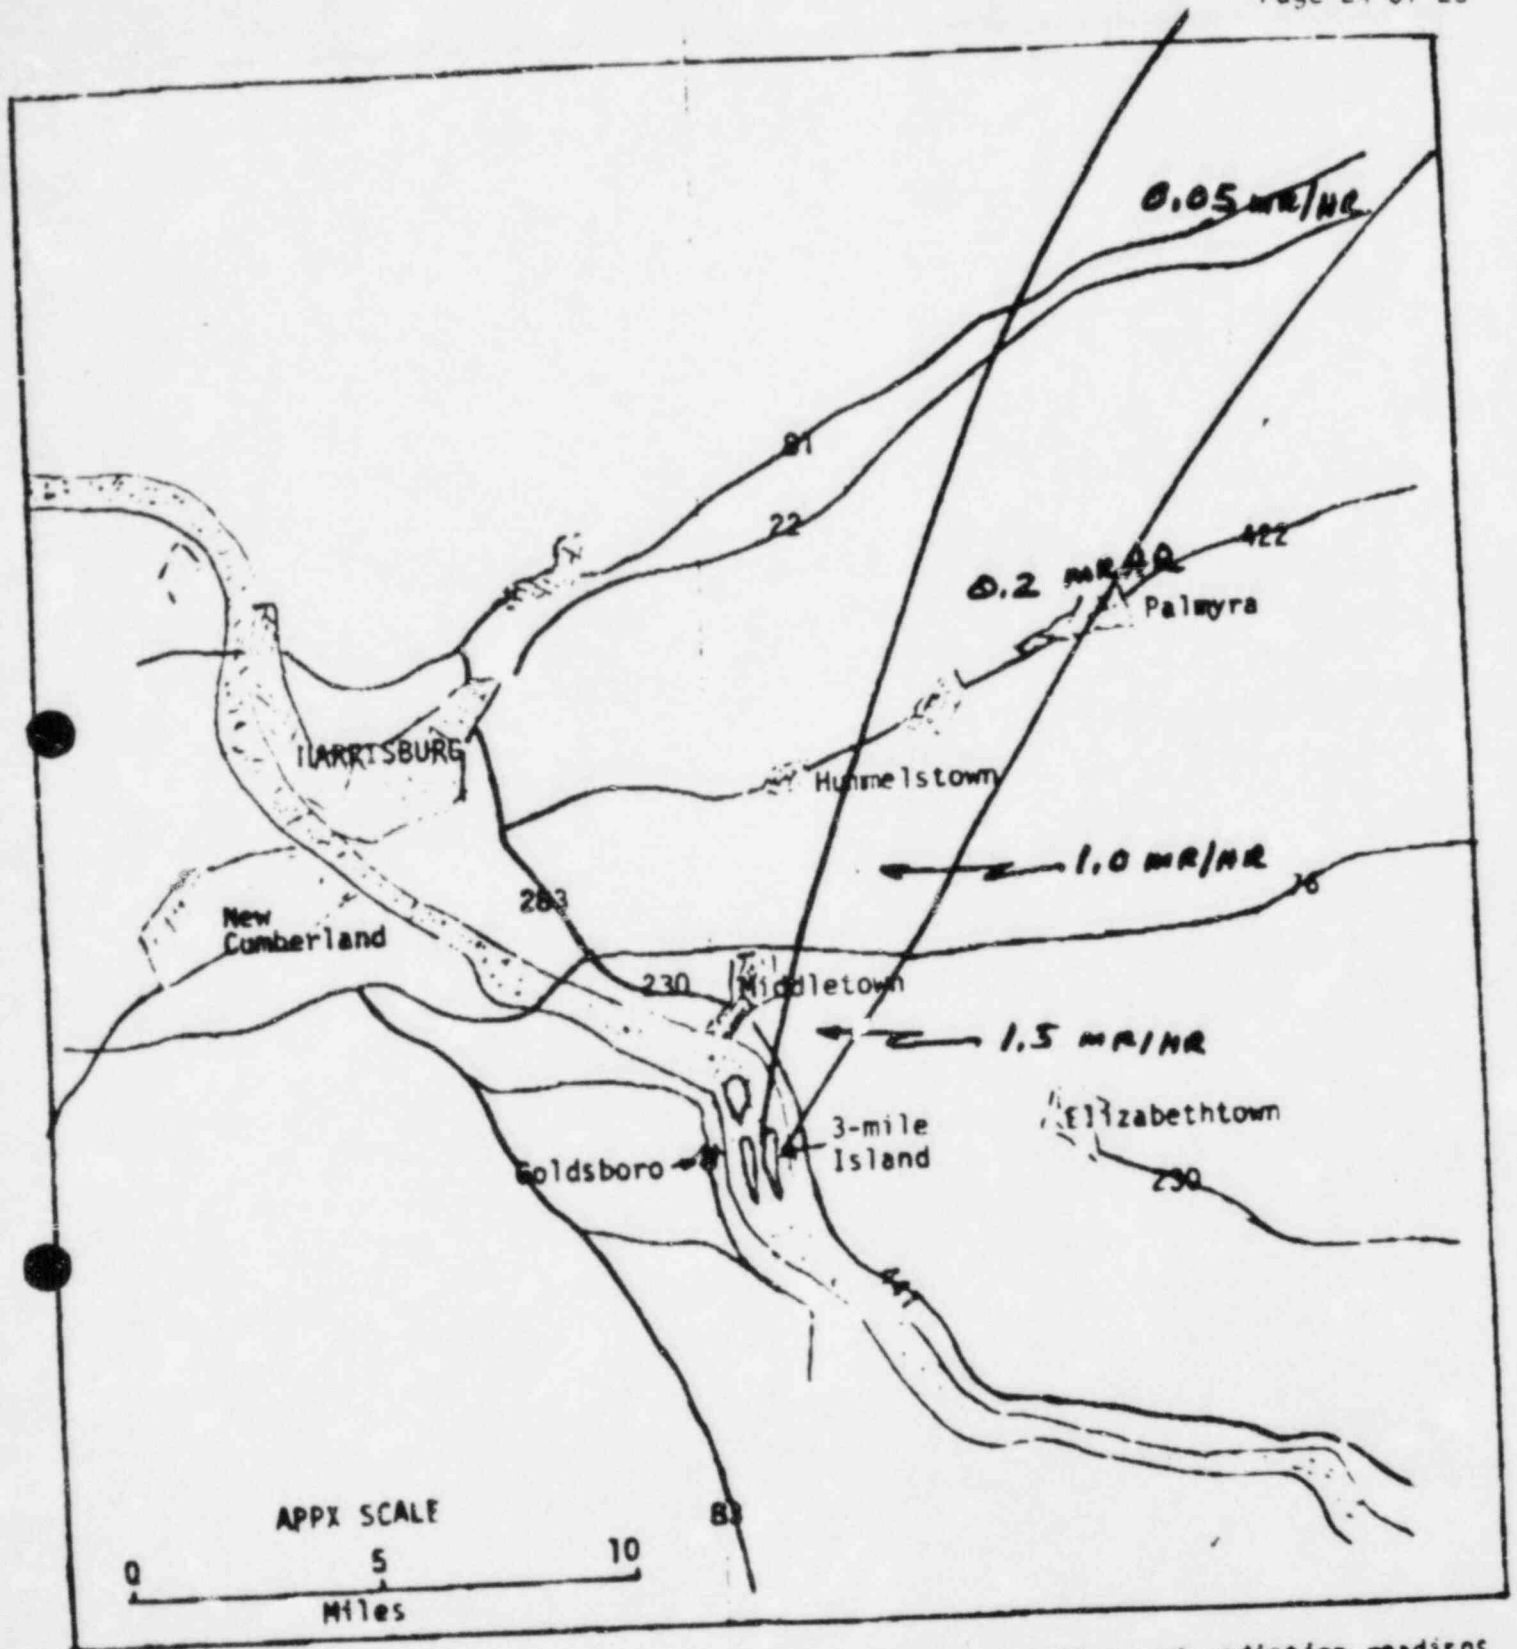
March 31, 1979 4:00 a.m. AERIAL SURVEY plume direction and radiation readings shown above.

March 31, 1979 1:00 a.m. All ground level readings were less than 0.1 mr/hr. measurements made in vehicle travelling route 441 from about ten miles south of plant to route 76 and south along roads on the west side of the river.
