Investigation of Intergranular
Stress Corrosion Cracking at
Three Mile Island - Unit 1

Date: January 4, 1980

ABSTRACT

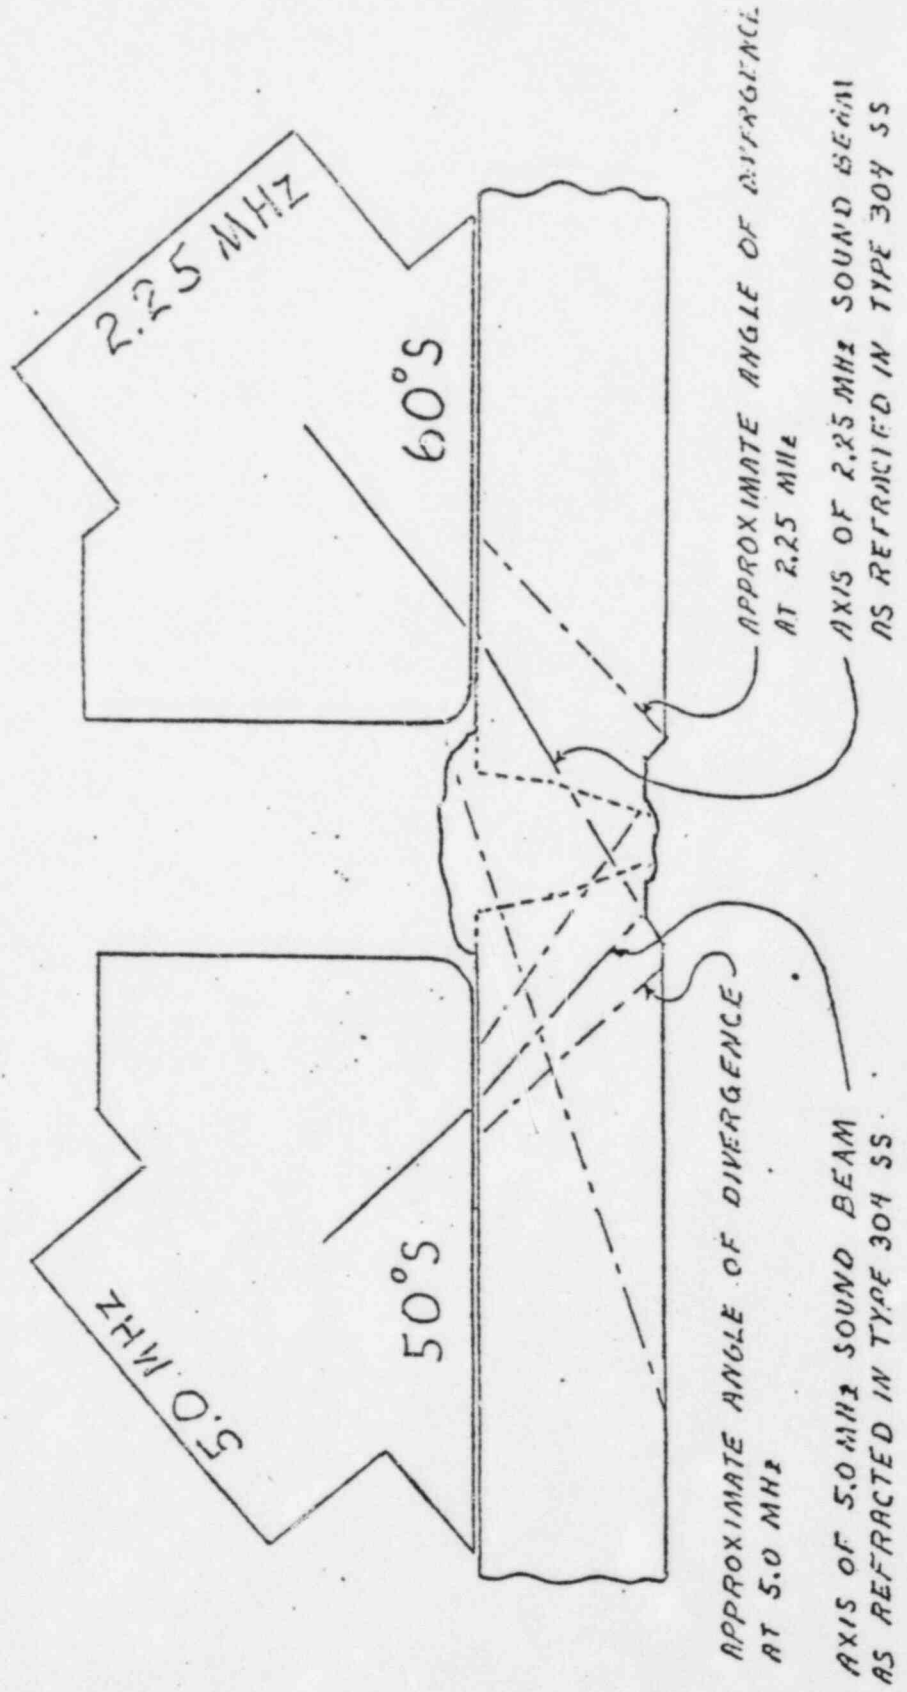
Figure 1-1

- 1) Increasing the incident angle to 60° causes geometric type reflectors to "disappear" as the transducer is scanned inward toward the weld, (see Figure 1.1)
- 2) The 60° angle does not make use of corner reflectors, thus a discontinuity with some depth is required before a return signal can be generated.
- 3) The greater beam spread of the 2.25 MHz transducer was necessary to prevent relevant reflections from also "disappearing" as the transducer is scanned inward (see Figure 1.1)

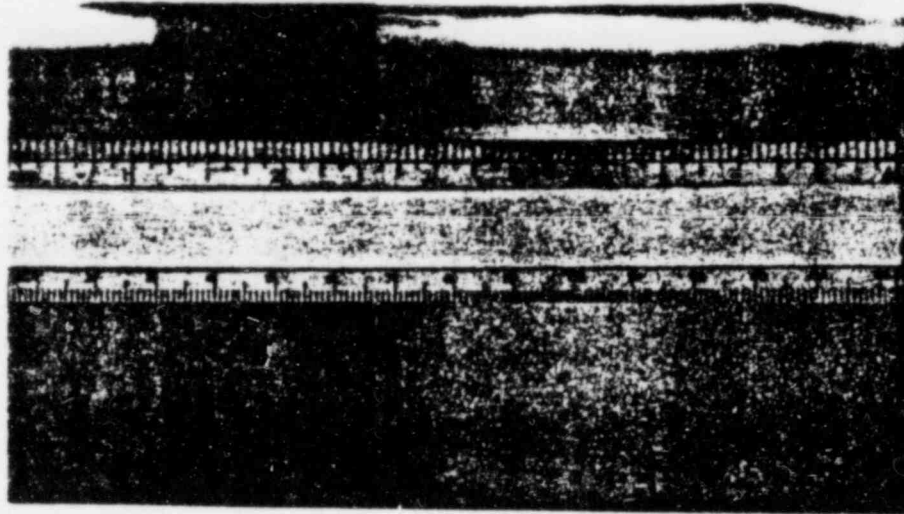
A. Near S marker in Figure 2.

FIGURE 1. Radiographs showing cracks at two locations in SFP pipe section next to a circumferential weld (8" Sch. 40, Type 304 SS).

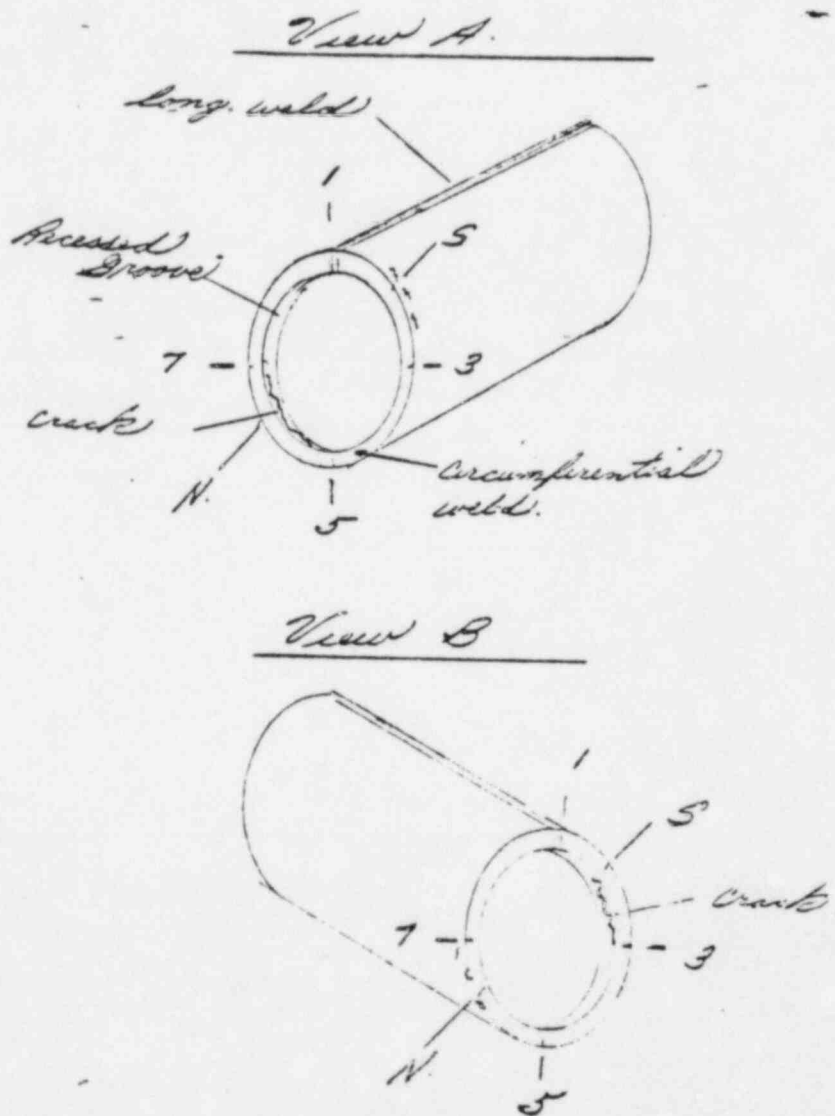
FIGURE 2. Locations of cracks in Spent Fuel Pool Pipe Section.

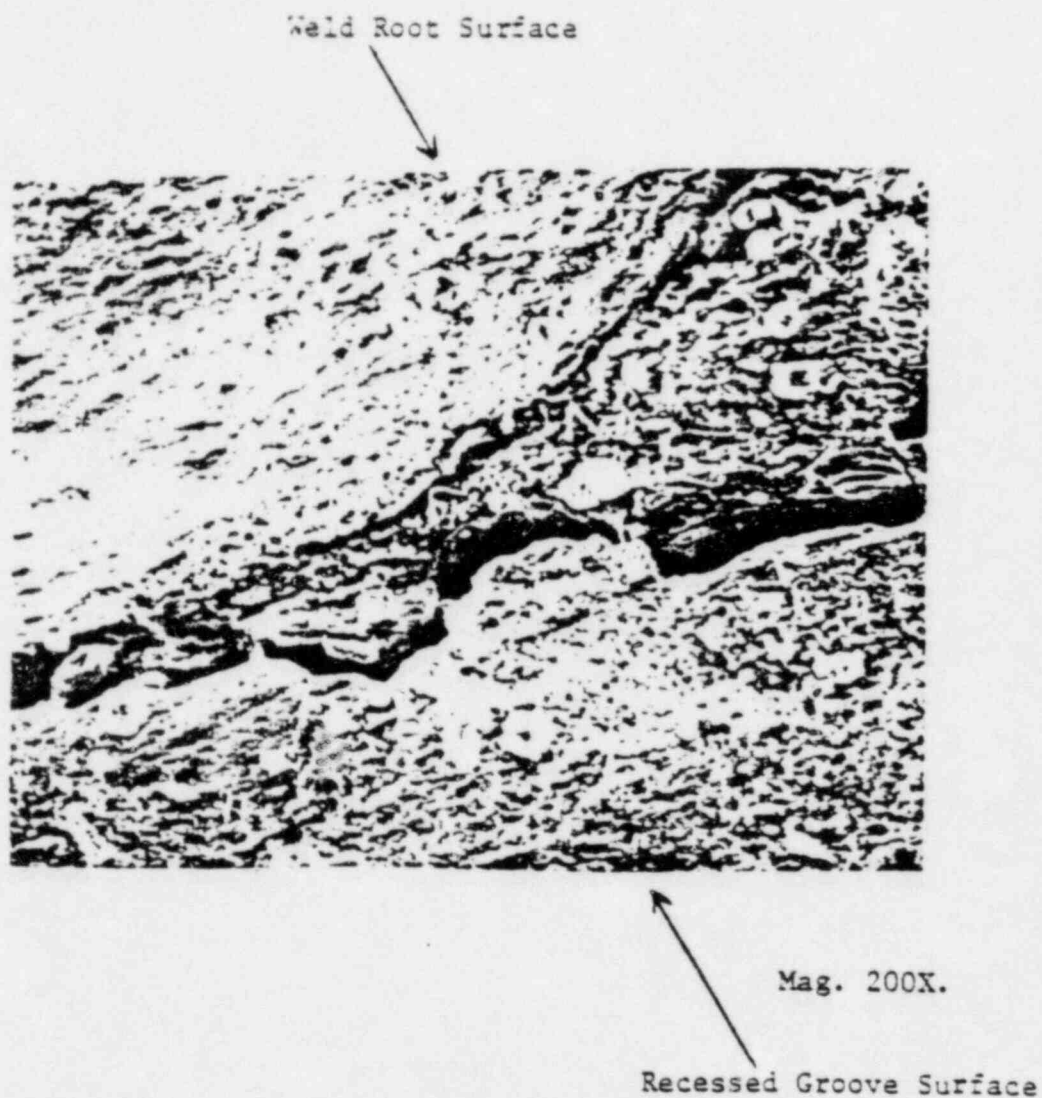
FIGURE 3. SEM Micrograph showing cracks located on the I. D. surface of TMI-1 Spent Fuel Pool Pipe (8" Sch. 40, Type 304 SS) in recessed groove next to weld root.

(NOTE: Fine crack follows weld root.)

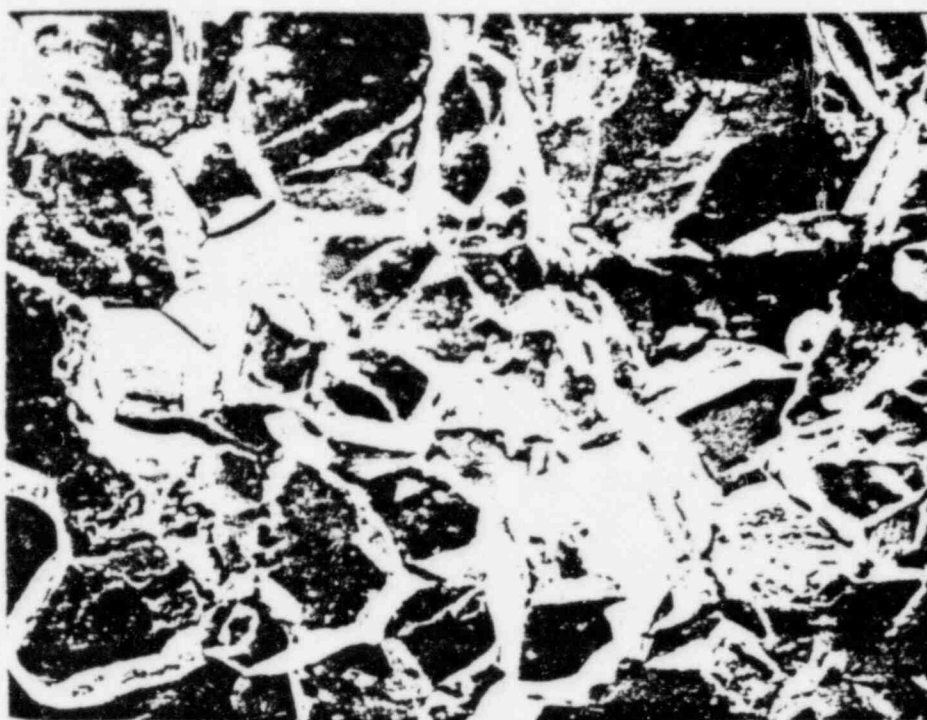
FIGURE 9. Crack Topography and Associated EDAX Spectrum.

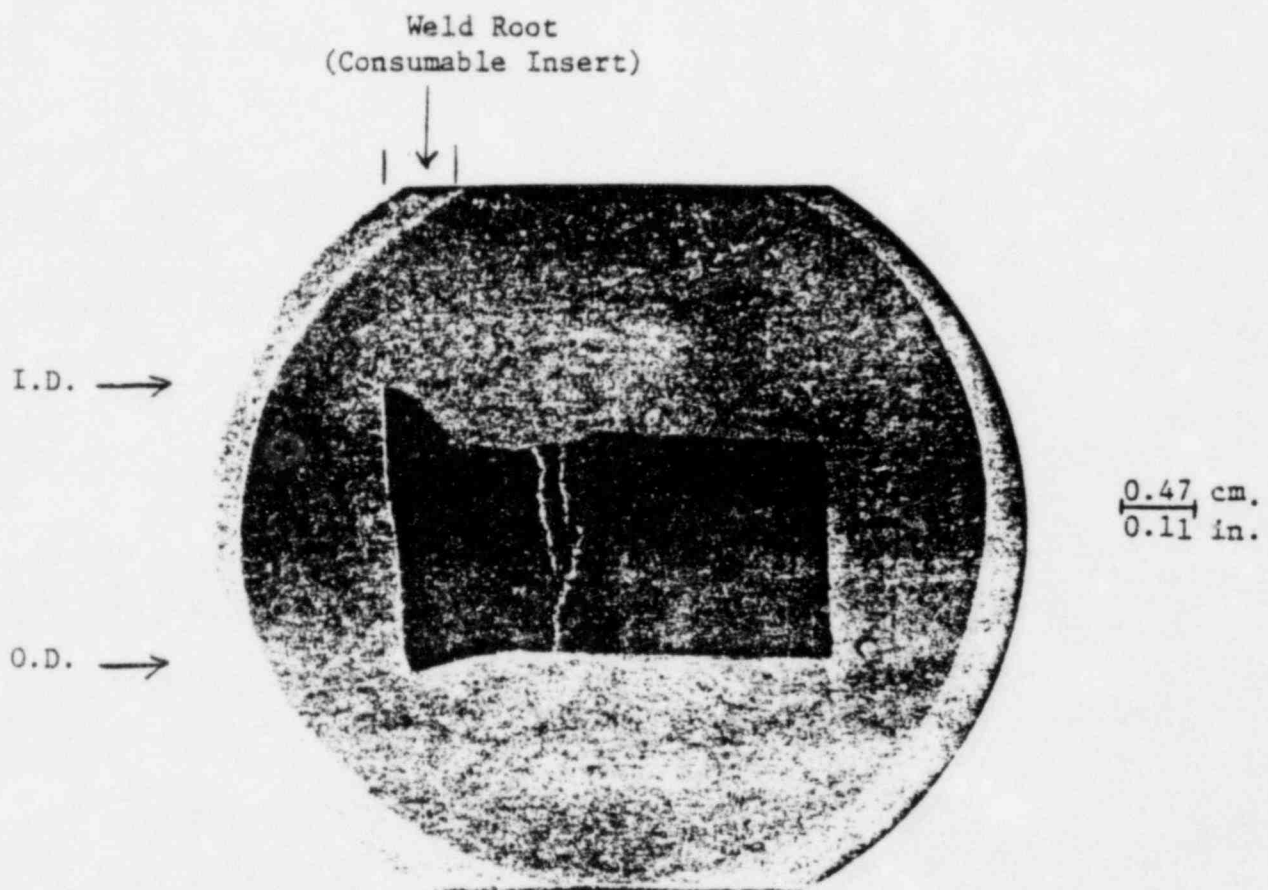
FIGURE 10. Metallographic Cross Section Showing Through Wall Cracks in 8" Sch. 40, Type 304 SS SFP Pipe. See Figure 14 for higher magnification photo.

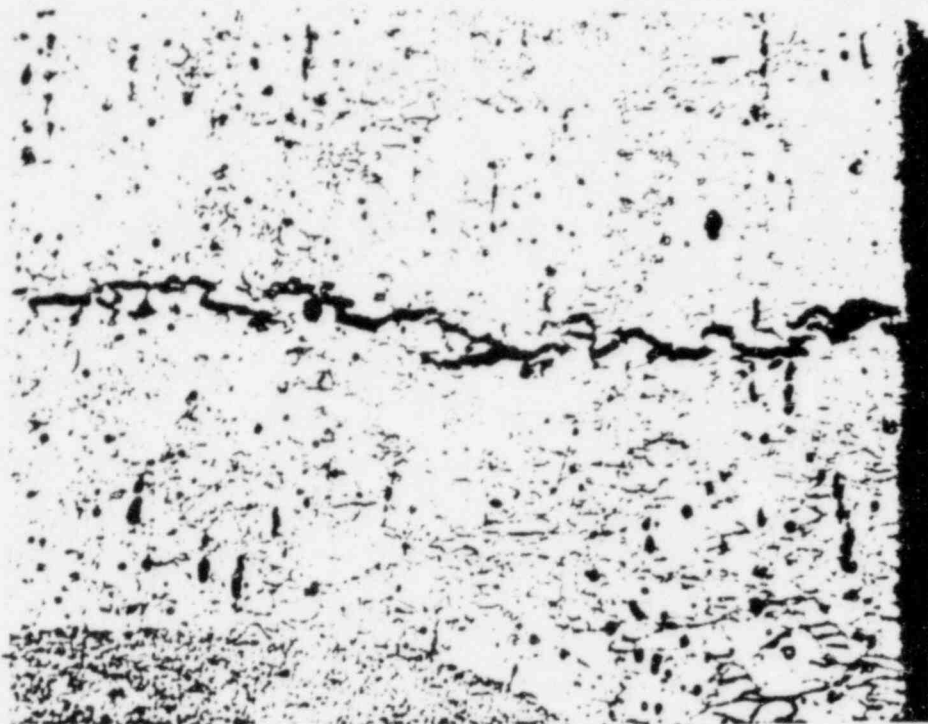
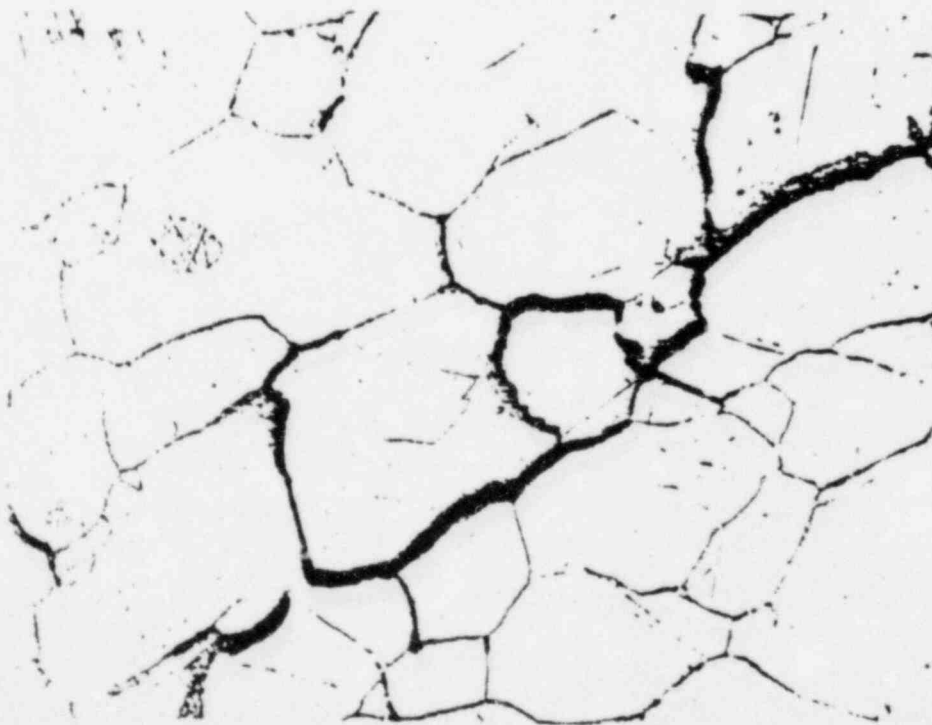
FIGURE 11.. Typical Crack in Type 304 SS 8" Sch. 40, SFP Pipe.

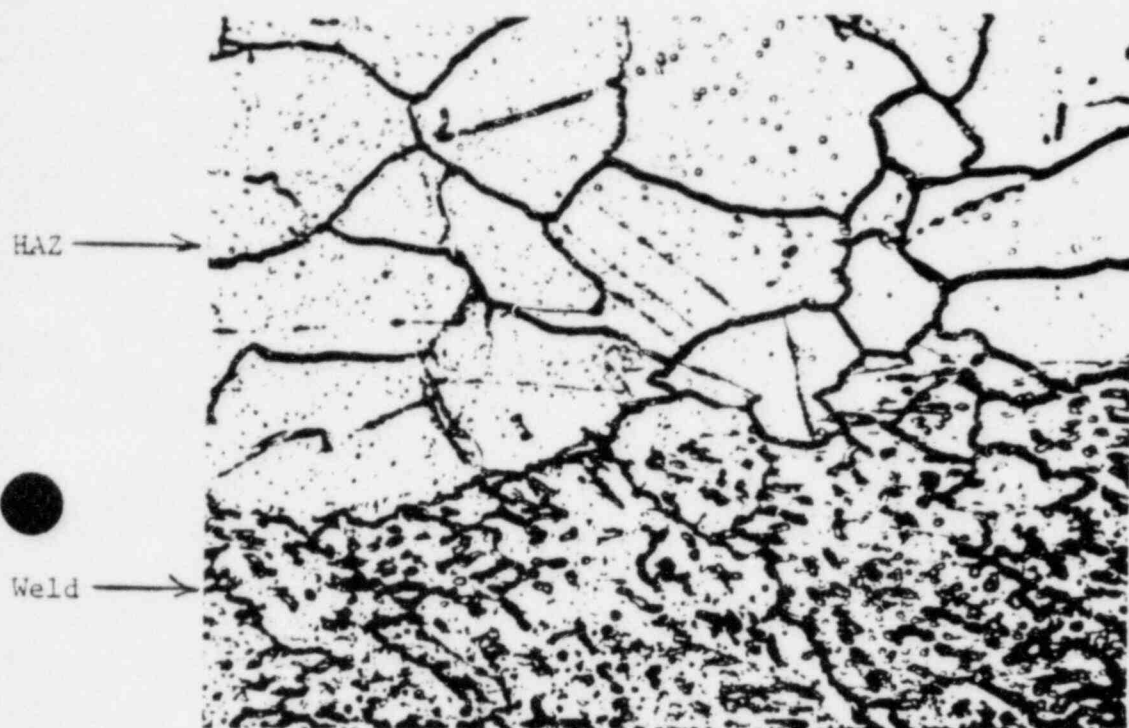
FIGURE 13. ASTM-A-262A; Oxalic Acid Ditching Test Results.

A. Ditching in Weld/HAZ at pipe I.D.

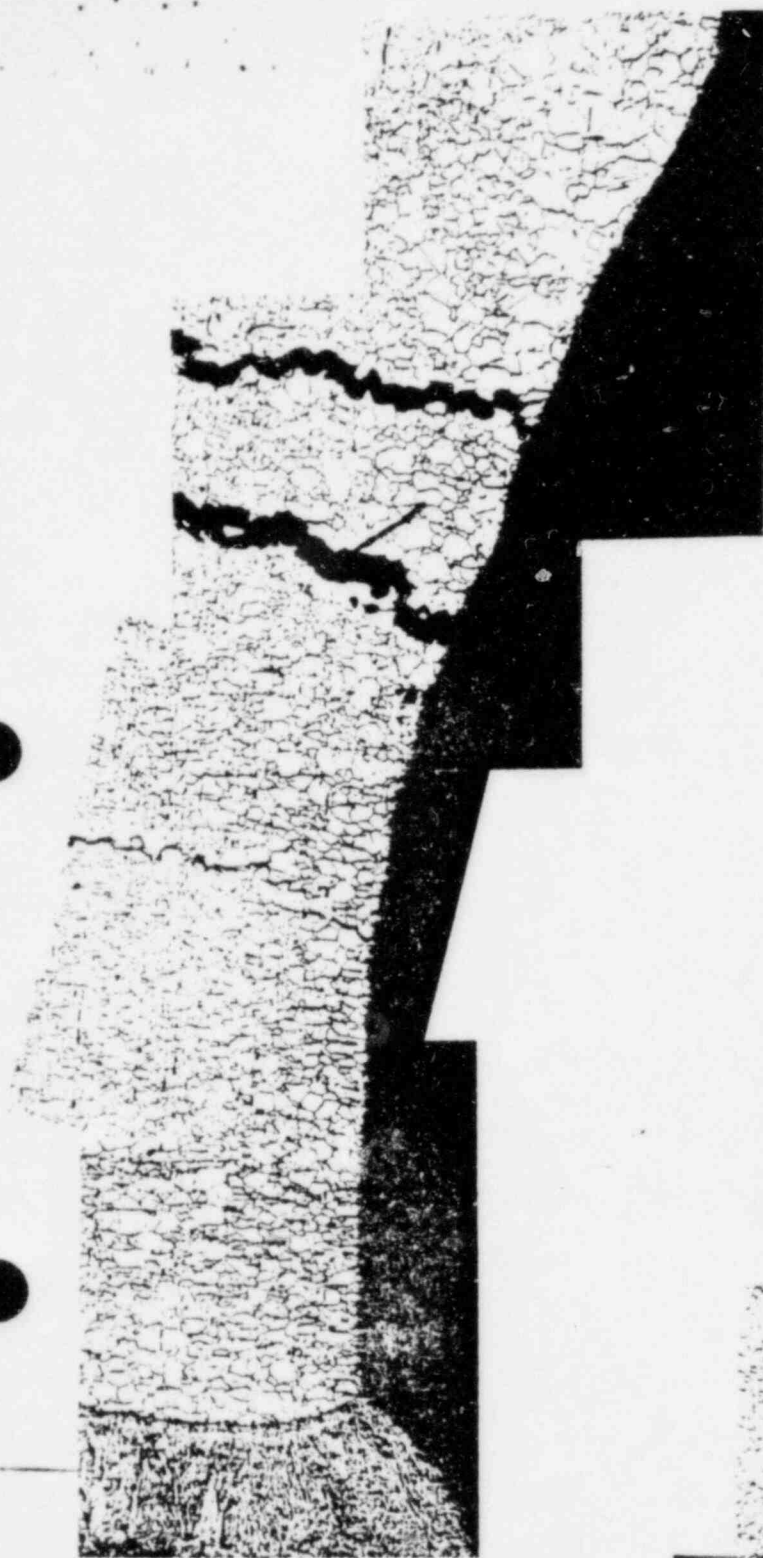
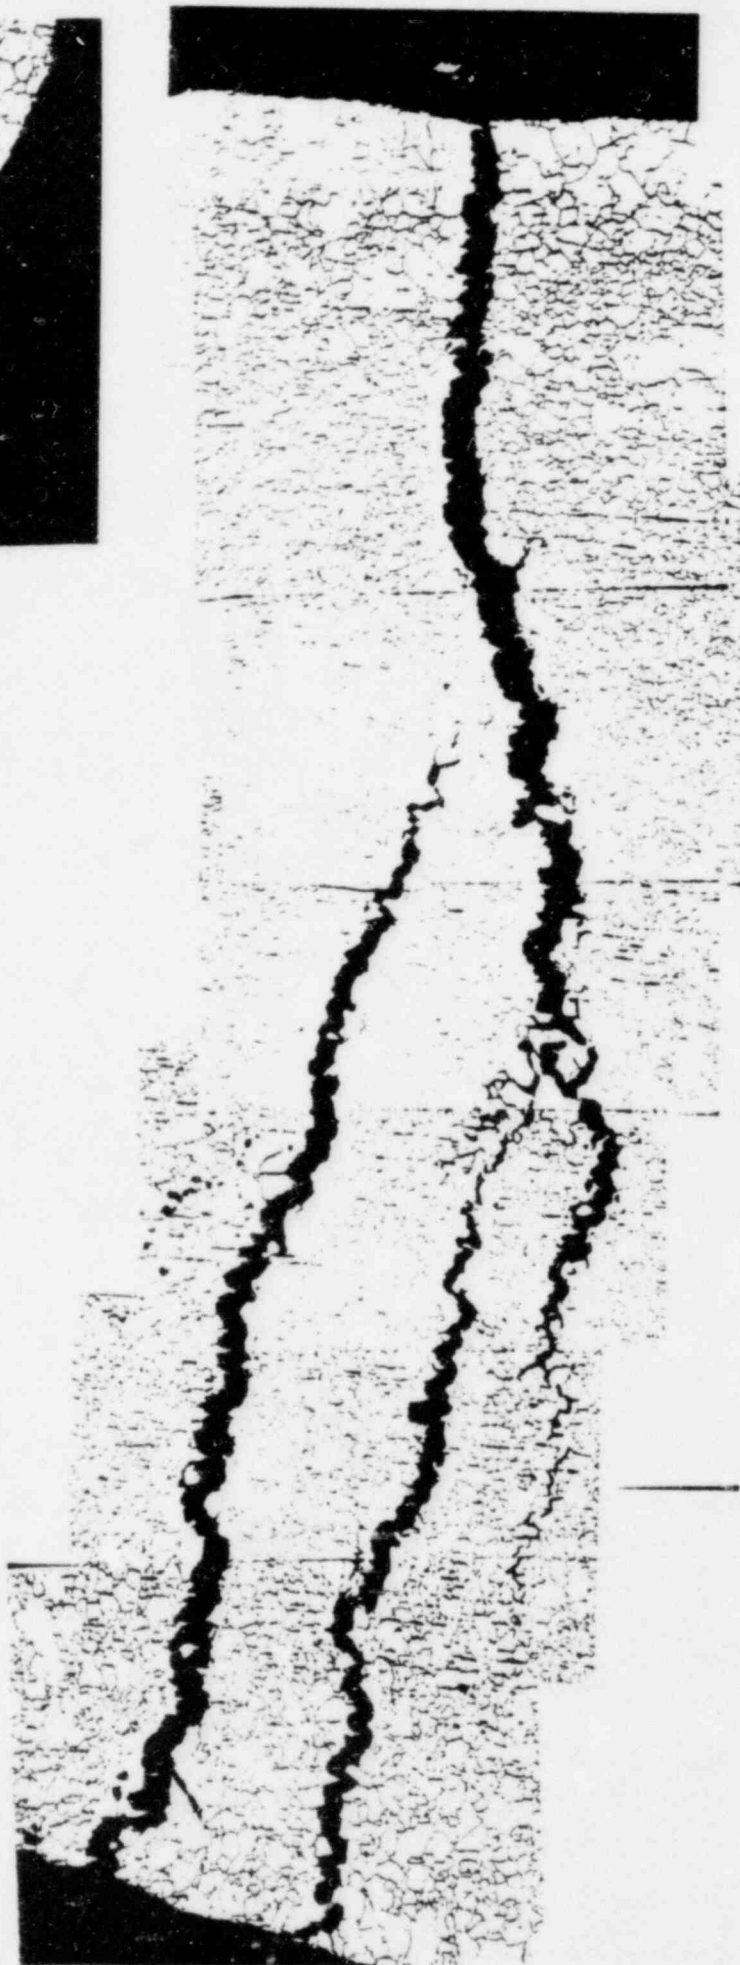
FIGURE 14

Photomicrograph on left shows I.D. surface in the counterbore where cracks initiated. Photomicrograph on right shows multiple crack propagation from I.D. to O.D.

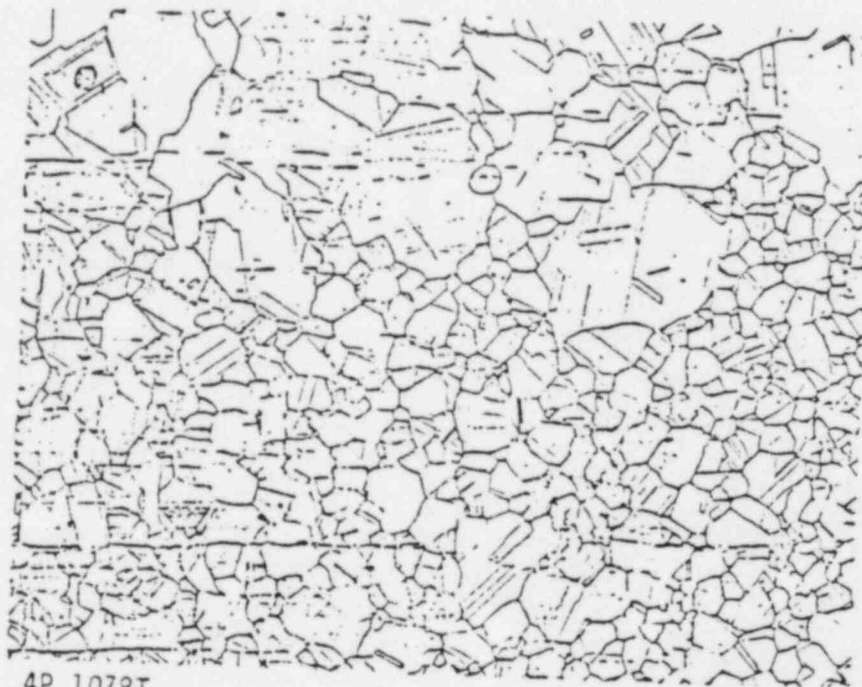
Figure 6. Optical micrographs showing inner surface of pipe from weld root to major crack. Section 3-3'.

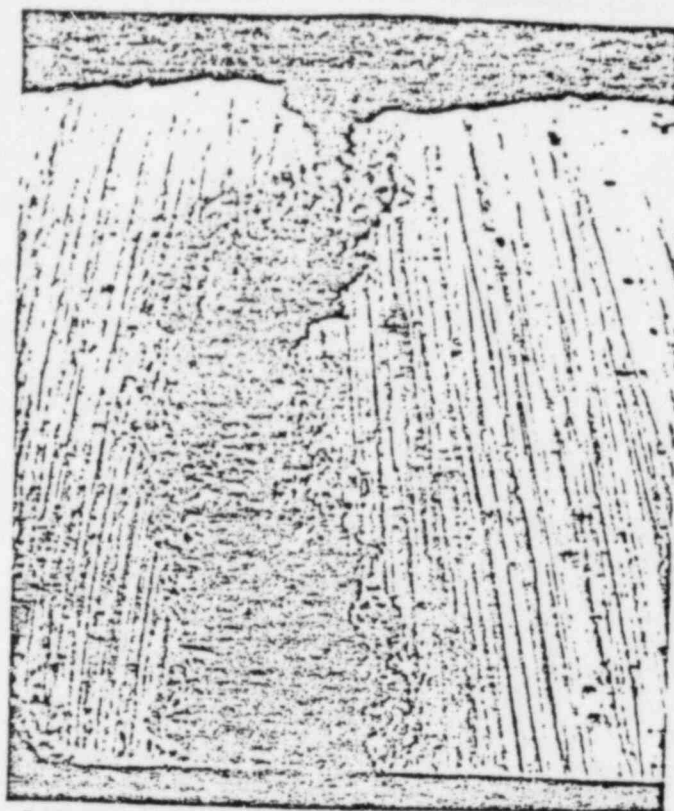
Figure 7. Optical Micrograph of Pipe Section
Showing Non-uniform Grain Size and
Longitudinal Defects.

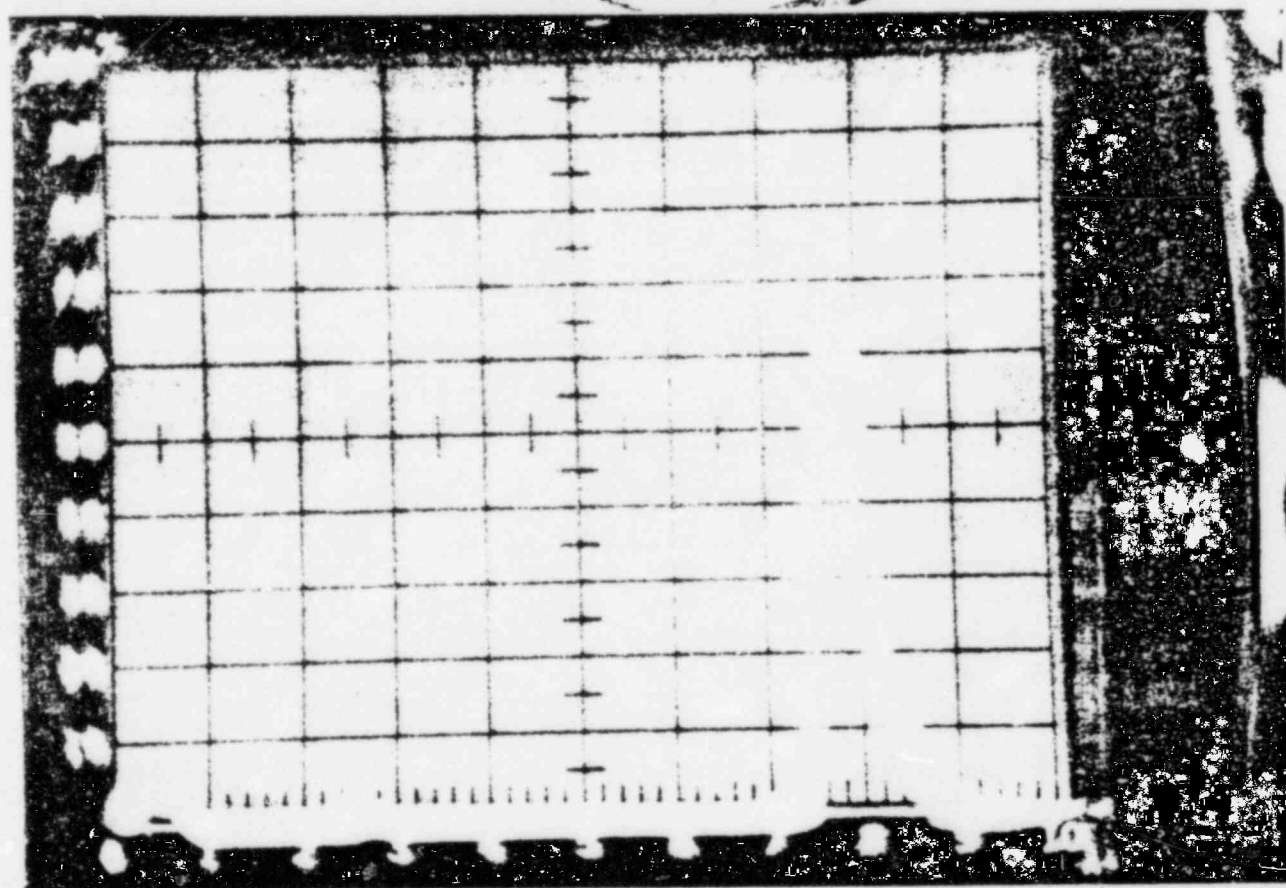
FIGURE 3

Joint geometry and resulting UT screen presentation produced by lack of root fusion defect seen in Figure 4.

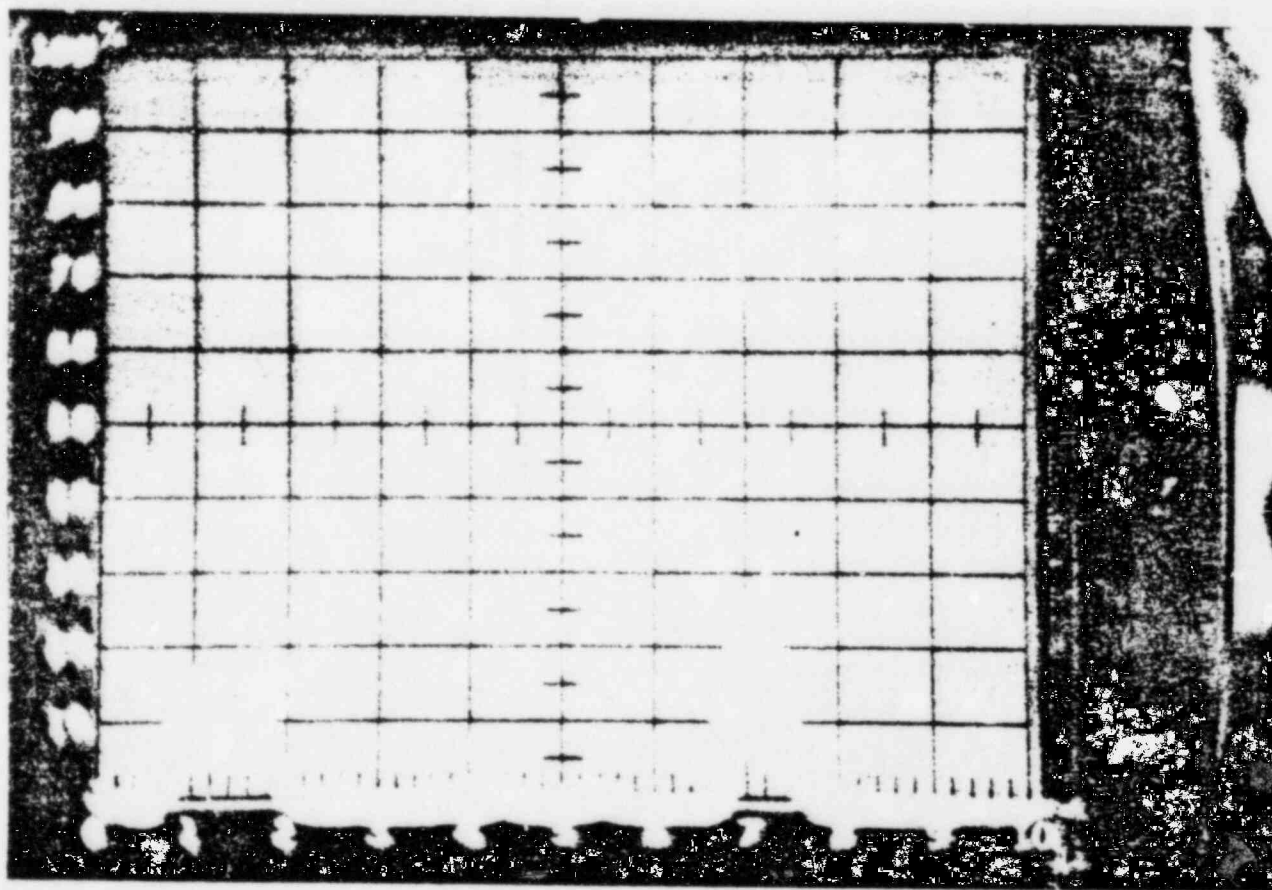
FIGURE 5

Joint geometry and resulting screen presentation produced by lack of root fusion defect seen in Figure 6.

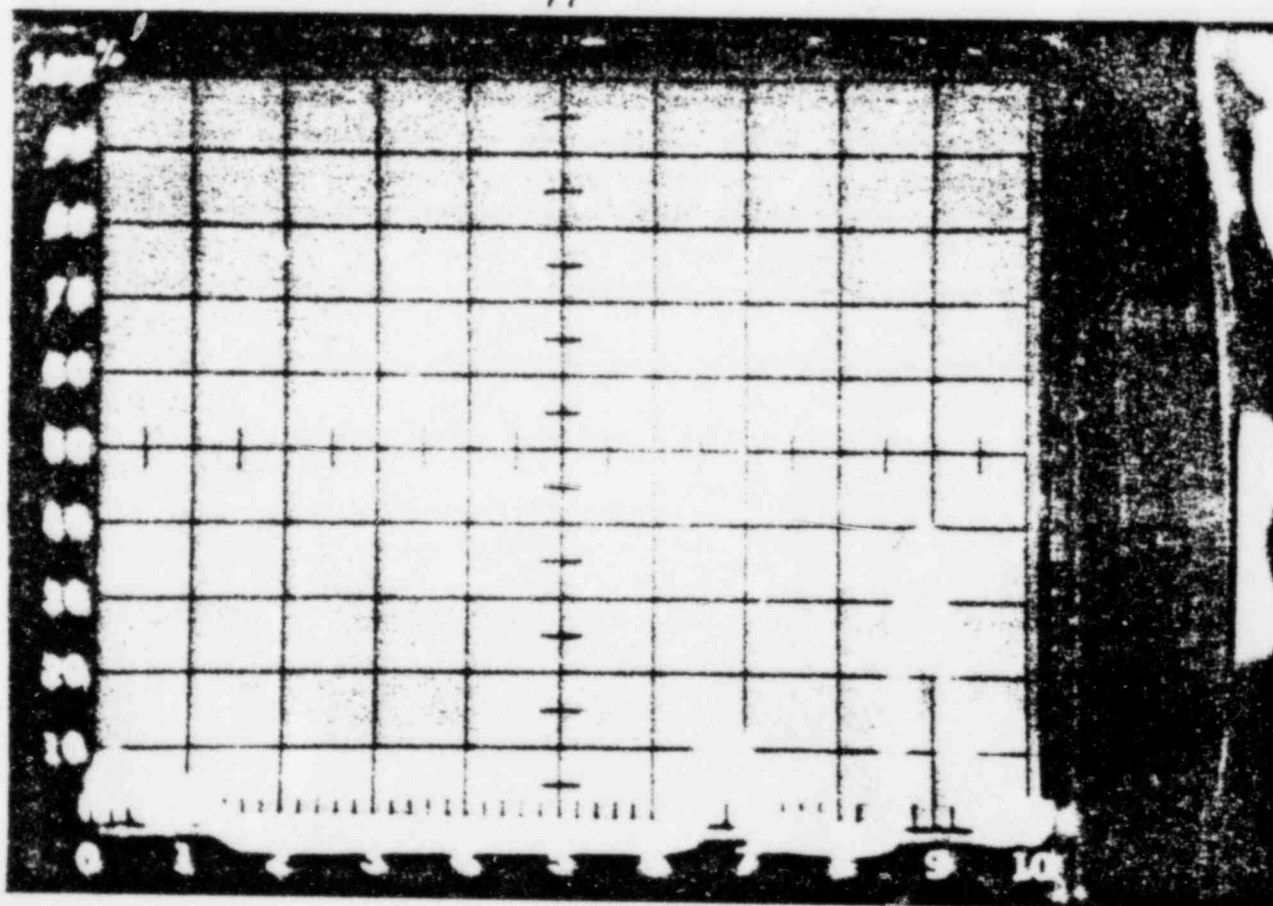
FIGURE 13
Indication 2 I 2

Joint geometry and UT screen presentation. Produced no clear p.t.
indication on I.D.

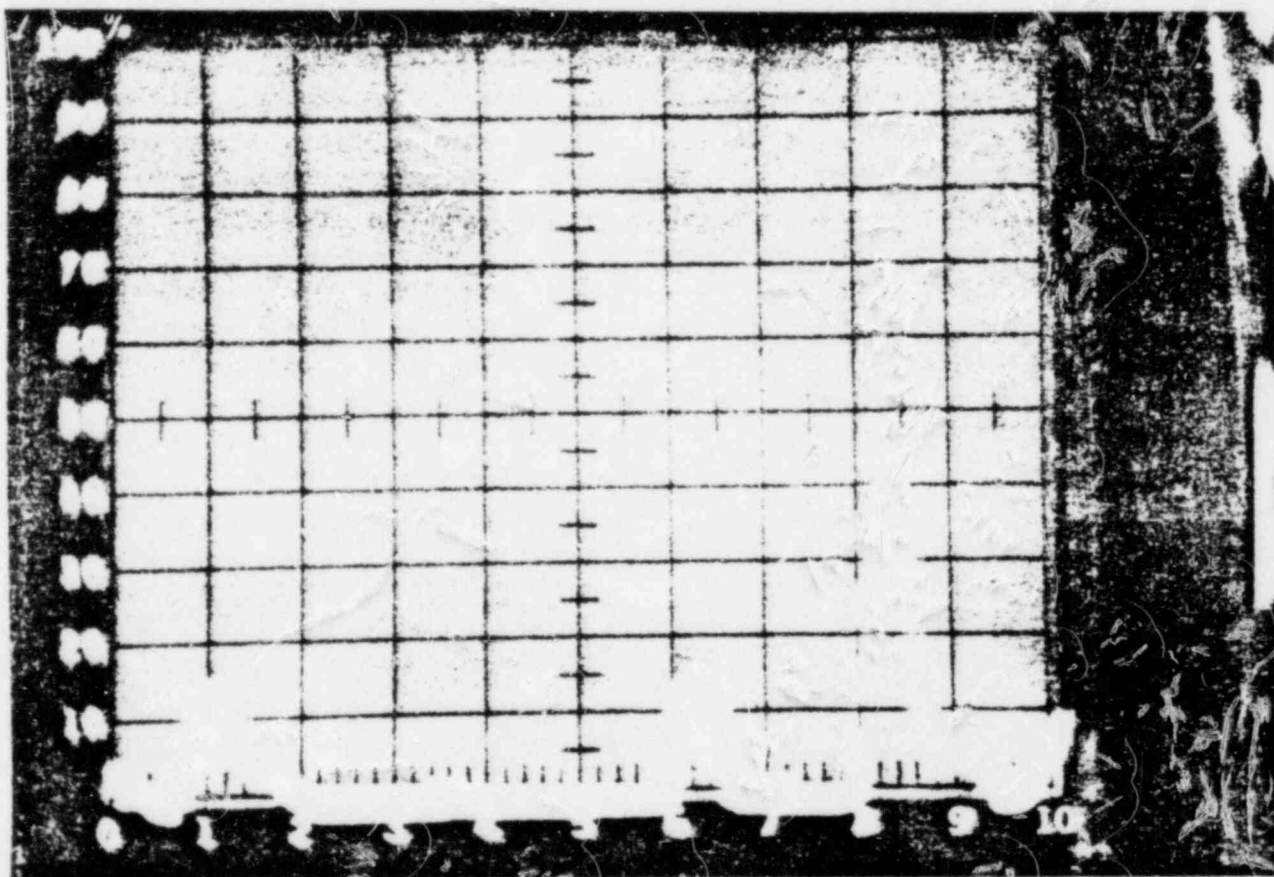
FIGURE 15
Indication 2 I 3

Joint geometry and UT screen presentation most likely produced by sharp change in joint geometry. No p.t. indication on I.D. surface.

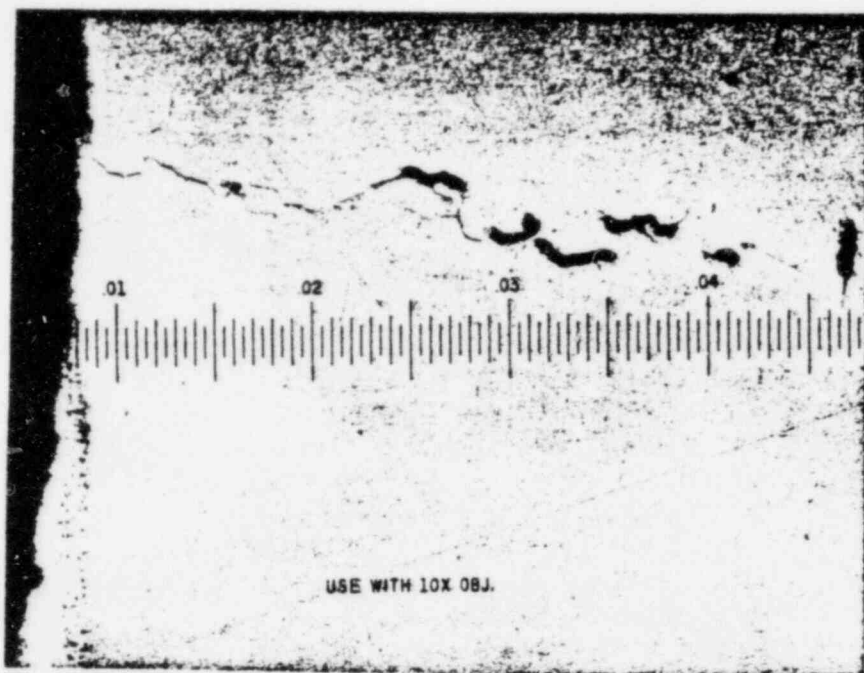
Joint geometry and UT screen presentation for crack on pipe side $\approx .043$ " deep.

Intergranular crack .043" deep on pipe side.

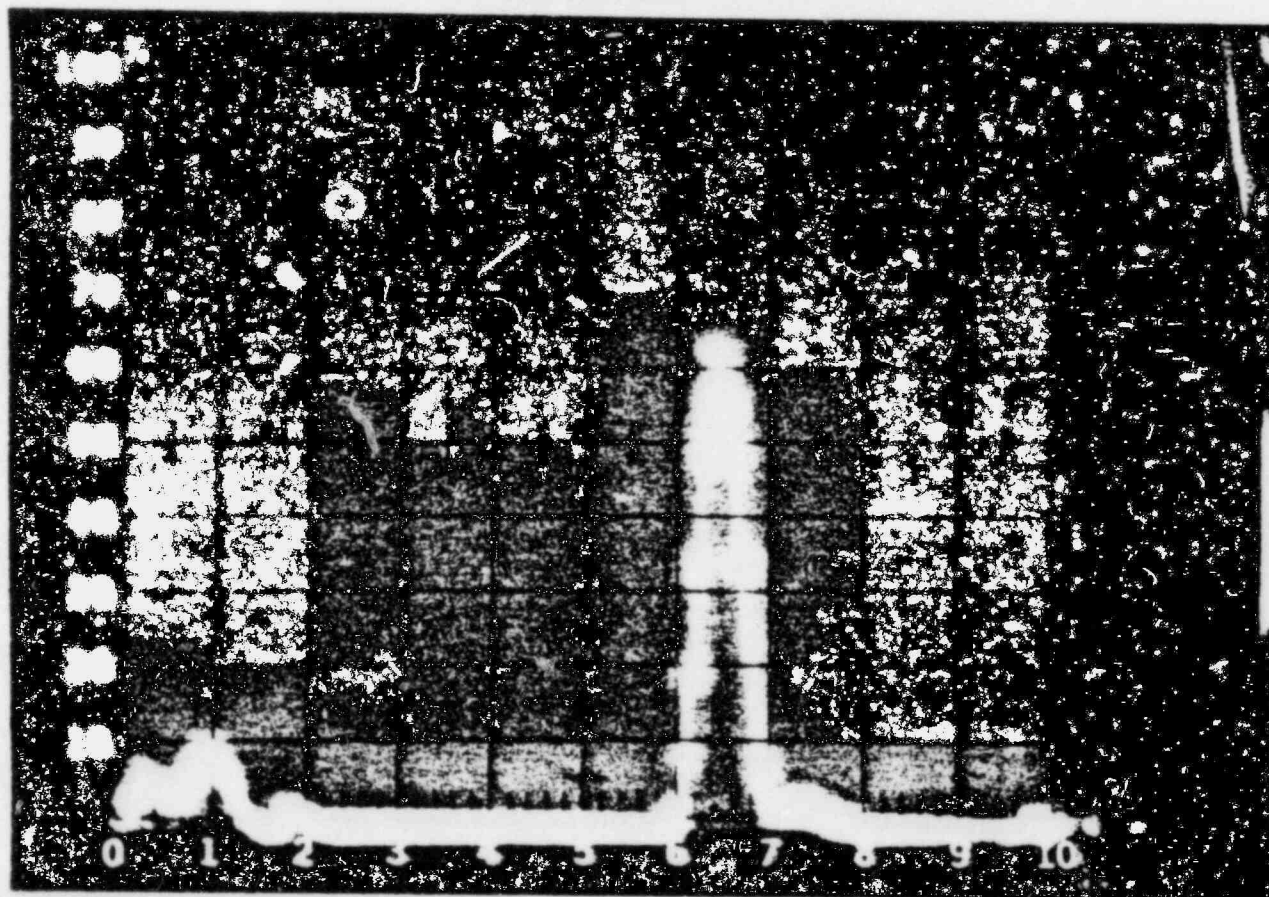
FIGURE 25

Joint geometry and UT screen presentation for .062" deep crack on pipe side.
Note sharp angle on pipe side counterbore.

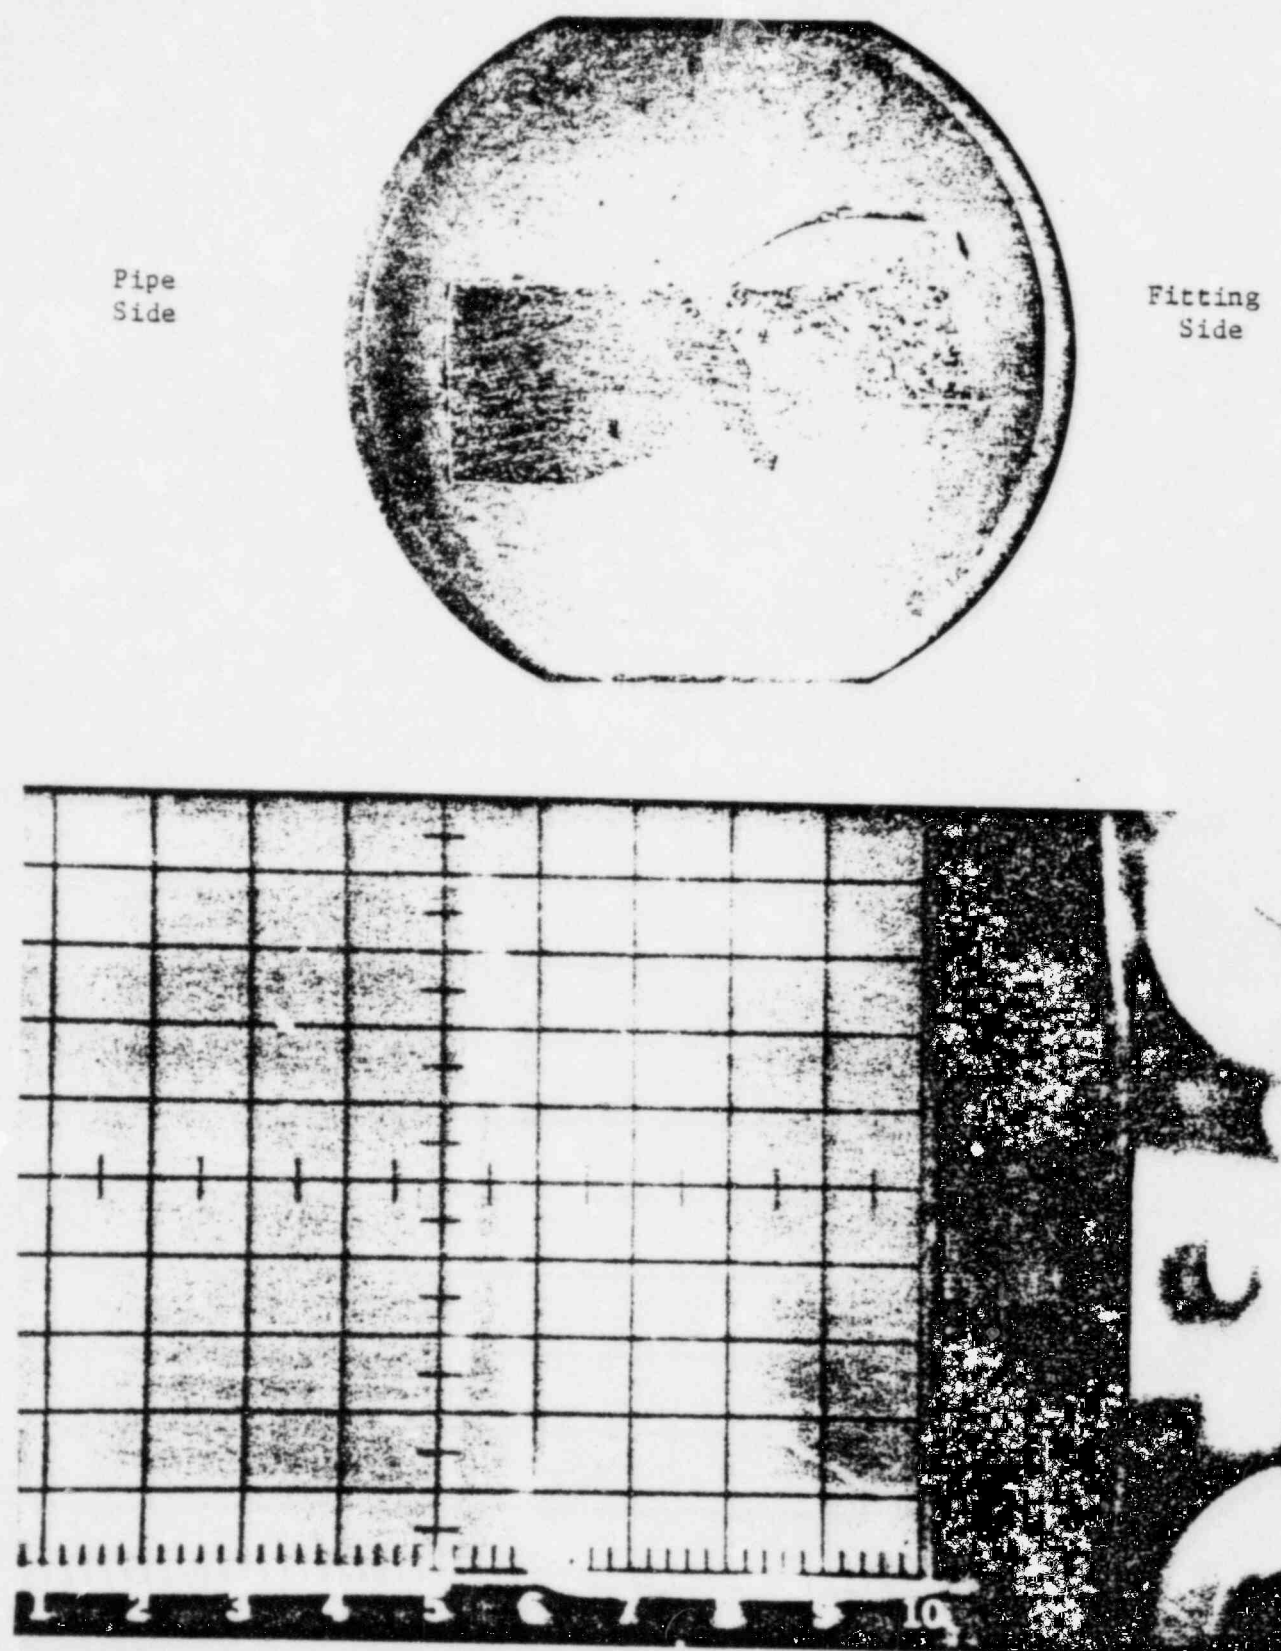
FIGURE 27

Joint geometry and UT screen presentation for deep crack on pipe side.

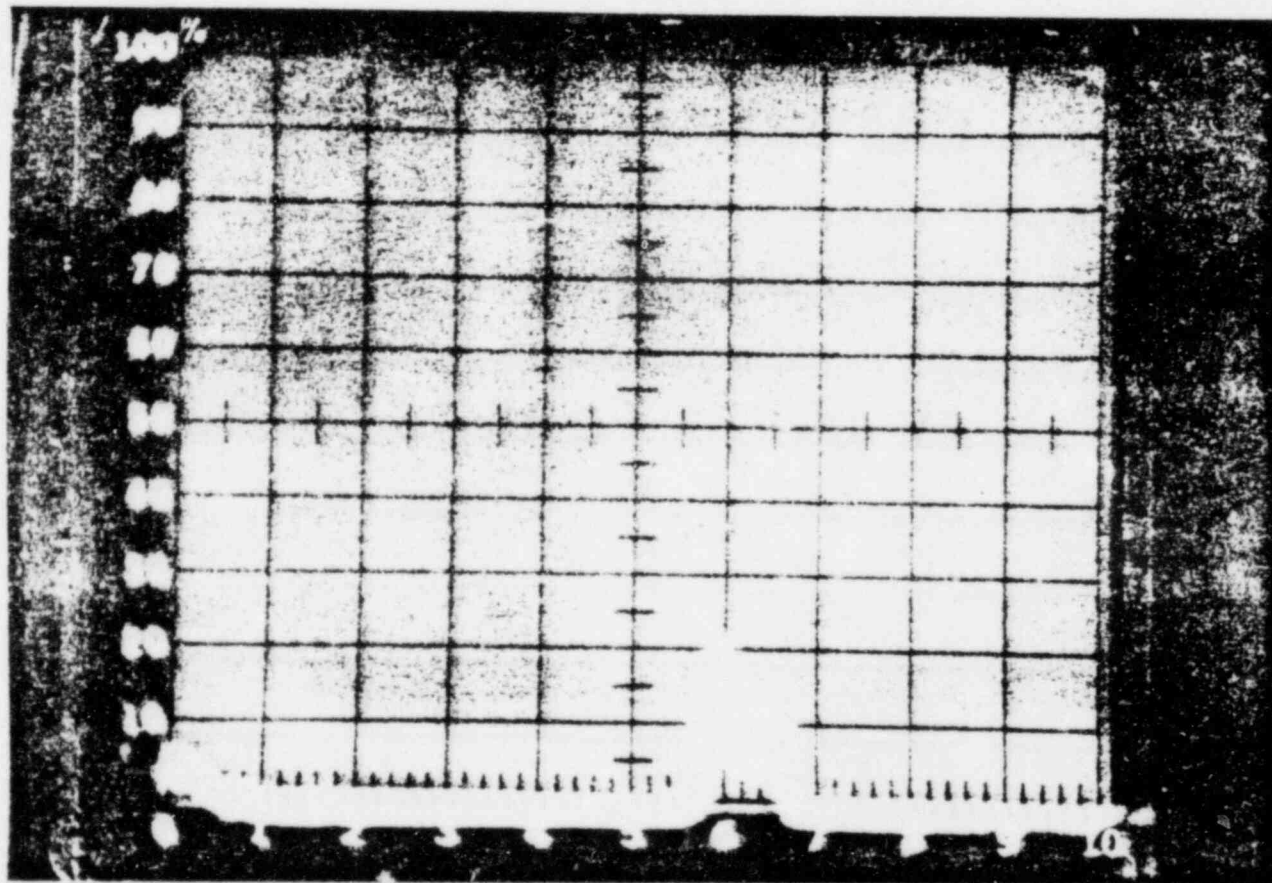
FIGURE 29

Joint geometry and UT screen presentation from .047" deep crack on pipe side. Double blip on screen is because two small cracks were adjacent to each other.

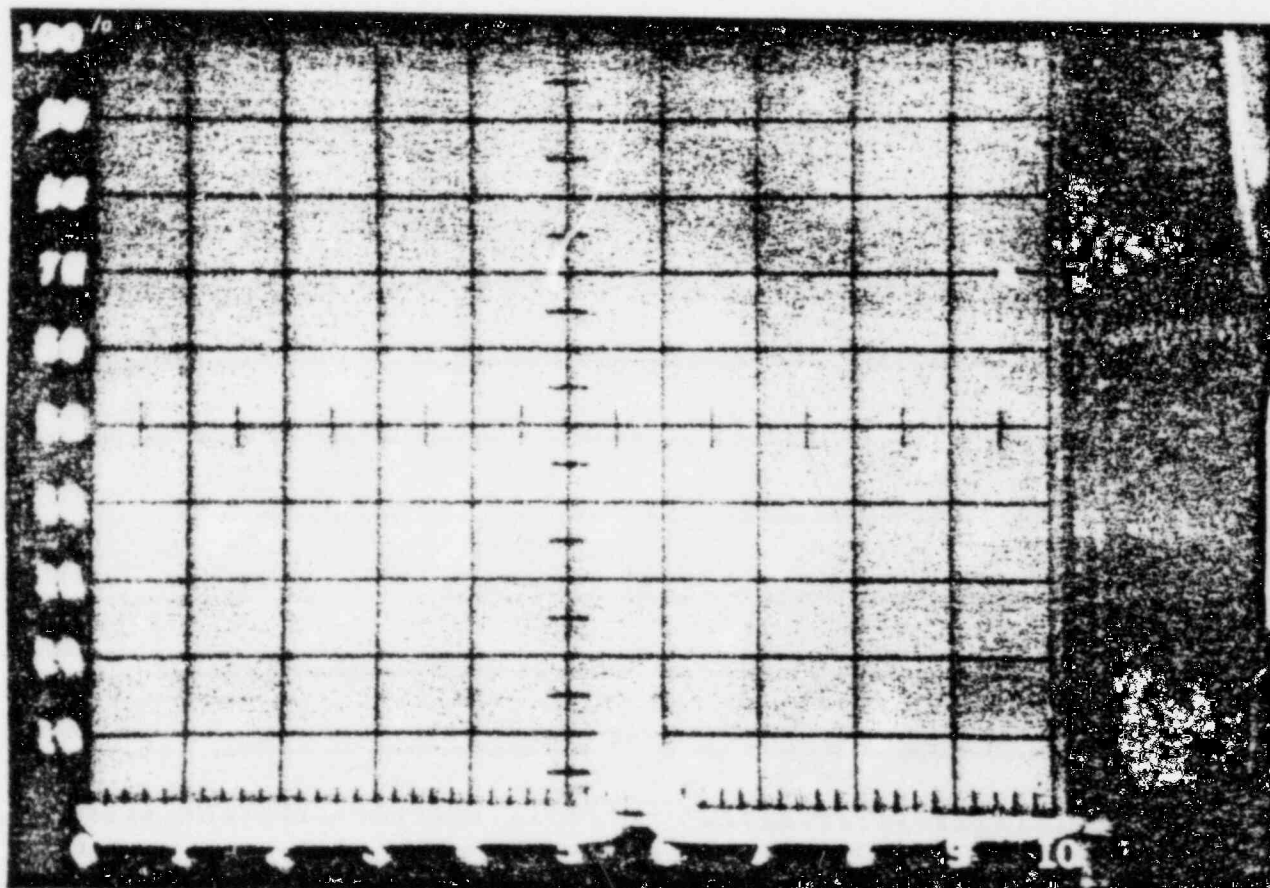
FIGURE 32

Joint geometry and UT screen presentation from $\approx .010$ " crack on pipe side.
