Report No. TR-V-MCM-003

Metallurgical Examination  
of  
Diffuser/R.C.P. Casing Bolts  
Returned from Arizona Unit 2  
(791350)

K. W. Dollansky, P.E.

1-25-1983

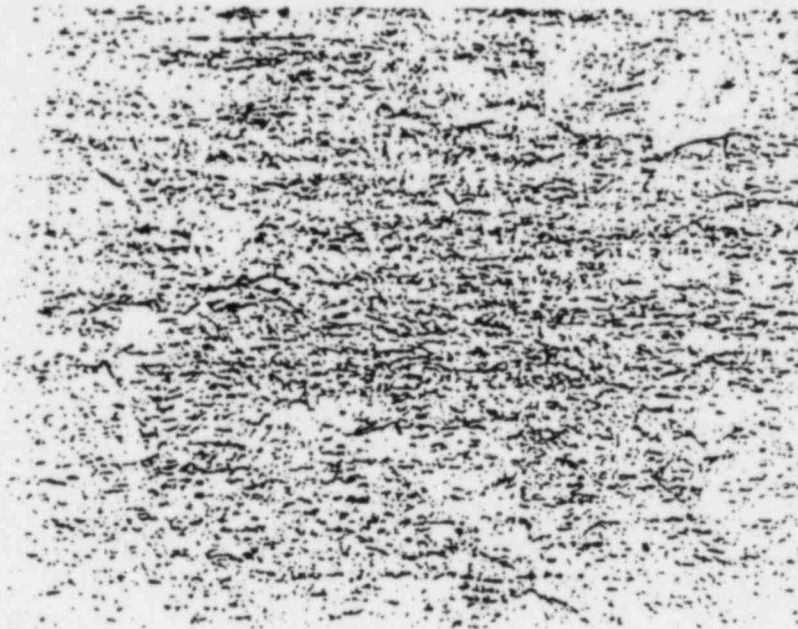
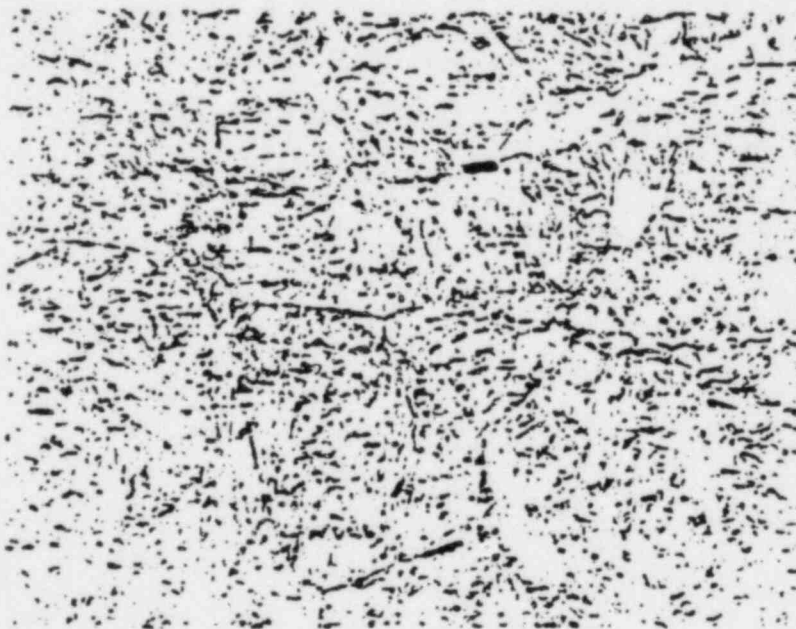
Fig. 2 Microstructure of Bolt Sample 1

Metallographic examination of the samples 1 and 3-1 revealed the microstructure to be tempered martensite with a grain size of about ASTM No. 7 (Fig's 2 and 3) and with clearly distinguishable former, austenitic grain boundaries (see also Fig. 3 in Report TR-MCM-112, the presence of the former, austenitic grain boundary was discussed in this report).

The micro hardness of both samples was found to be DPH 468-470 (500g load), corresponding to about Rc 47.

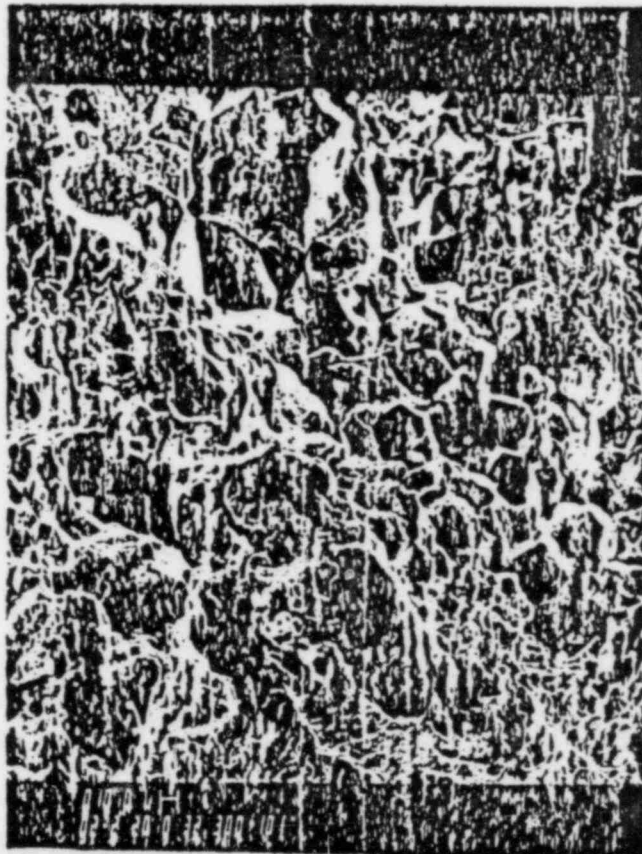
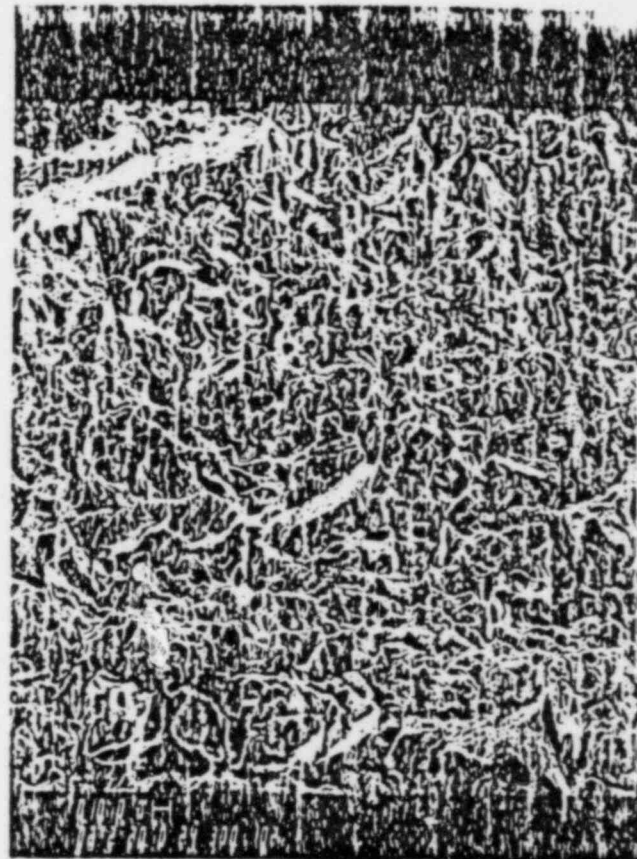
Fig. 4 SEM Photographs of Fracture Surface of Bolt Sample 1

The fractured surfaces of the two samples were examined on the scanning electron microscope (SEM). The crack which initiated the failure of the two bolts (see Fig. 1) is shown in the left photographs of Fig's 4 and 5. As can be seen the cracks are intergranular and follow the former, austenitic grain boundaries visible in the photomicrographs of Fig's. 2 and 3. The appearance of the crack surface (left, Fig's 4 and 5) is almost identical with that of Fig. 5, Photo A of Report TR-MCM-112, including some secondary cracking between adjacent grains.

The right photographs of Fig's 4 and 5 show the fractured surfaces of the final break of the samples 1 and 3-1, respectively (clean portions of the fractured surface in Fig. 1). The finer appearance of the fracture of sample 1 is believed to be due to the fact that this bolt broke by delayed hydrogen cracking whereas bolt 3-1 broke by overstressing when used to pull the diffuser/wedges into position.

The initial cracking of all eight bolts occurred by hydrogen induced stress corrosion cracking as discussed in detail in Report TR-MCM-112. Bolt 8109-200-016-3-1 broke finally by delayed hydrogen cracking just as the bolts No. 13 and 15 examined and discussed in Report TR-MCM-112. The remaining seven bolts broke, after initial stress corrosion cracking, when they were used to pull the diffuser/wedges into position. It is believed that they also would have failed sooner or later by delayed hydrogen cracking.
