| TITLE: VISUAL EXAMINATION RESULTS OF SEGMENT 2 FSV<br>FUEL ELEMENTS 1-2415, 1-0172, 2-2693, 1-0108<br>AND 5-0801 | | | | | | | <input type="checkbox"/> R & D<br><input checked="" type="checkbox"/> DV & S<br><input type="checkbox"/> DESIGN | | APPROVAL LEVEL <u>5</u> | | |
| DISCIPLINE<br>N | | SYSTEM<br>18 | | DOC. TYPE<br>RTE | | PROJECT<br>6400 | | DOCUMENT NO.<br>906577 | | ISSUE NO./LTR.<br>/2 | |

TITLE: RESULTS OF VISUAL EXAMINATION OF FSV FUEL ELEMENTS S.N. 1-2415,  
1-0172, 2-2693, 1-0108, 5-0801

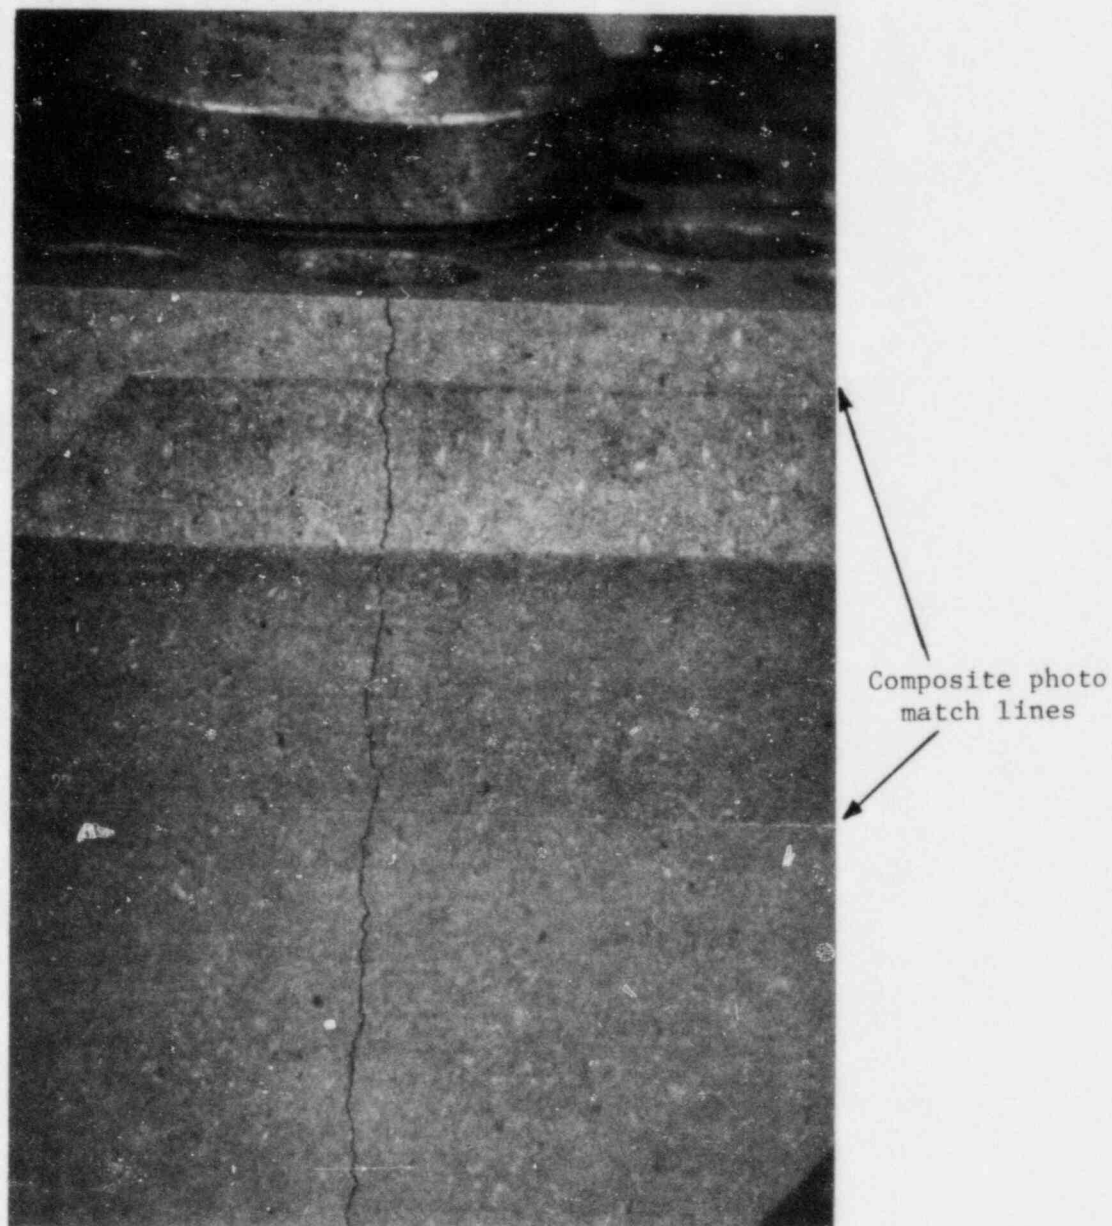
The crack in this block, which extends down the entire length of the B face, was scrutinized closely in this visual exam. Figure 1 shows part of a composite photo of the crack with the coolant hole and B dowel visible at the

Fig. 1 Composite photo of crack at top of block 1-2415.  
(Appearance of crack on photo enhanced with pen for clarity.)

top of the block. The crack extends across the coolant hole and up to the B dowel as shown in Figure 2a. However, it was not possible to determine at the top of the element whether the crack extended further without removal of the dowel, which is not possible without block disassembly. The crack did not reappear on the far side of the dowel. Figure 2b shows the use of one of the standard line cards placed near the crack at the top of this block; the crack width at this point was estimated to be .008 to .010 in. (.20 to .25 mm).

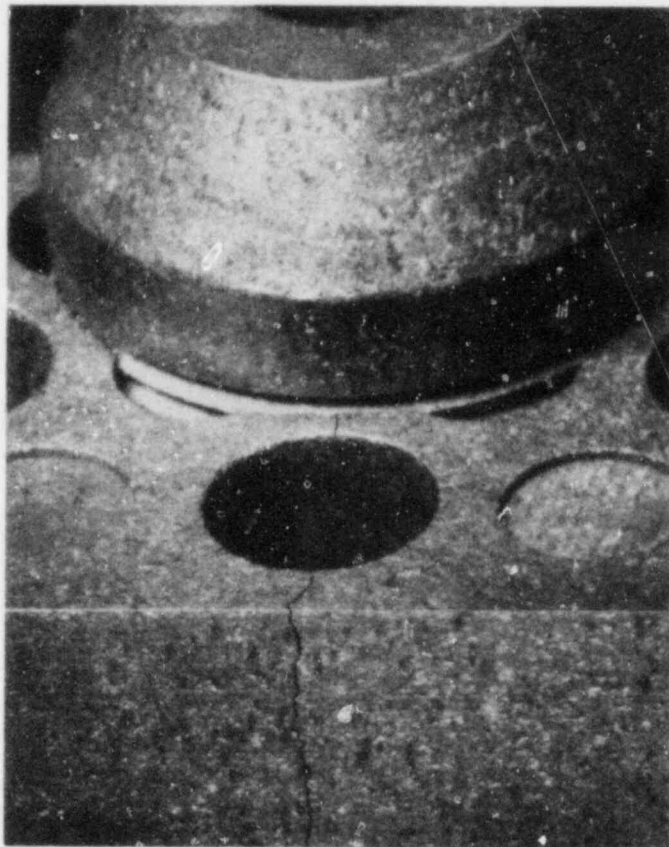
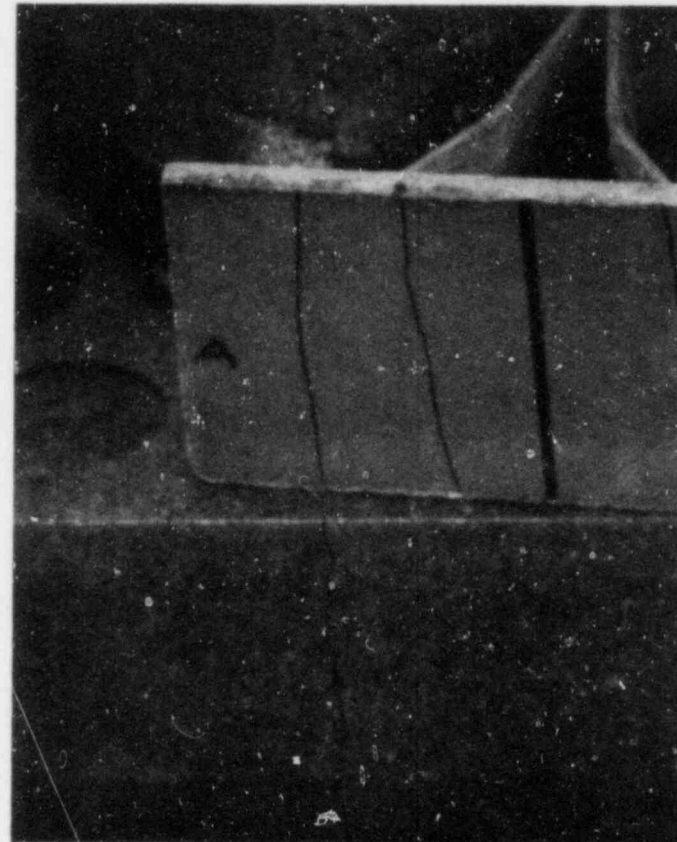
Fig. 2 Crack in element 1-2415. (a) Top view of block near "B" dowel showing crack extending across outermost coolant hole to dowel. (b) Example of use of standard line card for estimation of crack width. Line widths on cards were pre-measured. (Appearance of crack on photo (a) enhanced with pen for clarity.)

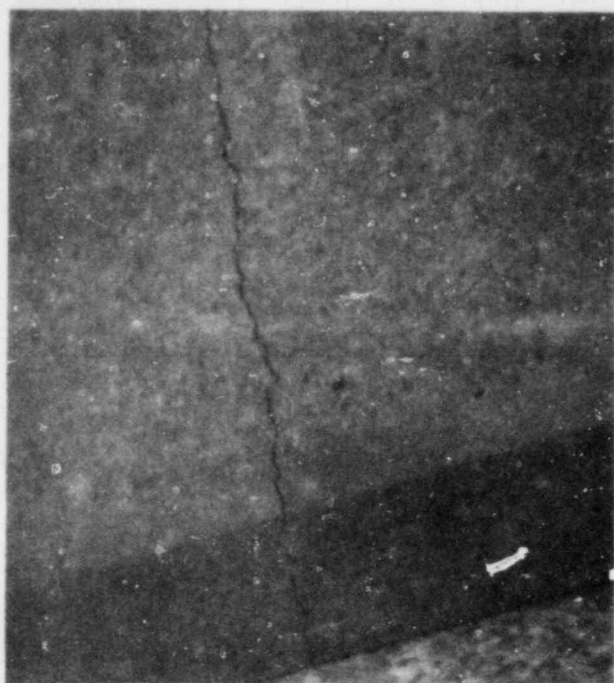
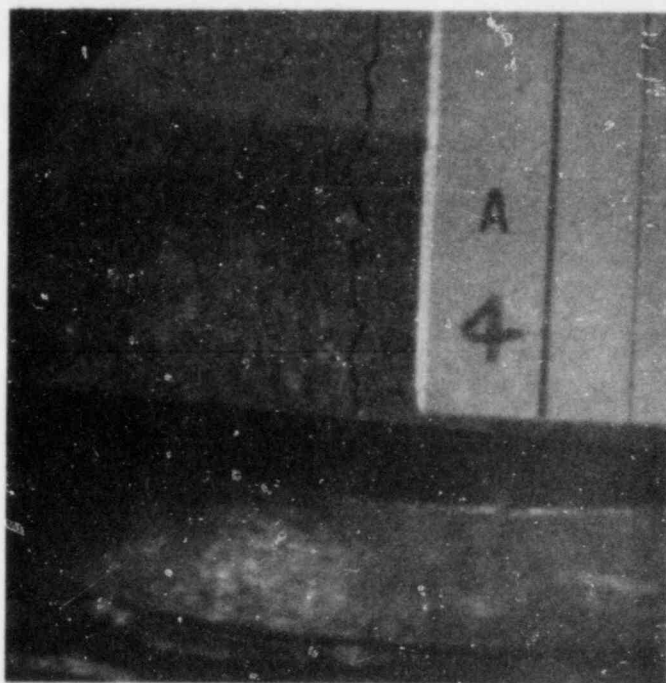
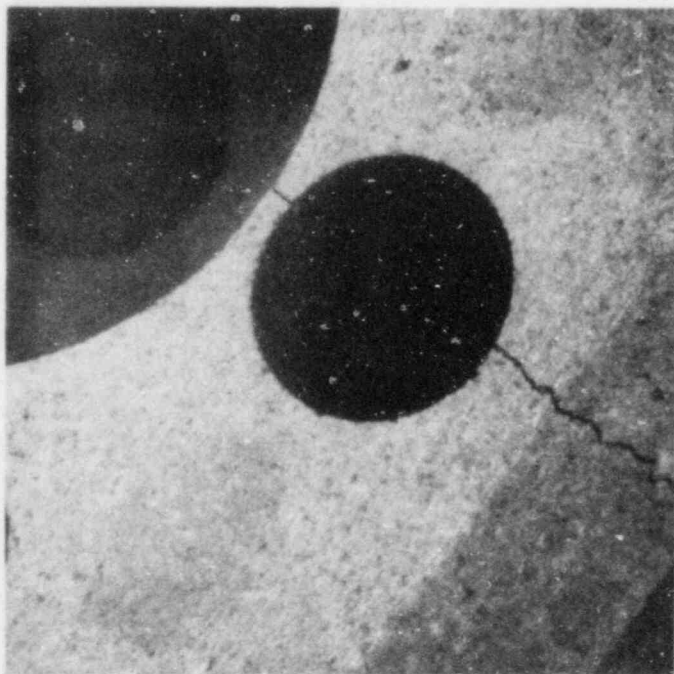
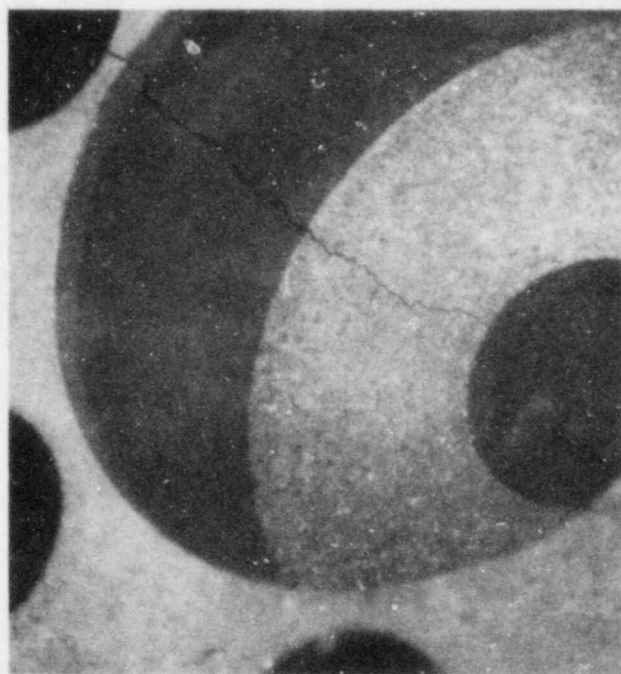
Fig. 3 Bottom views of crack in element 1-2415. (a) Bottom of "B" face (b) Standard line card used to gauge crack width (c) crack crossed outermost coolant hole into dowel socket (d) crack continued into dowel socket up to but not across coolant hole in the dowel socket. (Appearance of crack on photo (d) enhanced with pen for clarity.)

At the bottom of block 1-2415 (Fig. 3a) the crack appeared slightly wider and was estimated to be .011 to .012 in. (.28 to .30 mm) wide at this point (Fig. 3b). The crack also crossed the outermost coolant hole (Fig. 3c) and extended into the dowel socket and up to but not across the coolant hole in the dowel socket (Fig. 3d). The direction of the crack into the block at both the top and bottom is perpendicular to the B face on a line which, if extended, would intersect the fuel handling hole approximately through the middle. Assuming that this line of the crack holds true along the entire block length, it would appear that no fuel holes were intersected by the crack. This assumption should be confirmed in the destructive phase of block examination.

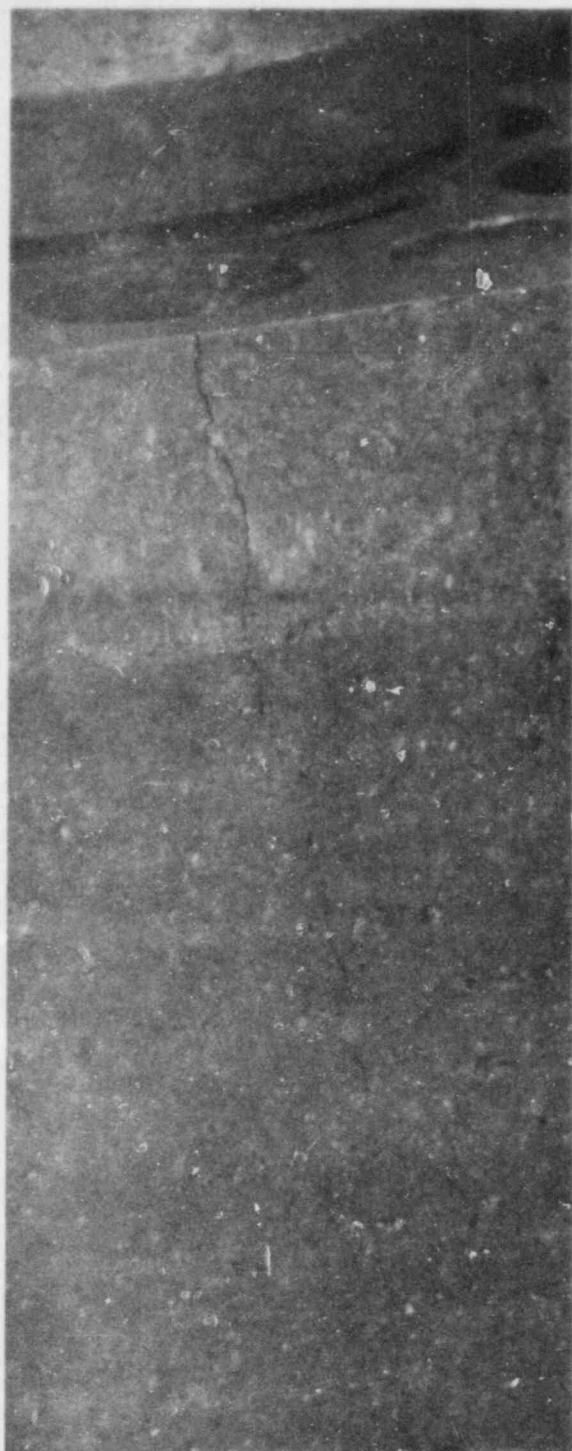
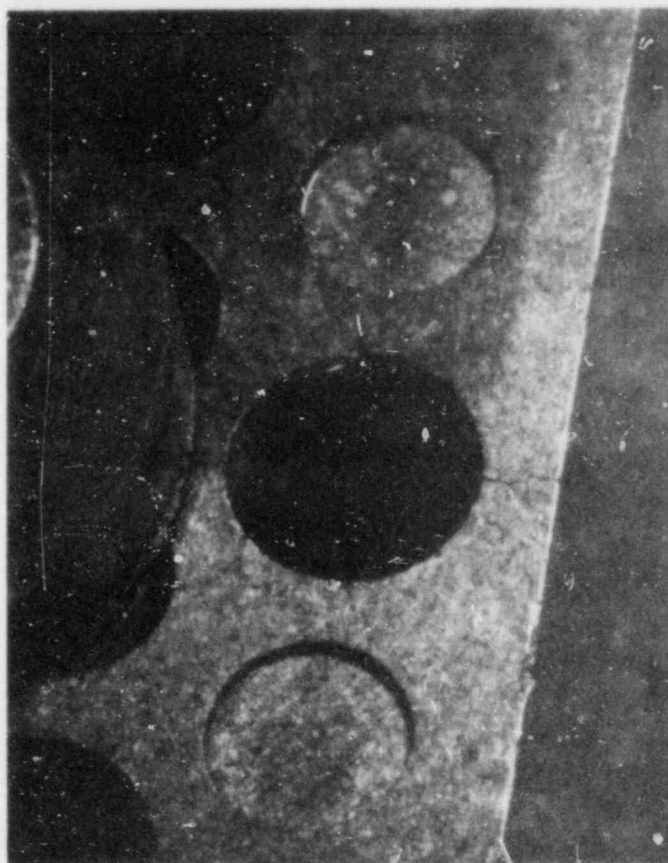
Fig. 4 Crack in element 1-0172. (a) View at top of ''B'' face (b) Top of block near ''B'' dowel showing crack crossing outermost coolant hole to dowel. (Appearance of cracks on photos enhanced with pen for clarity.)

through the Kollmorgen. Figure 4a shows the crack appearance at the top of the block and partway down the B face. Figure 4b shows that the crack goes across the outermost coolant hole at the top and up to the dowel. Crack width at the top of the block was estimated to be .005 to .006 in. (.13 to .15 mm). On the bottom of the block, the crack was so thin that it did not show up even in close-up pictures. It was apparent, however, that unlike block 1-2415, this crack did not cross the outermost coolant hole on the bottom end, and did not extend into the B dowel socket. Alcohol was used to verify this visual observation. The crack width at the bottom of this block between the side and the outermost coolant hole was estimated to be .002 to .003 in. (.05 to .08 mm).

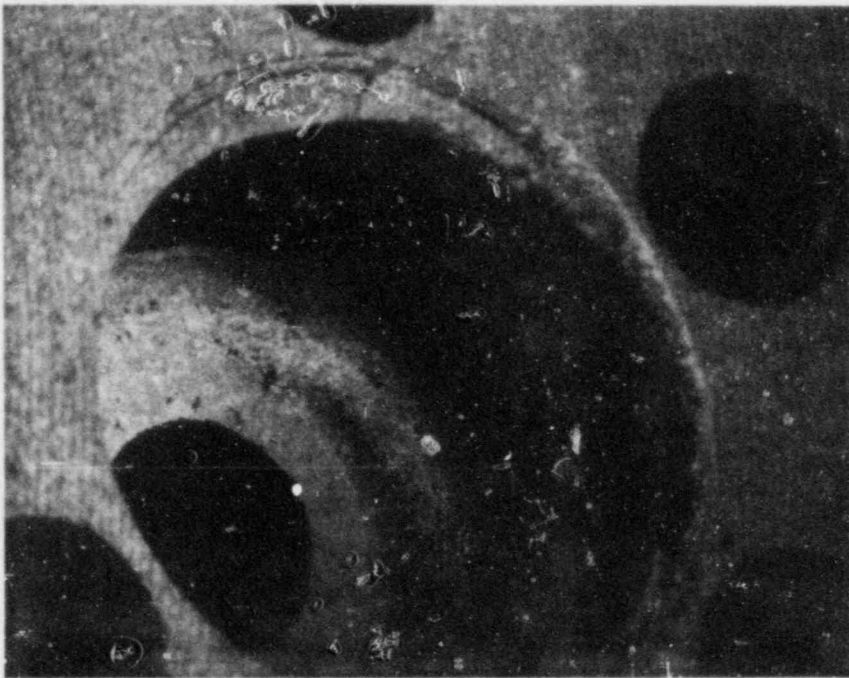
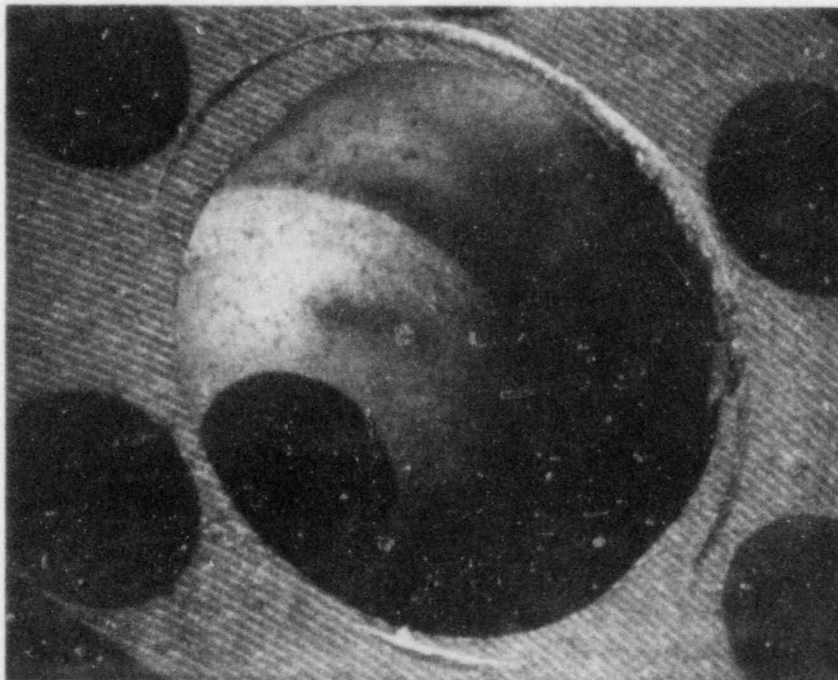
Fig. 5 Damage observed on two dowel sockets nearest "E" face on bottom of element 2-2693. See text Section 3.5.

This block was a control element, having two control rod channels and one poison channel in addition to fuel and coolant holes. The most notable feature observed on this block was slight damage to two of the dowel sockets on the bottom end, shown in Figure 5. This damage is tentatively being attributed to placement dowels on the bottom plate of the FSV shipping cask which prevent undue movement of the blocks during shipment.

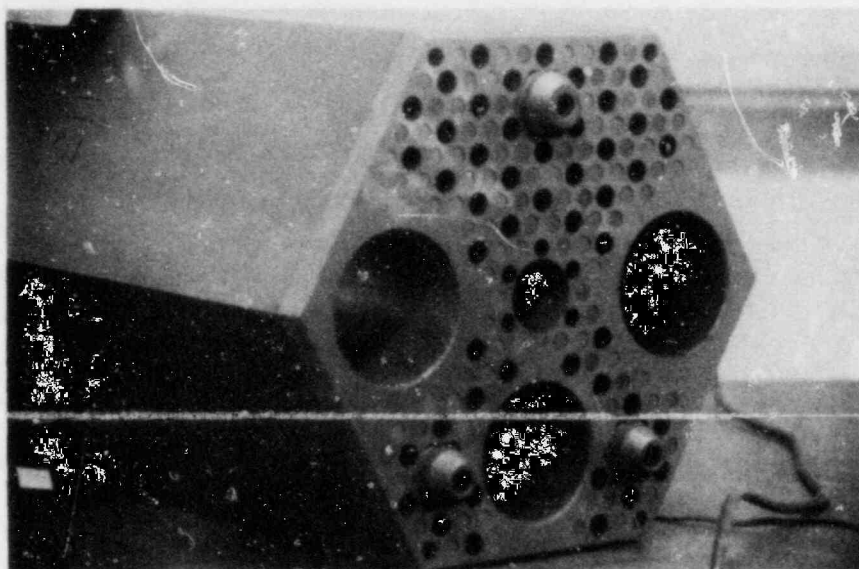
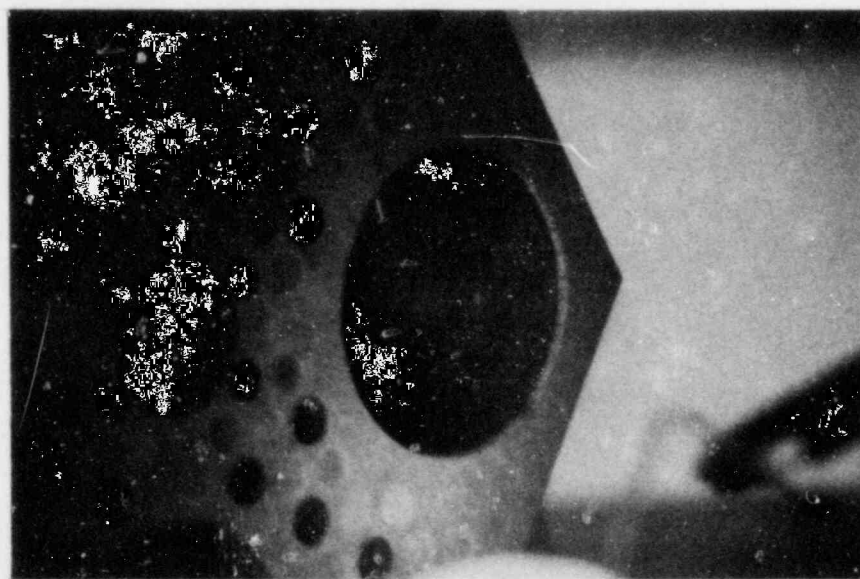
Fig. 6 Control element 2-2693 (a) Overall top end view (b) Closeup of control rod penetration showing light, vertical scratches attributed to control rod movement.

The insides of the control and poison channels were inspected with the aid of a small in-cell spotlight. No cracks were observed in any of these holes. Shallow vertical scrape marks as shown in Fig. 6b, probably due to control rod movement, were seen in the two control rod channels.

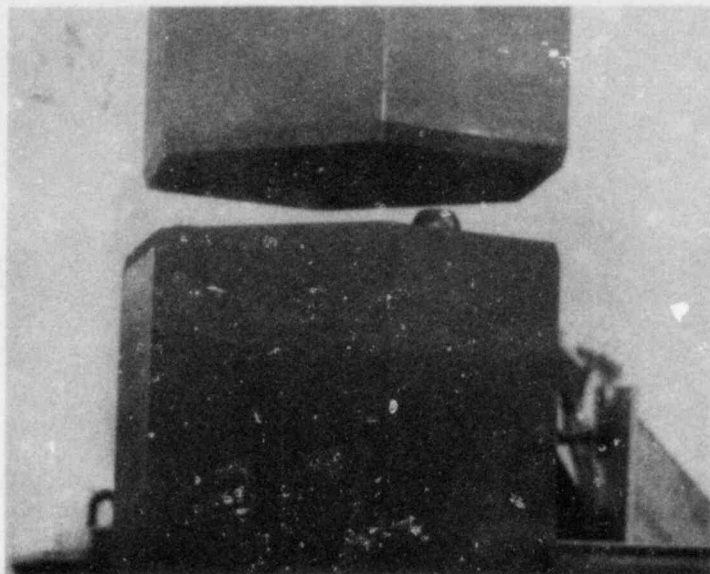
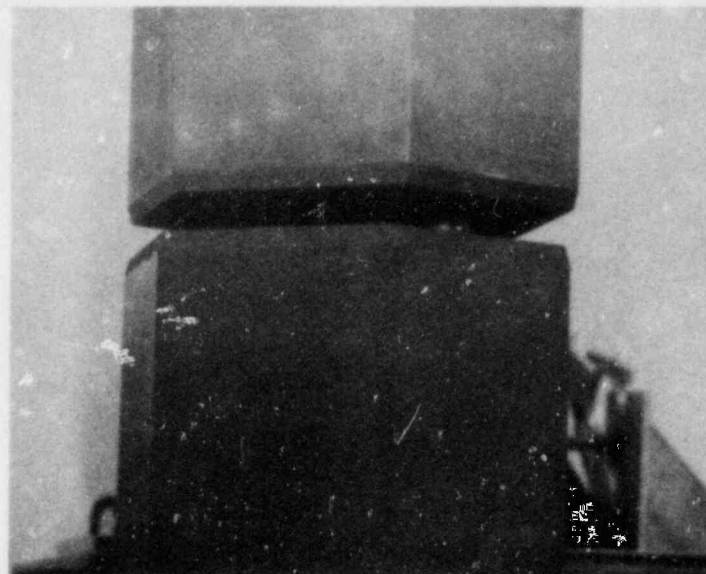
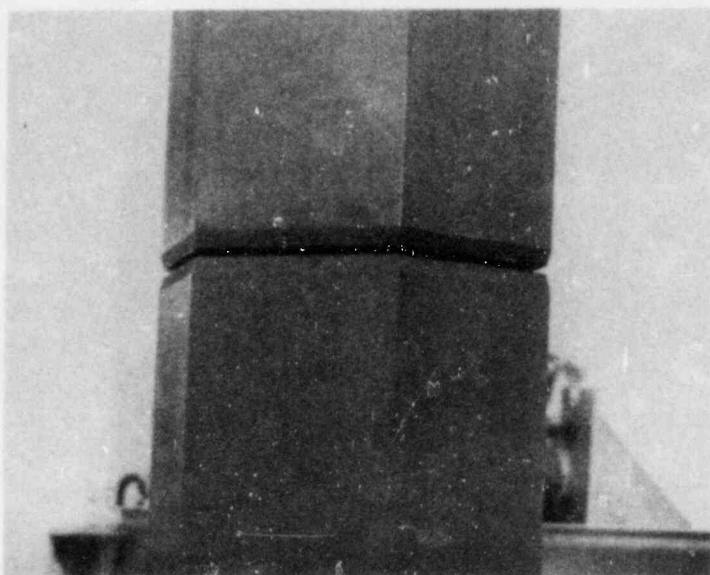
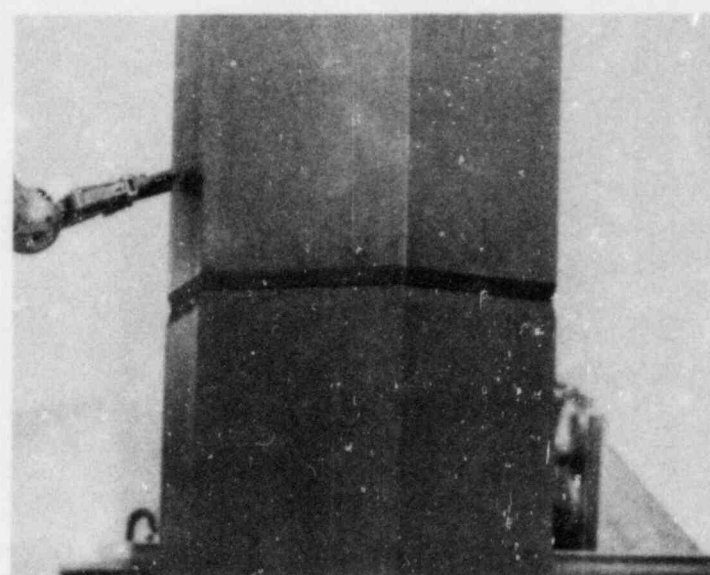
As called for in section 4.2.3 of the Test Specification (Ref. 2), block 1-2415 was stacked on block 1-0172 in their irradiation positions to investigate the fit of the dowels and sockets. This procedure is shown in sequence in Figure 7. The blocks stacked together easily with no apparent mismatch or interference. In fact, with the blocks stacked together but the weight of the top block supported by the overhead crane, there was noticeable lateral clearance, particularly at the B face dowel and socket location. This is shown in Figure 8. Figure 8a shows the view of the B faces just before finally lowering block 1-2415 onto 1-0172; the larger crack size in block 1-2415 is apparent. Figure 8b is a double exposure made by moving the top block to the two

Fig. 7 Stacking demonstration with block 1-2415 (top) and 1-0172 (bottom) in each photo. (a) Blocks approximately 6 inches apart (b) dowels about to engage sockets (c) dowels engaged (d) fully seated.

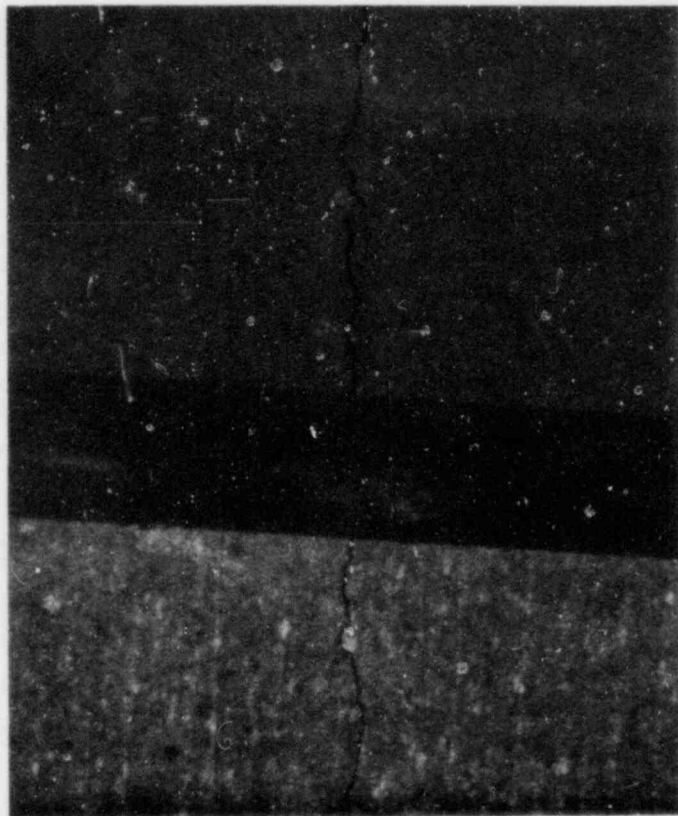
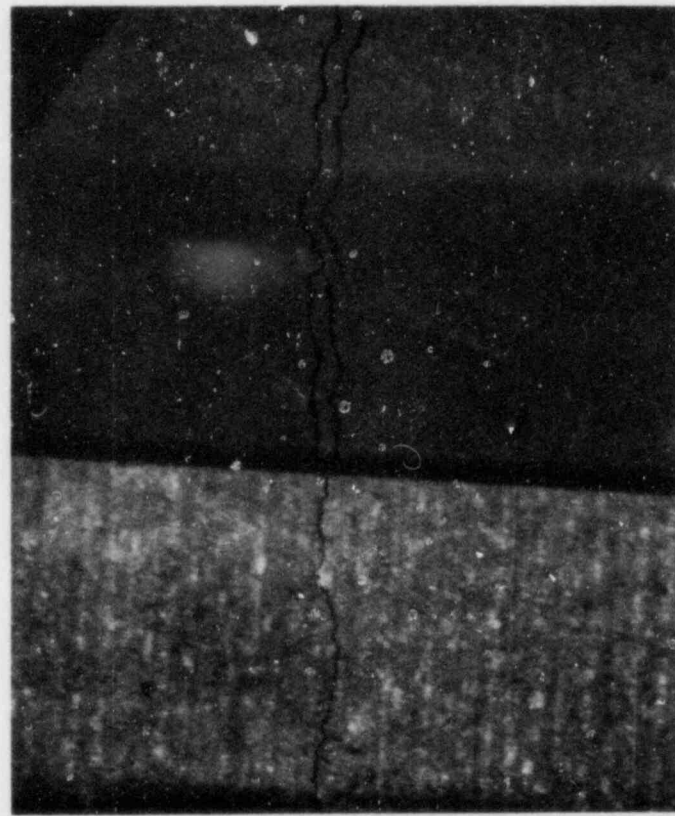
Fig. 8 Stacking demonstration of blocks 1-2415 (top) and 1-0172 (bottom) at the "B" faces showing cracks in both blocks. (a) Just before fully engaged (b) fully engaged; double exposure showing lateral movement possible at "B" dowel and socket. (Appearance of cracks on photos enhanced with pen for clarity.)

extreme positions allowed by the lateral clearance. From this exercise the relative movement and thus the diametral clearance at this point was estimated to be .040 to .050 in. (1.02 to 1.27 mm). The nominal design clearance is .040 in.

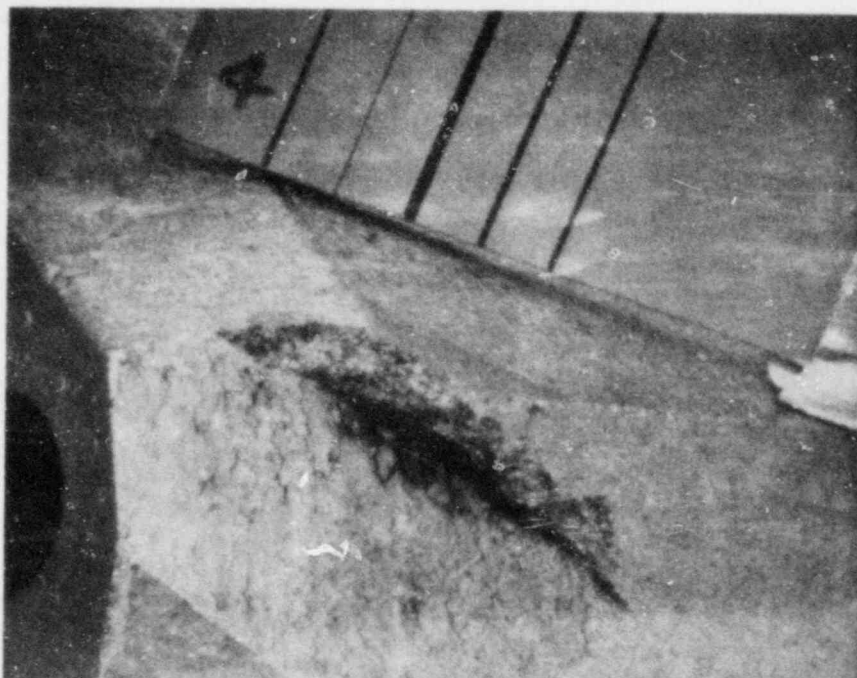
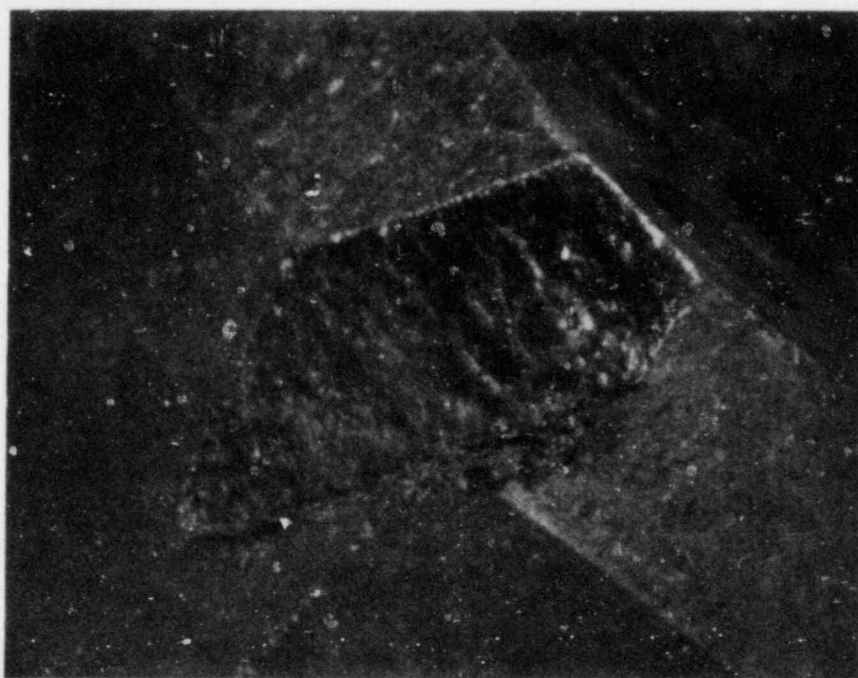
Fig. 9 Damage at the top corners of two of the five blocks examined which occurred when the blocks were removed from the FSV shipping cask; (a) block 1-2415, (b) block 1-0172.

Figure 9 shows deep gashes at the tops of the first two blocks examined (S/N's 1-2415 and 1-0172). The source of these has been traced to a protruding index bracket on the shipping cask that gouged the blocks as they were removed for this examination. This damage was avoided on the other three blocks after the problem had been identified.

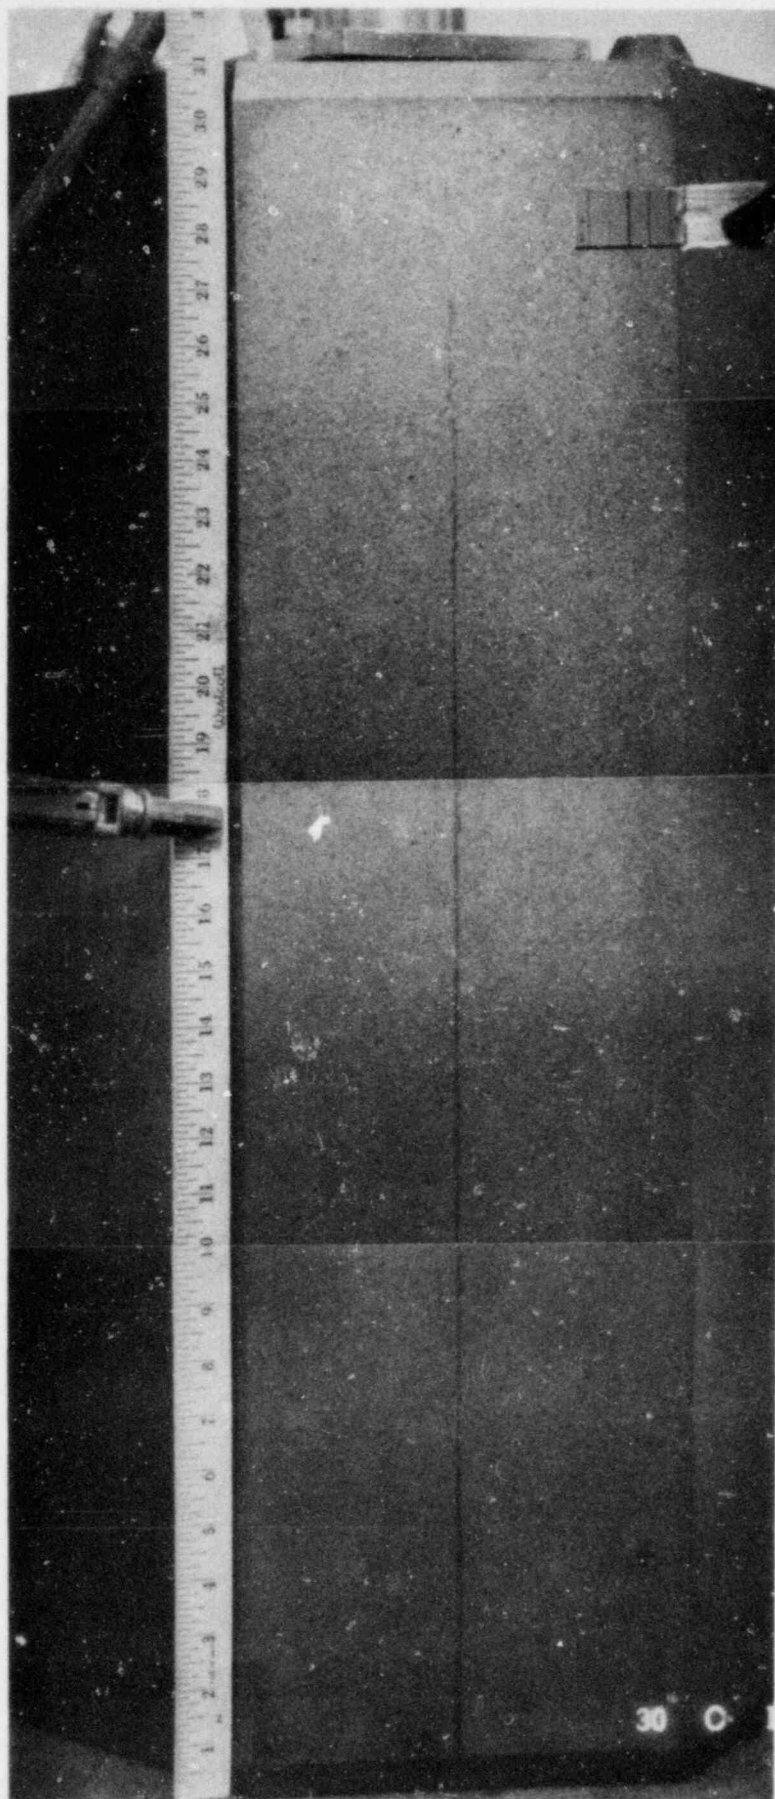
A feature seen on all the blocks examined is shown in Figure 10. A long, vertical scrape or scratch down the center of the C face, and sometimes near

the right hand edge of the D face was observed. The source of these marks is not known but it has been speculated that fuel handling in the fuel storage wells at the reactor site may be the cause.

Fig. 10 Composite photo of "'C'" face of element 1-0108 showing vertical scratch seen in same location on all elements examined. See text, Section 3.8, (scale in inches).
