# Design, Operating and Inspection Considerations to Control Stress Corrosion of LP Turbine Disks

**AMERICAN POWER CONFERENCE**

CHICAGO, ILLINOIS, APRIL 18-20, 1983

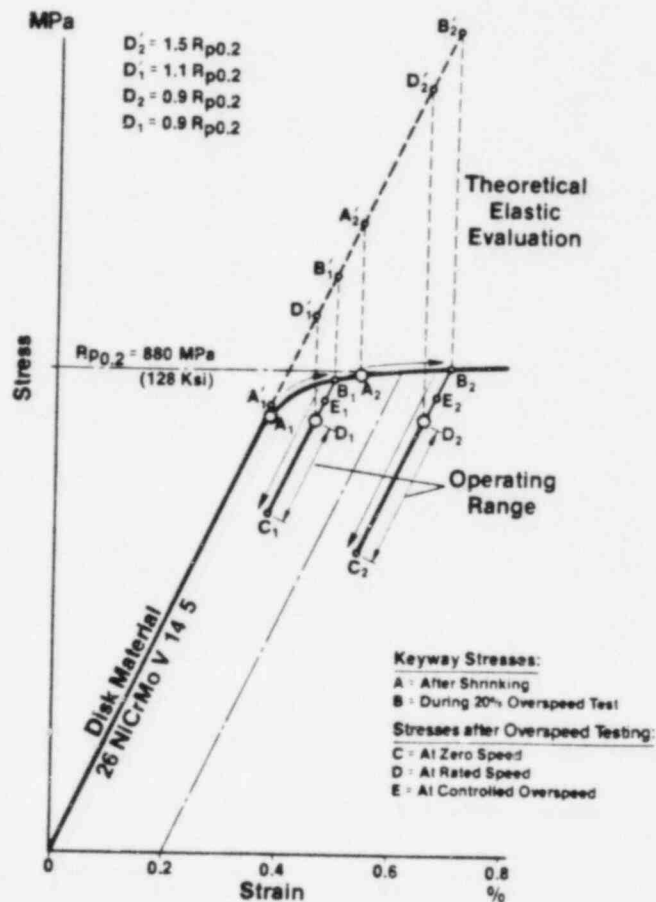
Relating stress corrosion susceptibility of disk keyways only to the evaluated design stresses, however, is inappropriate. Other factors are equally important, such as the formation of crevices and steam/water flow conditions. Design stresses also reflect an unrealistic picture since the factory overspeed test already causes local plastic deformation of the keyway and reduces subsequent local operating stresses as shown by the two examples in Figure 3.

However, the stresses in keyway 2 increase by only a small amount because of plastic elongation. Bringing the rotor back to standstill reduces the local stress levels at both keyways to much lower levels as shown by points C<sub>1</sub> and C<sub>2</sub>. At this time, the stress level of keyway 2 is lower, but keyway 2 underwent more plastic elongation. Subsequent power plant operation between zero and rated speed results in stressing keyway 1 and 2 between points C<sub>1</sub>-D<sub>1</sub> and C<sub>2</sub>-D<sub>2</sub> respectively. An overspeed event during plant operation would raise the stresses only to E<sub>1</sub> and E<sub>2</sub>, since overspeed is limited to about 10%. A different stress corrosion sensitivity of the two described examples cannot be concluded.

Fig. 3 Stress Levels of Two Different Disk and Keyway Designs.

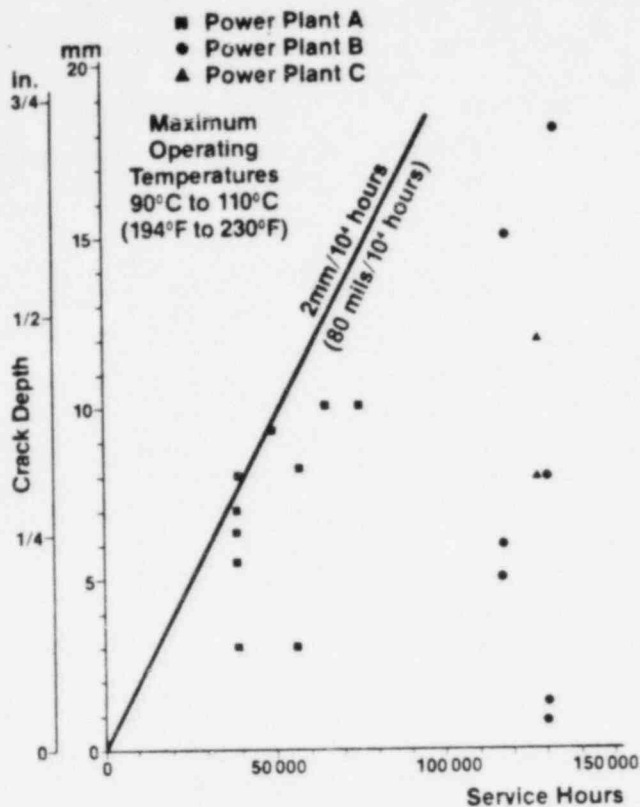
Subsequently, Kraftwerk Union has inspected sixteen of the total of twenty AEG LP rotors in South Africa, after 20,000 to 140,000 service hours. All these turbines are of the non-reheat design, rated between 100 and 200 MW and operate with a small moisture content in the LP turbine admission steam. Disk cracks were found in fifteen of the sixteen turbines in three different power plants. The test results from the 128 disks revealed stress corrosion cracking in 49 disks as listed in Table I. In forty disks, cracks were found only in the vicinity of the rectangular keyways. However, seven disks without keyways and two disks with keyways had stress corrosion cracks in the disk hubs, the disk faces and/or the anti-rotation pin holes. Only one disk showed corrosion cracking in the shrink-fit region. All the remaining disk-hub cracks were located in the non-shrink area. The shrink fit area of this disk design covers approximately 60% of the disk width and the adjacent 20% overlaps at each side actually have small clearances. Cracks in areas other than the keyway regions occurred in three of the sixteen turbines after 40,000 to 75,000 service hours.

All the disk cracks found revealed an intergranular crack pattern with branched crack propaga-

tion. The crack initiation locations were often pitted and heavily expanded by corrosion. Corrosion products penetrated to the crack tips and were analyzed to be magnetite ( $Fe_3O_4$ ). None of the cracks had any significant deposits of salts or sodium hydroxide (NaOH). All these findings are typical indications of stress corrosion. The maximum crack depth found in one of the 128 inspected disks was 18 mm or almost 3/4 in. As plotted in Figure 5, the inspection results from the three South African power plants indicate a conservative maximum crack propagation rate of  $2mm/10^4$  hours (approx. 80 mils/ $10^4$  hours) from initial unit start-up.

Fig. 5 Keyway Inspection Results of Three South African Power Plants.

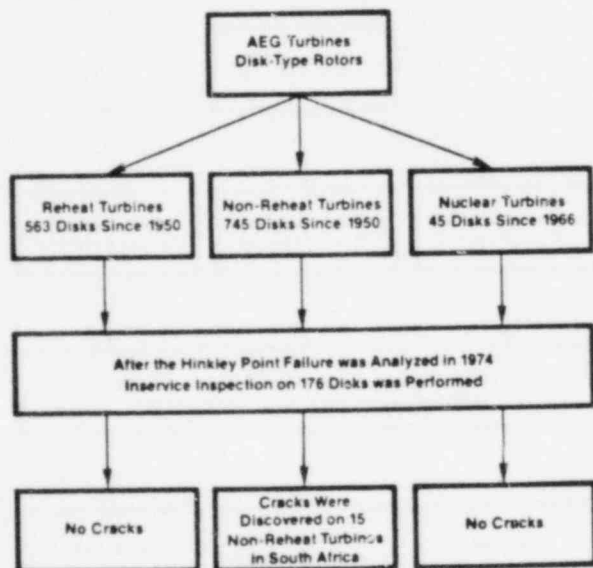
After Kraftwerk Union discovered the first corrosion cracks in the South African turbines, an inspection program for all disk-type LP rotors was introduced. In the meantime, several LP rotors have even been disassembled and the disks were tested using magnetic particle techniques. The inspected LP rotors have been operating over long time periods in various European countries, such as Germany, Denmark and Greece. Results of these inspection programs are depicted in Figure 6. The disks of seven of these turbines have been inspected and no disk cracking has been discovered after 10 to 20 years of operation.

Fig. 6 Hub and Keyway Inspection Results of AEG-Design LP Turbine Disks.

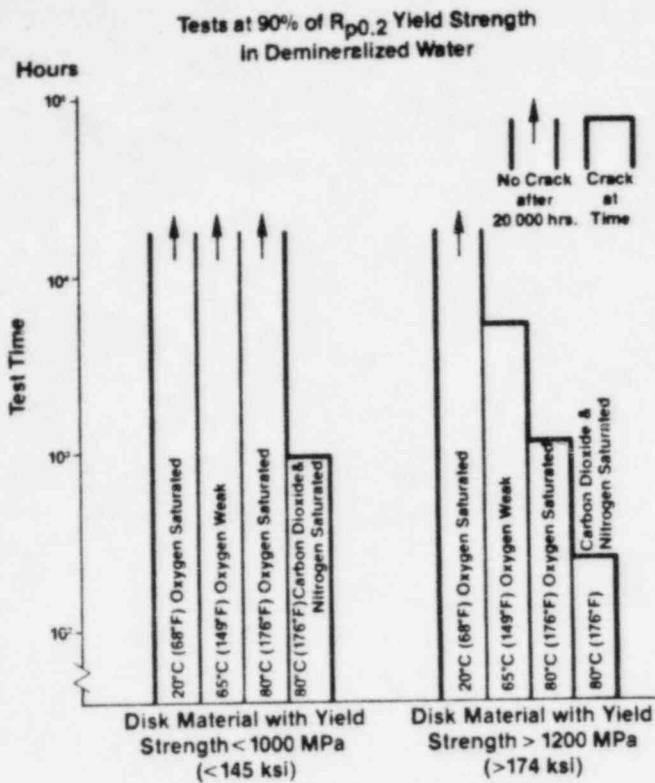
Figure 7 depicts the results of tests with specimens stressed up to 90% of their yield strength. Adding carbon dioxide to the water cycle resulted in corrosion cracking, even of the low yield strength material after less than 1000 hours. The specimens tested in water saturated with carbon dioxide exhibited extensive corrosion pits and

**Fig. 7 Stress Corrosion Test Results with Oxygen and Carbon Dioxide.**

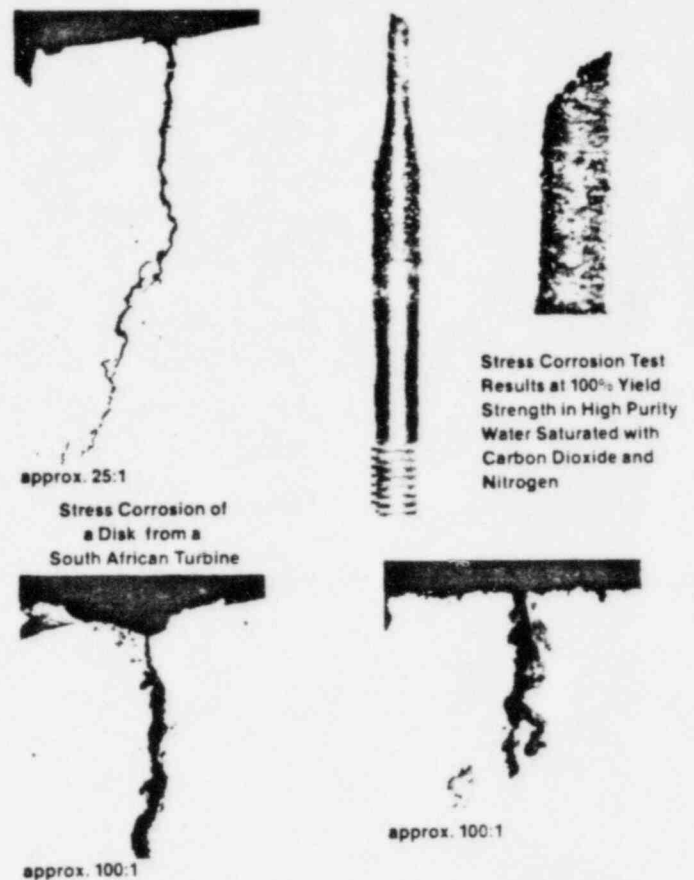
crack initiation as shown in Figure 8. The test sample surfaces were already covered with black oxide (magnetite) shortly after the tests began, whereas samples tested in oxygen poor and saturated demineralized water looked clean and had only a thin, light-colored passive layer even after 20,000 hours of testing. Spot checks with a weak sulfuric acid solution showed results similar to the test in carbon dioxide saturated water.

**Fig. 8 Stress Corrosion Caused by Carbon Dioxide.**

With a sufficiently low cation conductivity of the turbine condensate, stress corrosion can practically be eliminated, since low cation conductivity confirms the absence of acidic compounds such as carbon dioxide, sulfur dioxide, muriatic acid, organic acids and possibly salts. Oxygen in the steam or condensate has no influence in this regard. This passivity of oxygen is also confirmed by the fact that BWR and fossil-fueled plants with combined feedwater treatments operate with high oxygen contents. It can also be safely assumed that sufficient alkalization of the condensate at and below the Wilson line could eliminate stress corrosion or pitting corrosion in LP turbines.

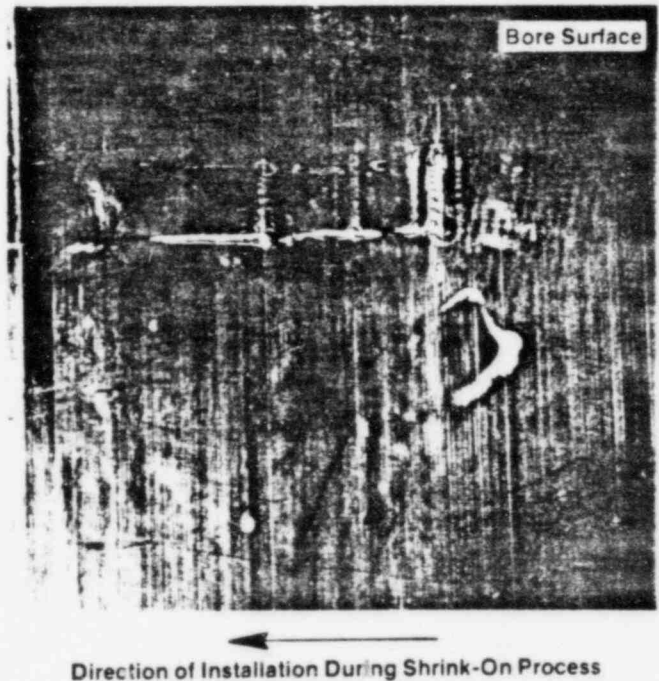
This newly developed system was applied for the first time to inspect an LP rotor after roughly 76,000 service hours in a German PWR nuclear power plant. The 100% volumetric inspection of the hub bores and keyways was performed on a completely bladed LP rotor. The ultrasonic testing showed a maximum indication of a 3.3 mm (0.13 in.) equivalent flat bottom hole over a maximum axial distance of 100 mm (4 in.) in one of the ten disks at the shrink fit.

As part of the development program of this specific LP rotor test all disks were removed from the shaft after the ultrasonic inspection. The ultrasonic indication on the aforementioned disk was found to be caused by score marks with a maximum depth of 0.5 mm (20 mils). The score mark configuration clearly indicated that scoring had occurred during the shrink-on and not the shrink-off process (**Fig. 14**). All the shrunk-off disks were closely inspected without indication of any stress corrosion after approx. 76,000 hours of operation.

**Fig. 14 Installation Score Marks at the Shrink Fit of a Disk.**
