LIMERICK GENERATING STATION

SUBJECT: Licensee Event Report
Limerick Generating Station - Units 1 and 2

Reference: Docket Nos. 50-352
50-353
Report Number: 1-91-006
Revision Number: 00
Event Date: February 18, 1991
Report Date: March 18, 1991
Facility: Limerick Generating Station
P.O. Box A, Sanatoga, PA 19464

LICENSEE EVENT REPORT (LER)

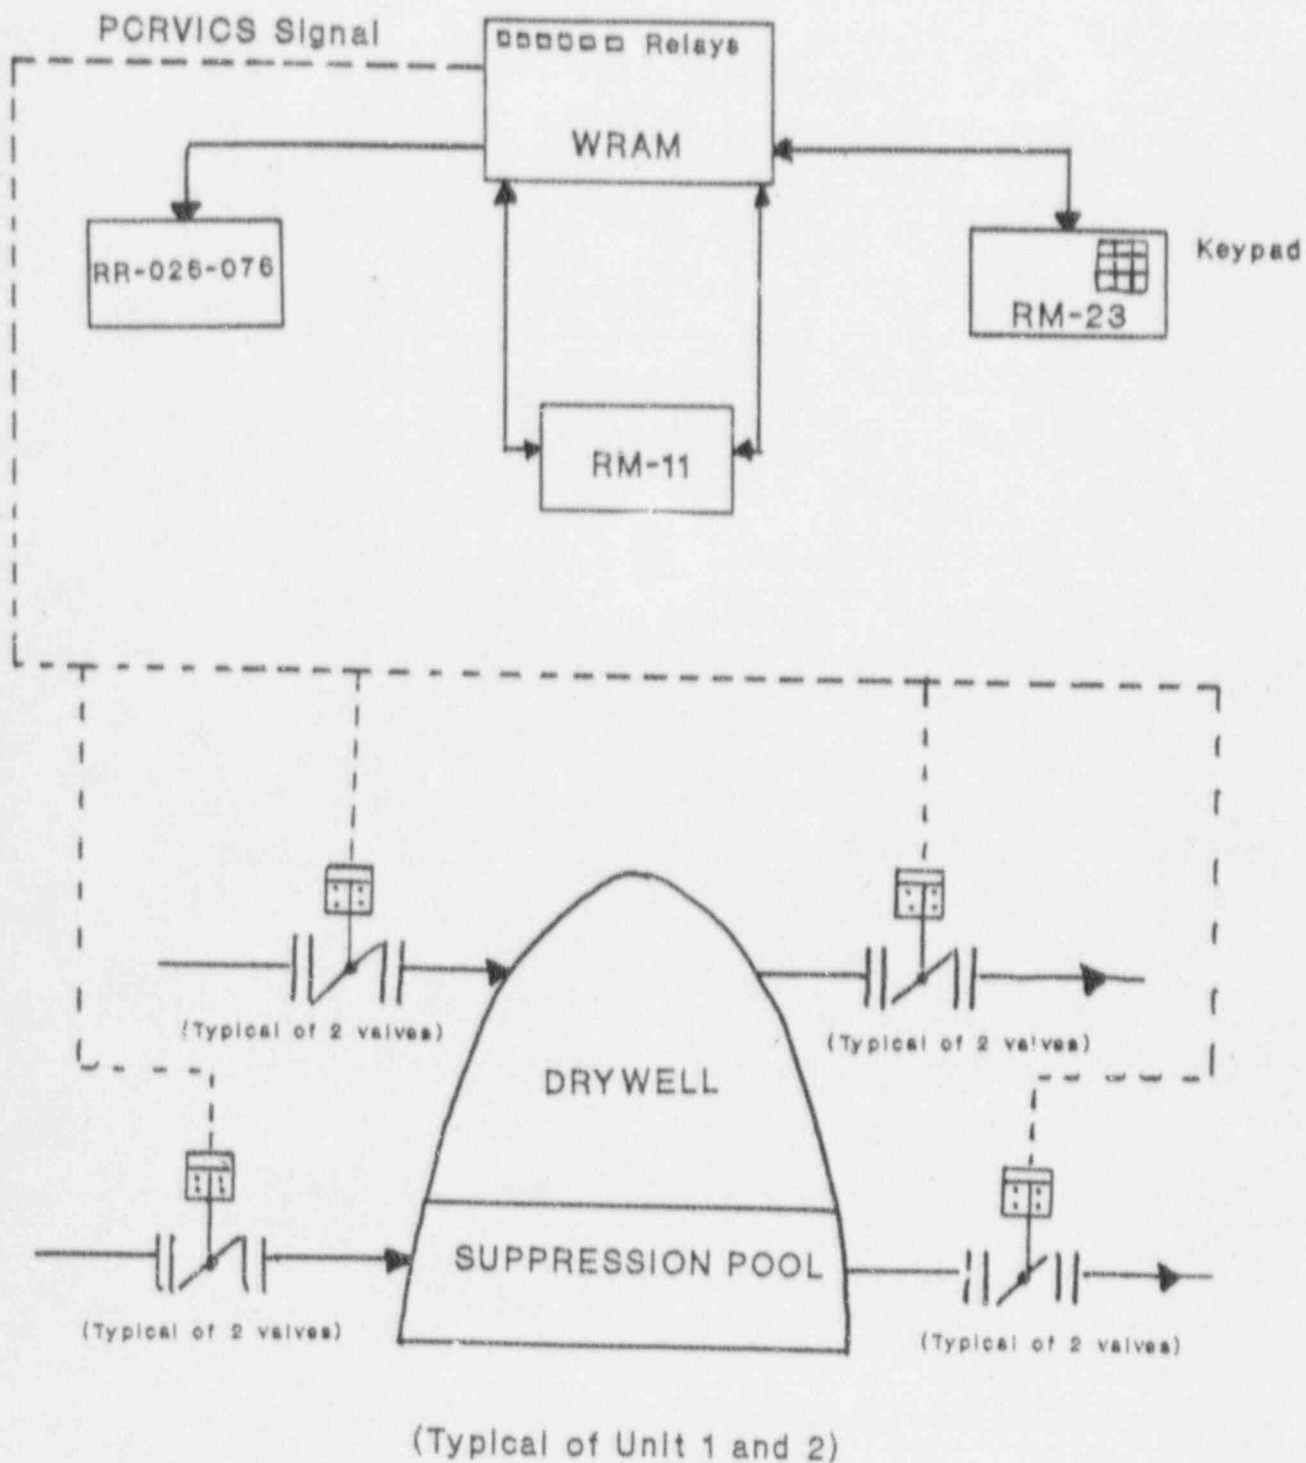
See Figure 1 for the single line system schematic.
