U. S. NUCLEAR REGULATORY COMMISSION
REGION I

Report No. 50-333/91-80

Facility Name: James A. FitzPatrick Nuclear Power Plant (JAF)

Inspection Summary: An Augmented Inspection Team (AIT) inspection was conducted March 19-28, 1991, to review the circumstances relative to the unmonitored release on March 18 of radioactive materials from the radwaste concentrator through the auxiliary boiler system to the environment through the auxiliary boiler vent. An Executive Summary can be found in Report Section 2.0. Potential enforcement issues are being considered separate from this inspection.

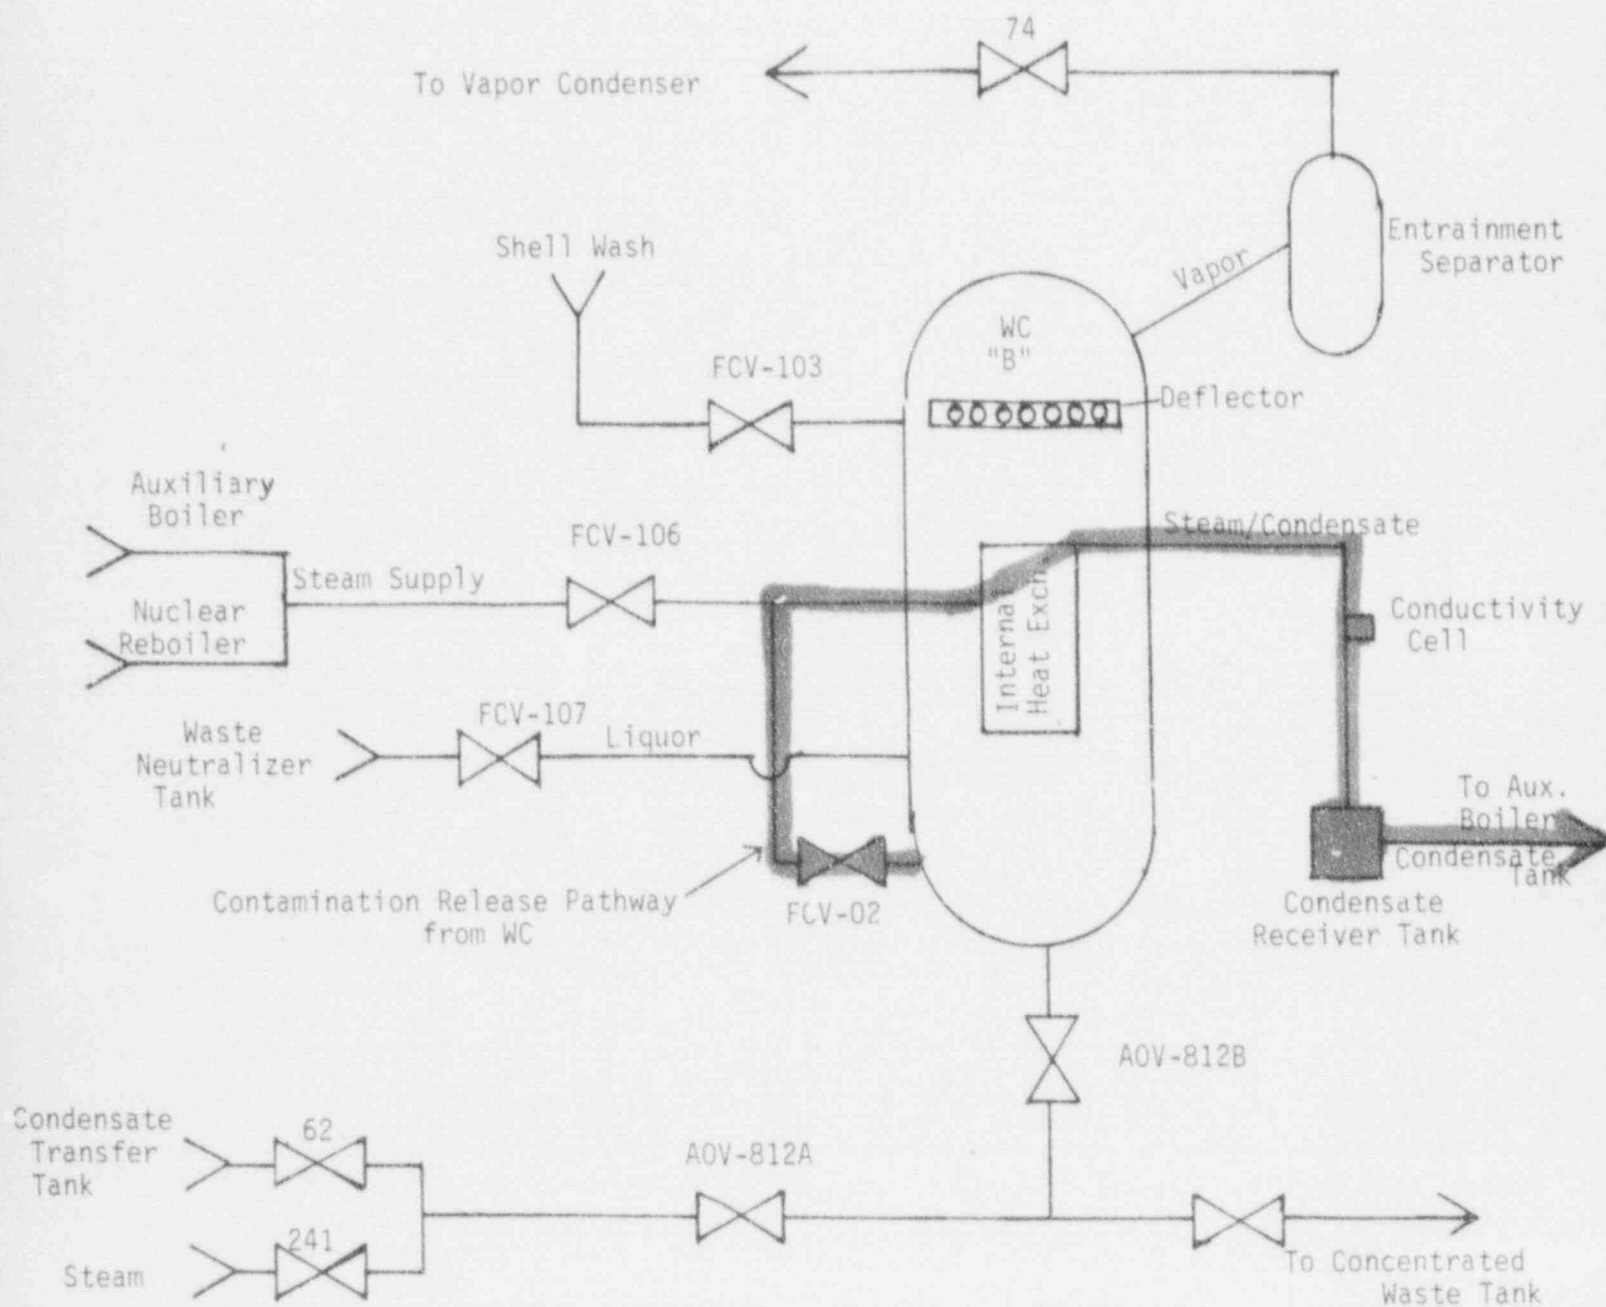
WASTE CONCENTRATOR (WC) B FLOW SCHEMATIC

Downstream of FCV-106 on the steam supply a line taps off which can be used to supply steam to the liquor side of the WC, either to agitate the liquor or to provide steam for flushing a refractometer, which is no longer used. Steam flow through this line is controlled by valve FCV-02. The inspectors determined that original design prints show this line tapping off the steam supply before FCV-106, but the as-built configuration is as described above. (See Figure 1.)

- Shutting valve 74 (between the entrainment separator and the vapor condenser - see Figure 1) to "bottle up" the concentrator and raise the internal pressure of the WC to help clear the plug. WC internal pressure was increased approximately 1.5 psi through this action.
- Shutting an inlet valve to the CWT (downstream of AOV-812B) and attempting to backflush the drain line by applying condensate water through a fitting, by use of a connecting hose, and opening of valve 62. In parallel with the condensate supply, valve 241 was also opened to admit steam to also assist in backflushing the line. Several other valve manipulations were also made to align the backflush sources to the B WC.

- d) The inspectors determined, as noted in Section 3.1, that the liquor agitation/refractometer steam wash line was not installed as shown in the design drawings, in that the installed line taps off downstream of the steam admission valve, FCV-106, rather than upstream as shown in the design drawings.
