PEACH BOTTOM ATOMIC POWER STATION

SUBJECT: Licensee Event Report  
Peach Bottom Atomic Power Station - Unit 2

| Report Number: | 2-91-012 |

| TITLE (4)<br>Technical Specification Violation due to Failure to Perform Testing as a result of Improper Development of Original Procedure | | | | | | | | | | | | | | | | |

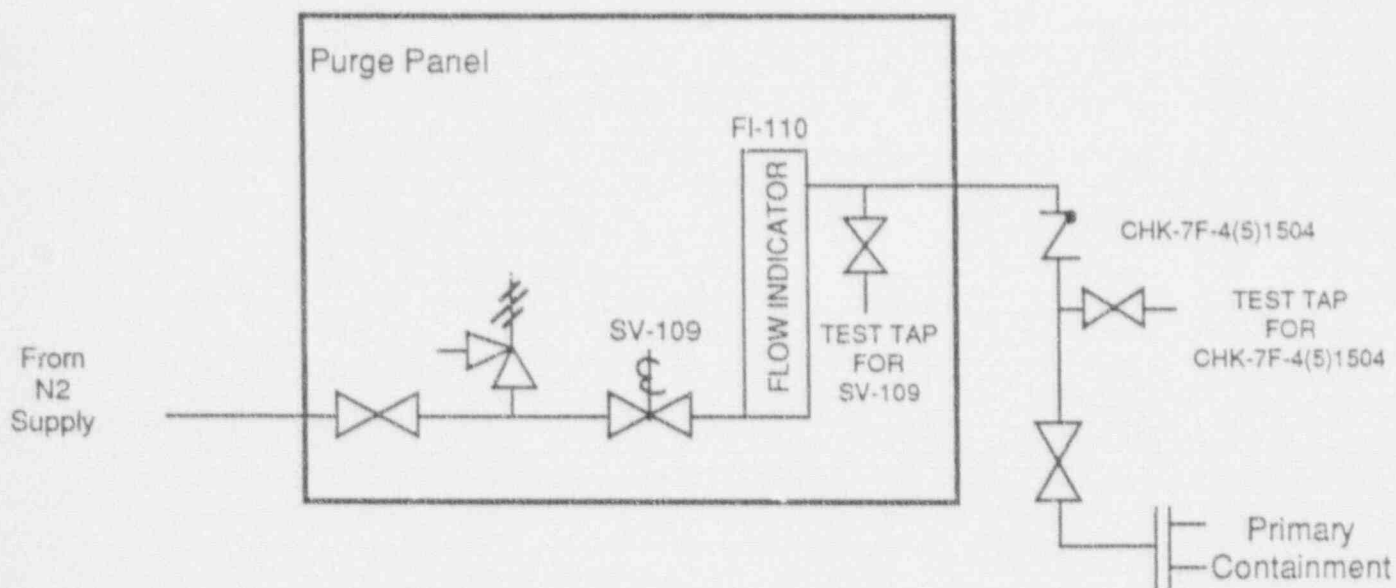
## ATTACHMENT 1 SIMPLIFIED TIP PURGE LINE

On 5/14/91 during the performance of a Local Leak Rate Test (LLRT) on the Unit 3 Traversing Incore Probe (TIP) System purge line isolation valves, it was discovered that one of the isolation valves (SV-109) was not actually being leak rate tested. This is a violation of Technical Specification 4.7.A.2.F which requires that LLRT's be performed on primary containment isolation valves once each operating cycle. Although LLRT's had been performed on the TIP purge line isolation valves during each of the past operating cycles, SV-109 had been essentially isolated during the test by a rotometer type flow indicator (FI-110) which is installed in the piping between the test tap and SV-109 (see attached figure). The same condition was subsequently identified to exist on the Unit 2 TIP purge piping.

The cause of this event was an inadequate review of the TIP System purge piping configuration during the original development of the LLRT procedure. The effects of reverse flow on FI-110 during the LLRT was not fully recognized.

There were no actual safety consequences as a result of this event. The TIP System purge line is a 3/8 inch stainless steel pipe which is isolated from primary containment during accident conditions via a check valve (CHK-7F-4(5)1504) and an electrically operated solenoid valve (SV-109). LLRT's are performed on these valves each operating cycle to ensure primary containment integrity is maintained. Previous LLRT's on CHK-7F-4(5)1504, which is located upstream from SV-109, verified leakage to be within acceptable limits on both Unit 2 and 3. Additionally, following the

Following the discovery of this event, the LLRT procedures for SV-109 on both Unit 2 and 3 were temporarily modified to allow leak rate testing downstream of FI-110. Leakage through SV-109 on both Unit 2 and 3 was verified to be within acceptance limits.

The LLRT procedures for SV-109 on both Unit 2 and 3 will be permanently revised to allow leak rate testing downstream of FI-110.

A modification will be considered to either relocate the test tap on FI-110 to provide a more suitable means of adequately leak rate testing SV-109.
