**NRC/INEL Radiation Therapy
Event Investigation Team
Report 9501**

NRC/INEL RADIATION THERAPY EVENT INVESTIGATION TEAM REPORT 9501

A two-position, solenoid-operated valve on the hydraulic system of a gamma knife unit failed during a recent treatment. The valve (valve 20) that failed controls the direction of bed movement. The valve was inspected by personnel from Elekta Instruments, Inc., the U.S. distributor of the gamma knife, and then sent to the valve manufacturer for analysis. Elekta has attributed the failure to a particle of metal that either caught between the valve spool and valve body or scored the spool, in either case essentially locking the valve in the 'bed in' position. The behavior of the device and the system response when valve 20 was replaced leave no doubt that a malfunction of this valve precipitated the event.

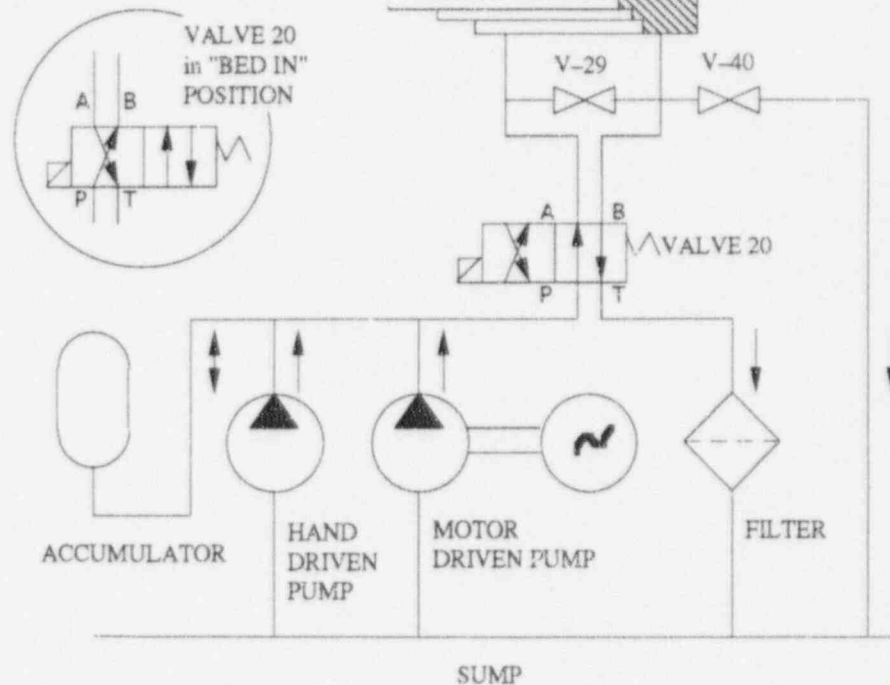
Figure 2. Simplified Hydraulic Schematic

The responses of the gamma knife device during the incident confirm that valve 20 was stuck in the 'bed in' position. The events that occurred during the incident and the corresponding status or reactions of the hydraulic system are listed in Table 1.

The contaminants caused valve 20 to jam in the 'bed in' position.

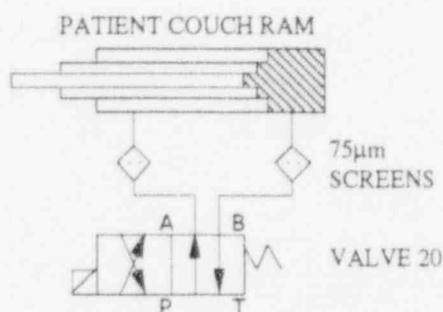
Figure 3. Elekta's Proposed Solution

To address this event, Elekta is testing the placement of 75 μ m screens between the hoses to

the treatment room and the valves in the hydraulic room at a separate facility. These screens would prevent any particles greater than 75 μ m that may be in the hoses or rams from reaching the solenoid valves that control bed and door positions.

With this solution, any particles that may be in the system between the screens would not be removed from the system. Rather, these particles would travel between the applicable screens and hydraulic ram cylinders each time the unit cycles. The Elekta engineer who repaired the unit stated that the rams have larger clearances than the position control valves in the hydraulic room and would not be affected by particles in the fluid.

The screens installed between the hydraulic manifold and the operating rams in a similar unit are 75 μ m filters. For the solenoid valves in this system, a filter size of 15–20 μ m is appropriate. While it is not known how large the particle that caused this event was, it is true that a particle small enough to fit through a 75 μ m screen could cause a similar valve malfunction. Thus, these screens will prevent a similar event in the future only if the particles are large. The INEL team therefore considers the placement of 75 μ m screens as a long-term corrective action to be marginally effective.
