**BOSTON EDISON**

Pilgrim Nuclear Power Station  
Rocky Hill Road  
Plymouth, Massachusetts 02360

The enclosed Licensee Event Report (LER) 94-007-00, "Primary Containment Pressure Boundary Degraded due to Uninstalled Instrument Plug", is submitted in accordance with 10 CFR Part 50.73.

| TITLE (4)<br>Primary Containment Pressure Boundary Degraded due to Uninstalled Instrument Plug | | | | | | | | | | | | |

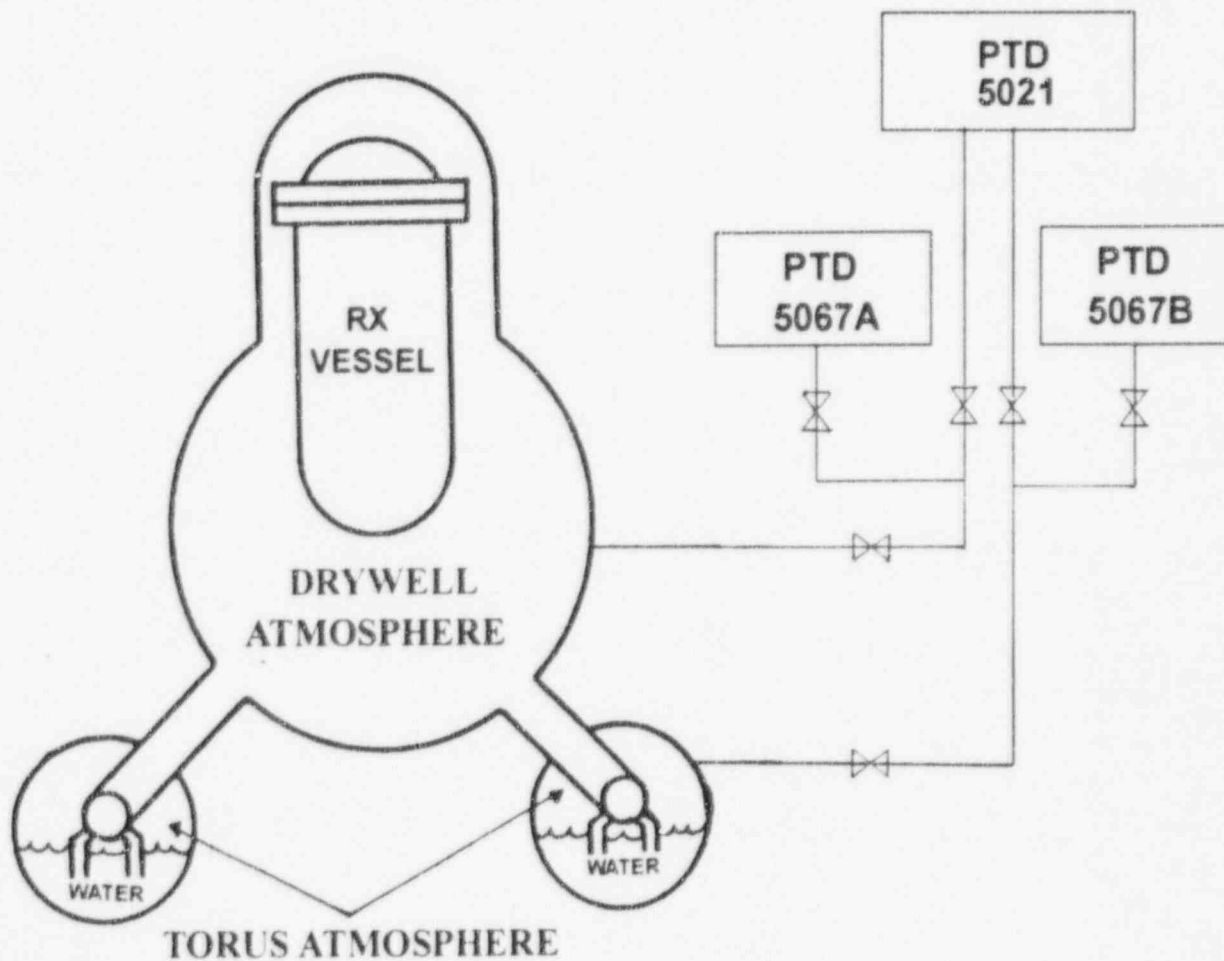
**SIMPLIFIED SKETCH OF DRYWELL-TORUS  
ATMOSPHERE PRESSURE TRANSMITTERS**

- Instrument design and installation:
  - Transmitter PTD-5021 is located on Panel C-88 approximately 18"-24" above floor level. The low pressure side of PTD-5021 has two test plugs one of which is removed from the low pressure side of the transmitter for a calibration. The plug that is removed for a calibration is located on the bottom surface of the transmitter's manifold and, as such, is not readily visible without crouching or significant body adjustment.

- Transmitters PTD-5067A and PTD-5067B that are also calibrated as part of Procedure 8.M.2-6.2 Attachment 2 are also located on Panel C-88. Transmitters PTD-5067A and PTD-5067B are located side-by-side and approximately five feet above floor level. Since these transmitters measure Drywell atmosphere pressure and Torus atmosphere pressure relative to Reactor Building atmosphere pressure, one of the low pressure side plugs is not installed during operation. This configuration is different from that of PTD-5021 which requires both low pressure side (Torus atmosphere) plugs to be installed during operation.

- Transmitter PTD-5021 does not have calibration valves consistent with most other transmitters and pressure switches installed in other applications.

A modification document (FRN 95-04-05) was approved on January 20, 1995. The modification includes provision for installing additional tubing, fittings, and valves to the drain/calibration ports of transmitters PTD-5067A, PTD-5067B, and PTD-5021. The changes have been scheduled for implementation beginning in the first week of February 1995.
