ATTACHMENT 1
ANO-2 CYCLE 1 REFUELING OUTAGE
FUEL EXAMINATION RESULTS

1.0 INTRODUCTION

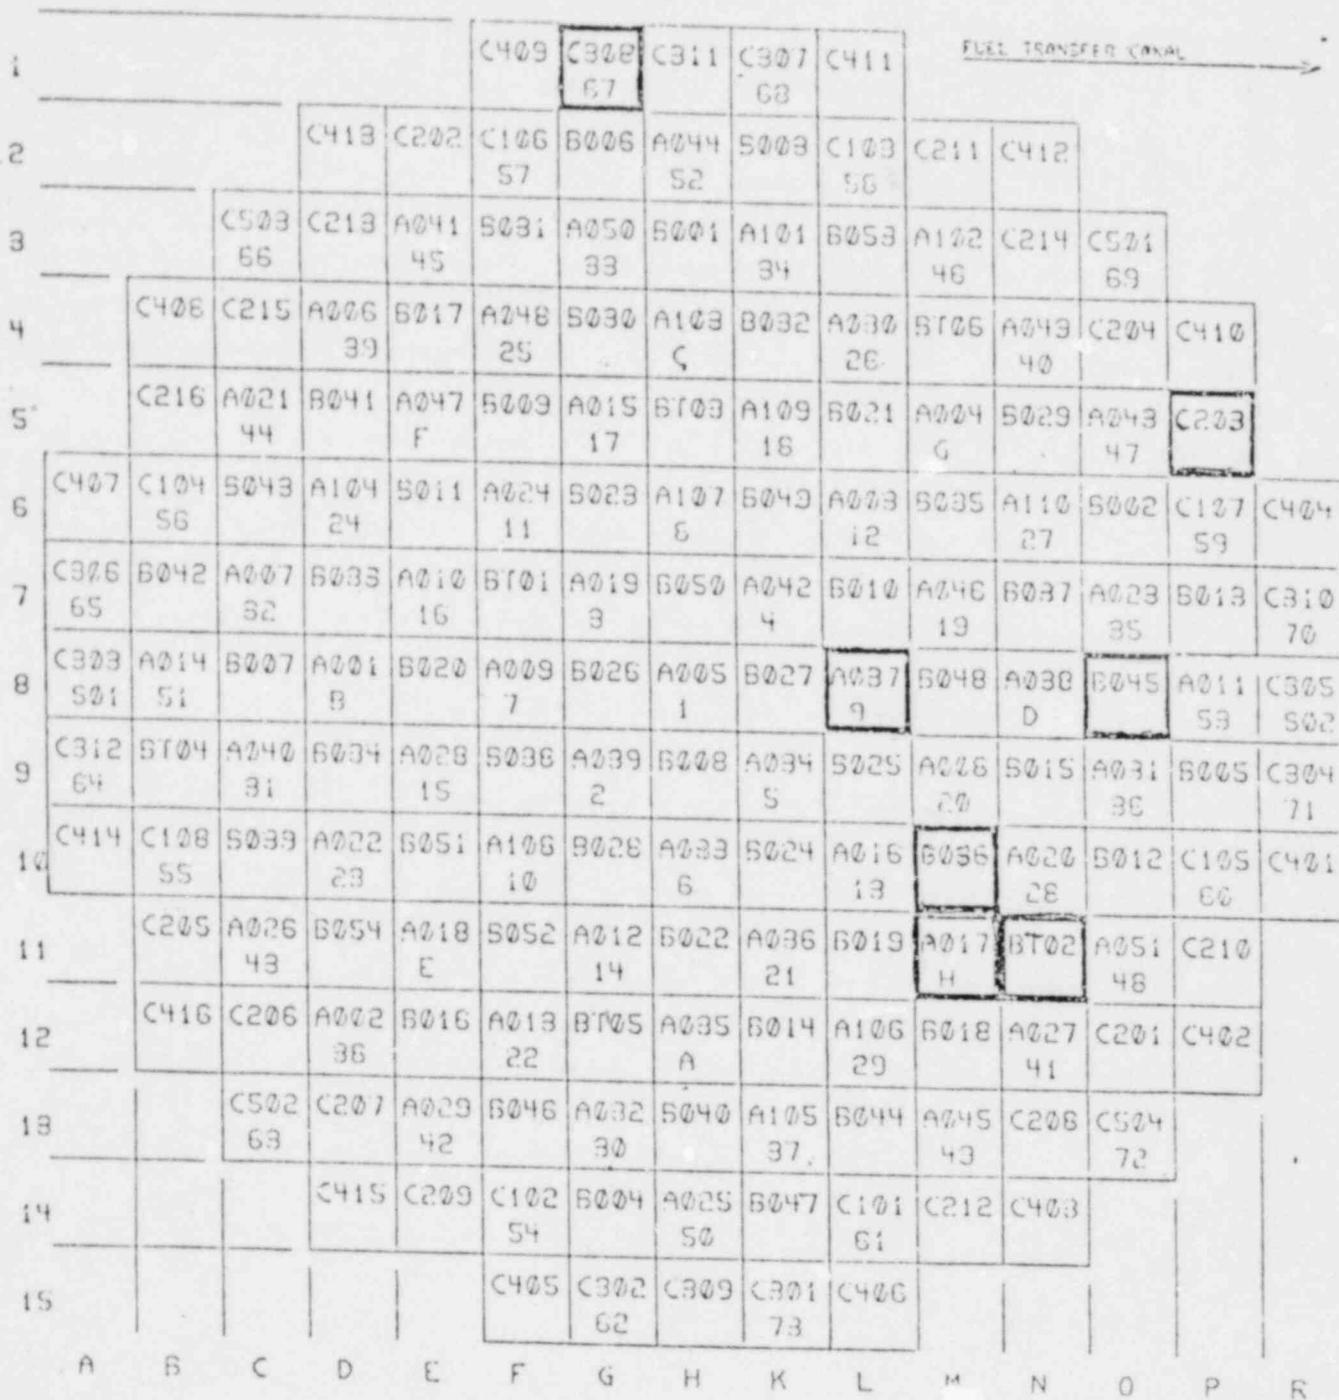
FIGURE 1
ANO-2 CYCLE 1

The conditions of the leaking assemblies and the reconstitution actions are summarized in Table I. The locations of the leaking assemblies are presented in Figure 1.

Leaking Assemblies in Heavy Outline
