# New Hampshire Yankee

NYN-91157

Subject: Supplemental Submittal for the Radiograph Reinterpretation Program Completion Report

ENCLOSURE 1 TO NYN-91157  
SUPPLEMENTAL SUBMITTAL FOR THE RADIOGRAPH  
REINTERPRETATION PROGRAM COMPLETION REPORT

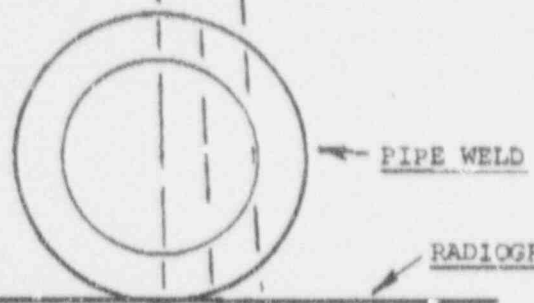
FIGURE #1

When pipe welds with relatively small diameters are radiographed using the double wall exposure and double wall view technique, (either elliptical or superimposed image) the effective composite through wall path the radiation passes through, radically changes as the distance away from the pipe center increases. (See Figure # 1).

If a typical radiographic technique produces an image with good contrast (beneficial in radiography in order to observe density changes resulting from small cross sectional thickness changes), the density variations as a result of this effective composite through wall path will be significant.
