June 1982

THREADED FASTENER EXPERIENCE IN NUCLEAR POWER PLANTS

William H. Koc
Operating Reactors Assessment Branch
Division of Licensing

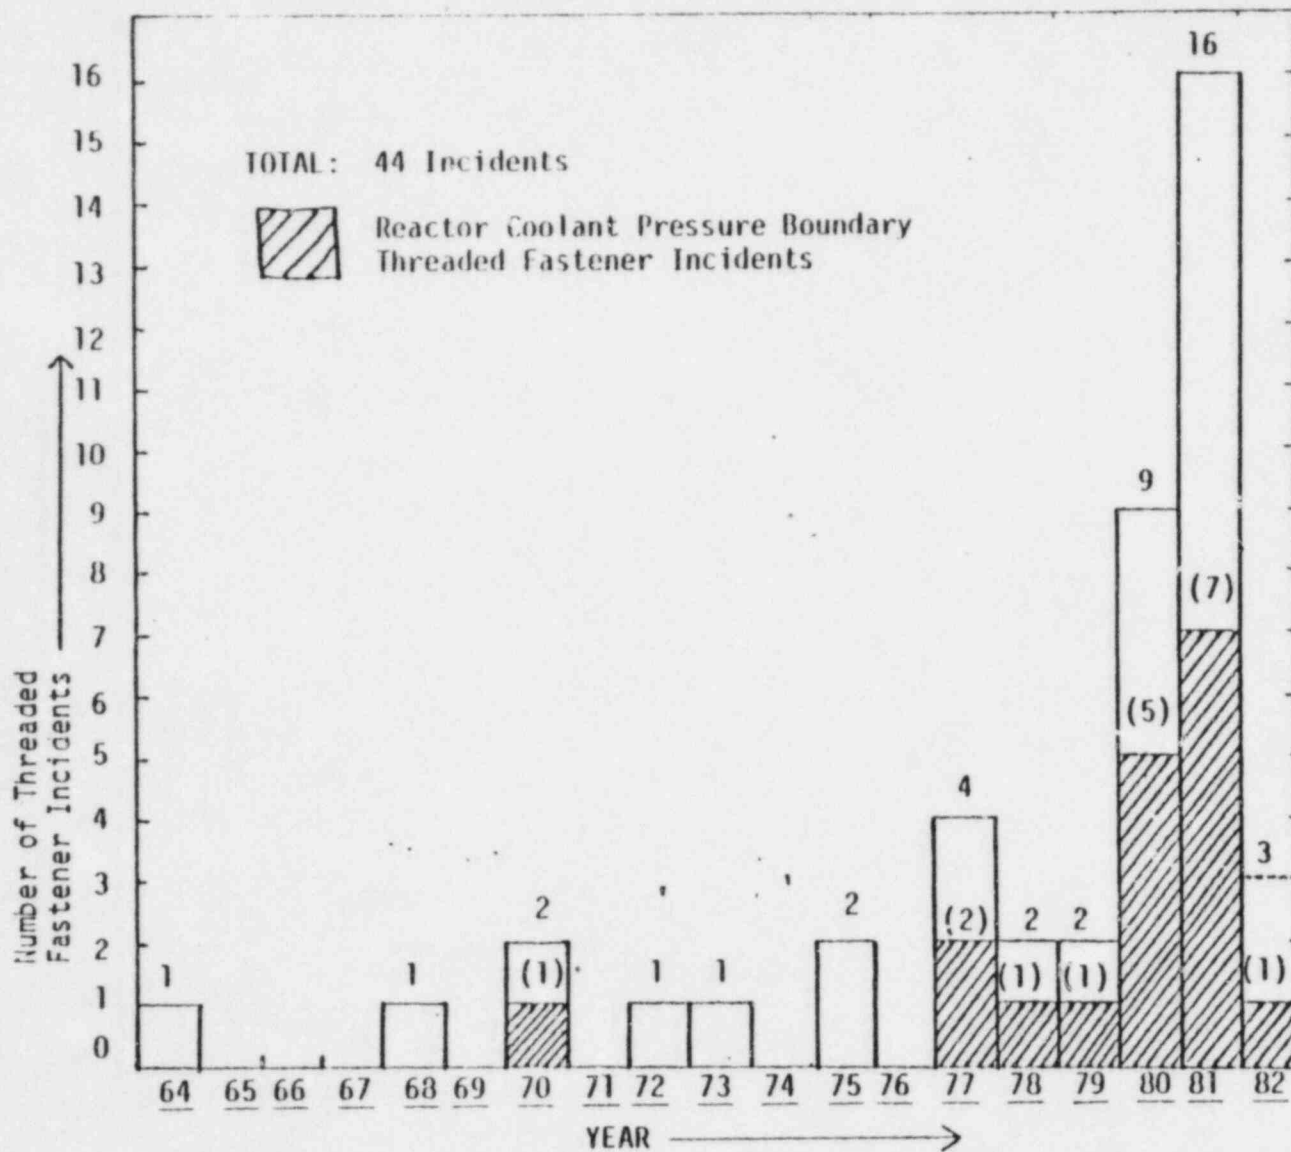
The safety implications discussed above are a cause for concern, especially in view of the increased number of reported threaded fastener incidents in recent years as shown in Figure 1. This concern is further compounded by the fact that the UT methods used in inservice inspection programs are not sensitive enough to detect initial cracking in the threaded fasteners resulting

FIGURE 1 - A plot of the number of threaded fastener incidents covered in this report from 1964 to March 1982. The numbers in parentheses refer to reactor coolant pressure boundary threaded fastener incidents for that year.

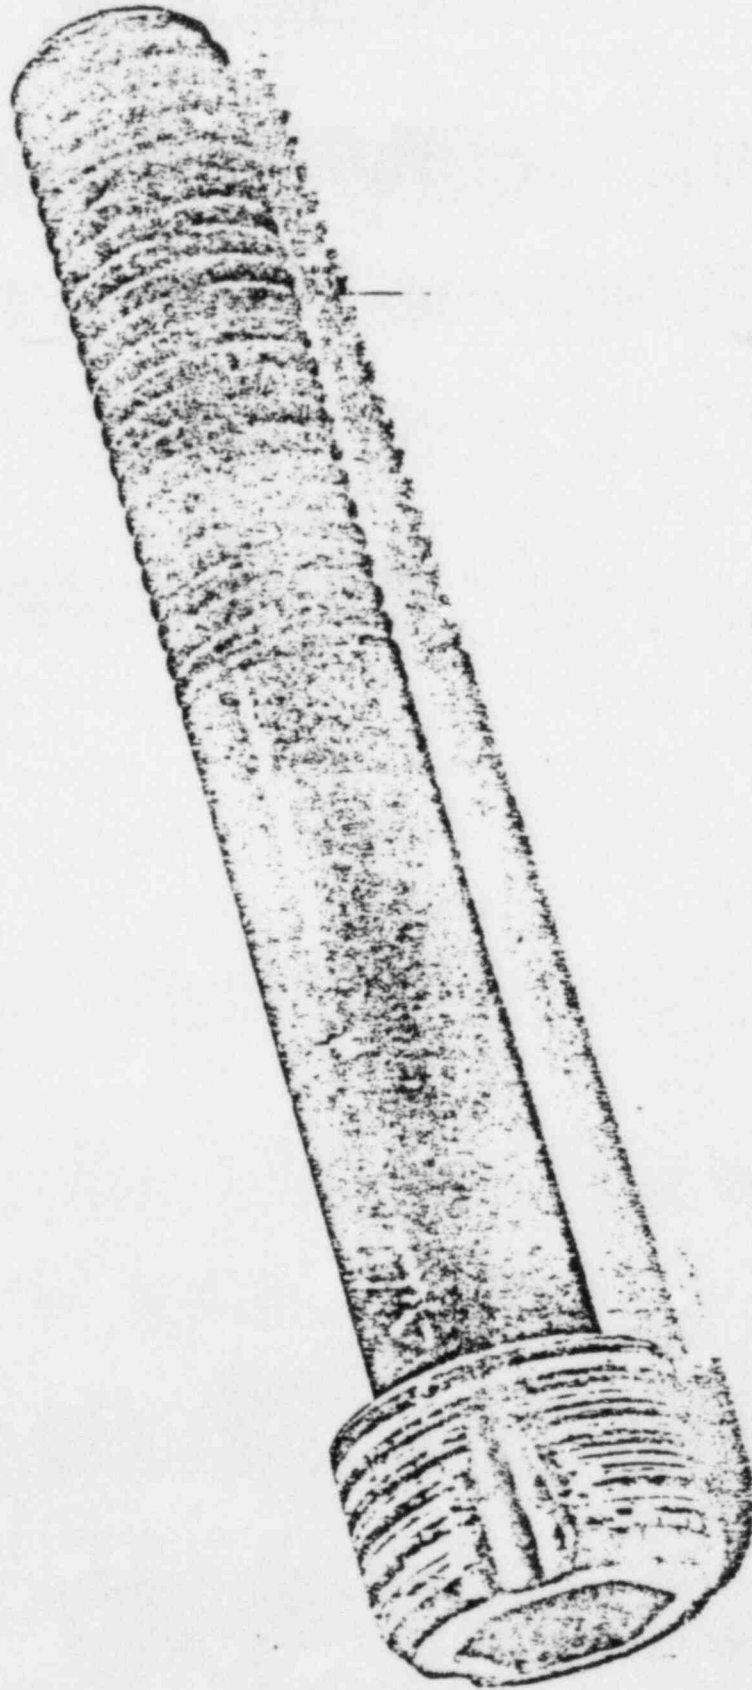
Figure 1. Photograph of archive bolt from H.B. Robinson.
(identified as PUMP:CAPSCREW 21)

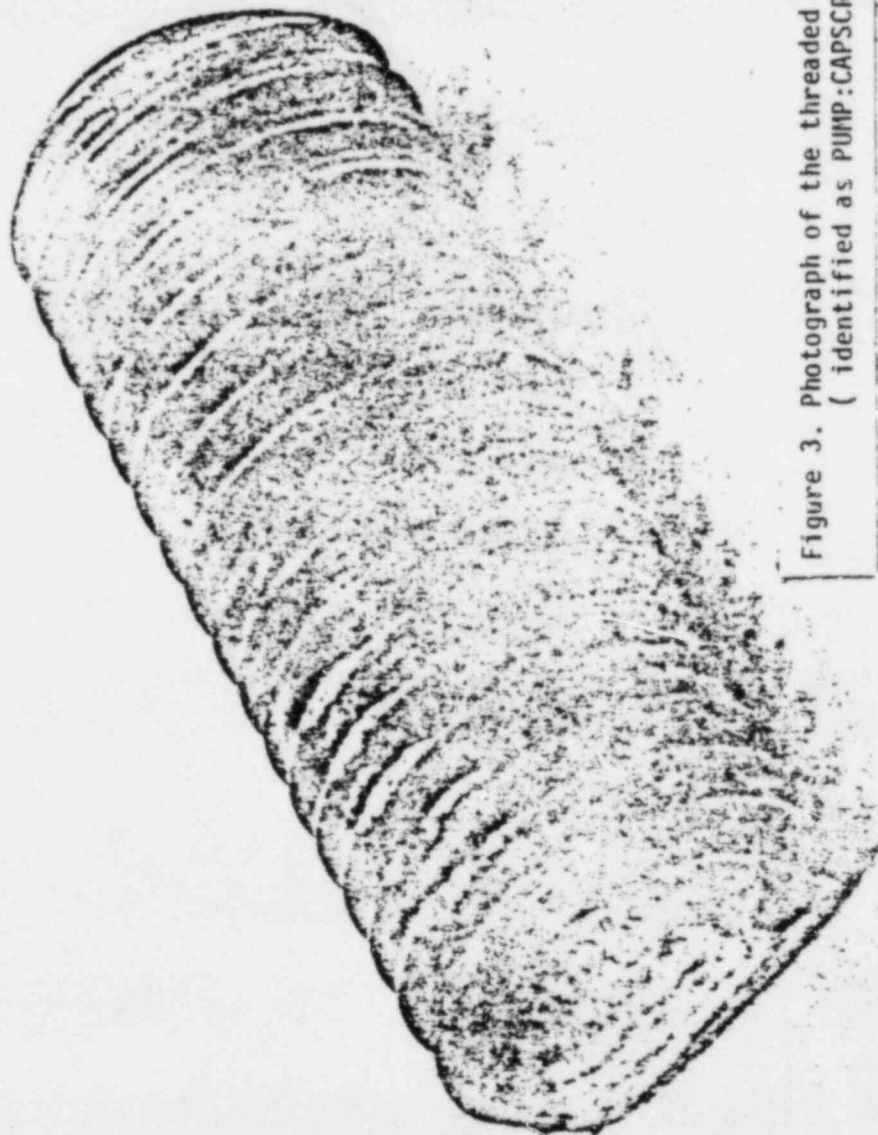
Figure 3. Photograph of the threaded portion of a bolt.
(identified as PUMP:CAPSCREW 13/14)

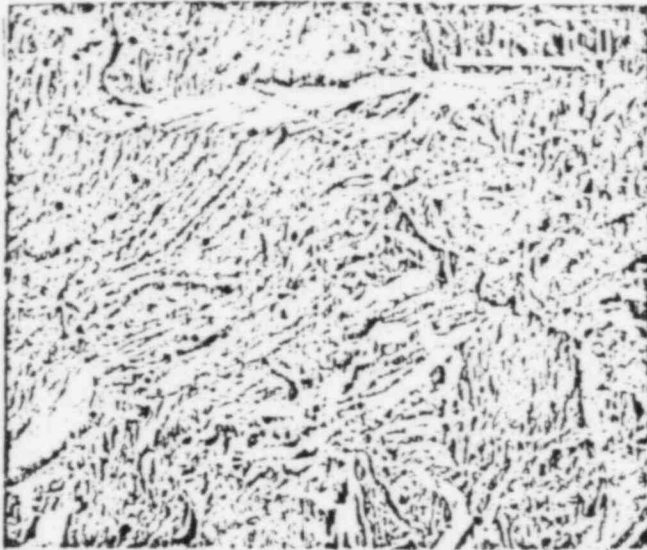
200X

Figure 10. SEM photo of a transgranular area of the fracture face on PUMP:CAPSCREW 13/14.

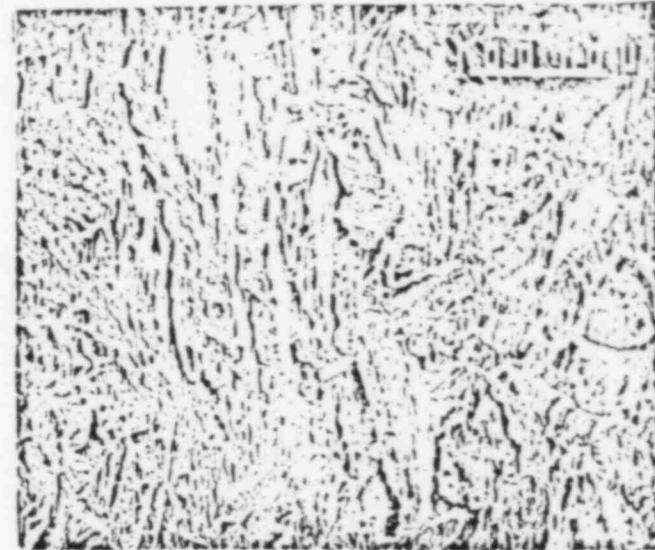
200X

Figure 11. SEM photo depicting the transgranularity near the edge of the fracture face.

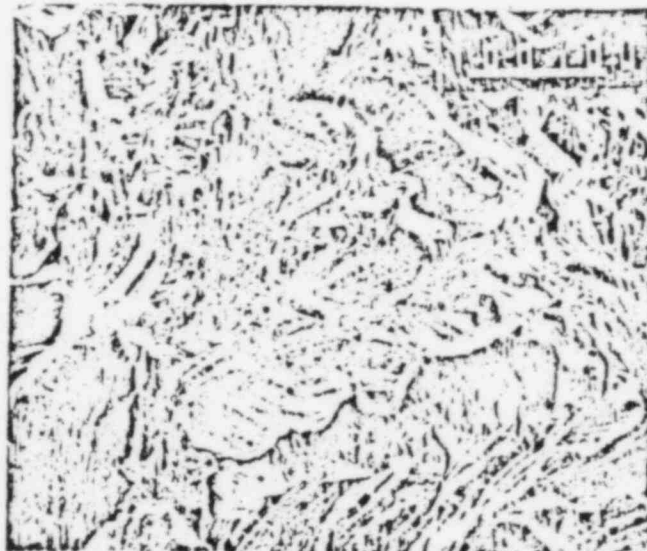
200X

Figure 12. SEM photo showing additional areas of transgranularity.

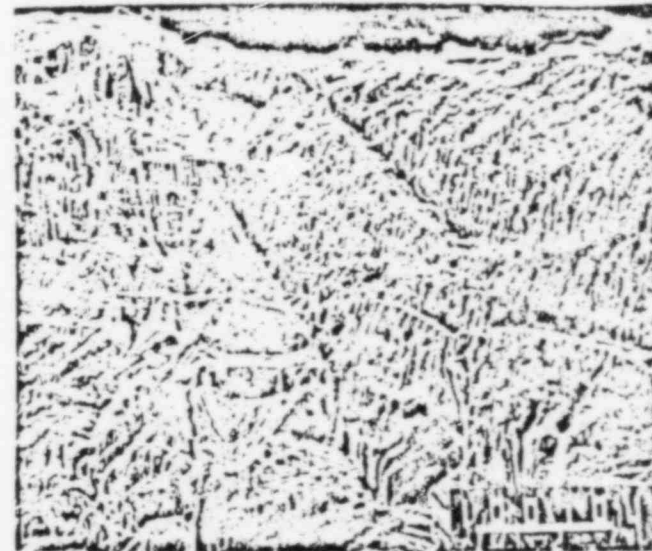
200X

Figure 13. SEM photo of fatigue striations on PUMP:CAPSCREW 13/14.

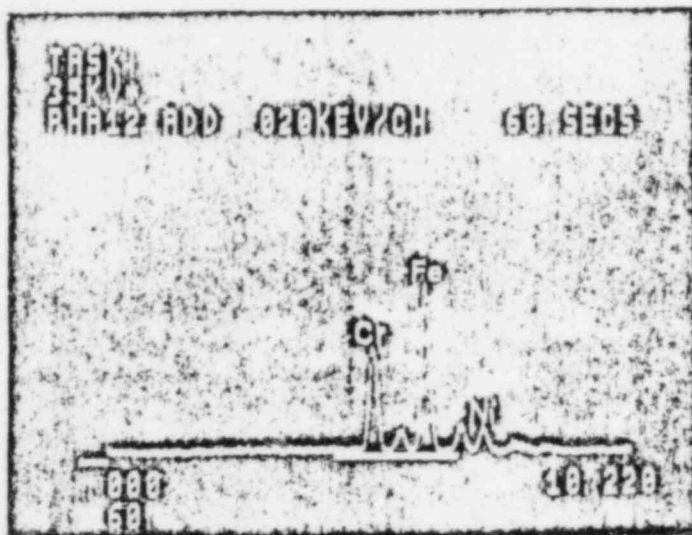
Figure 14. EDS scan of base metal for Cr/Fe ratio (Cr/Fe - .638)

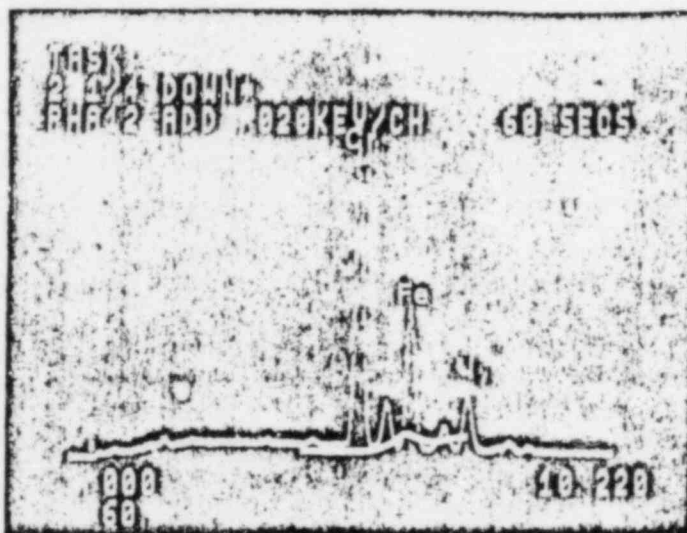
Figure 16. EDS scan of fracture face for Cr/Fe ratio (Cr/Fe - 2.10)

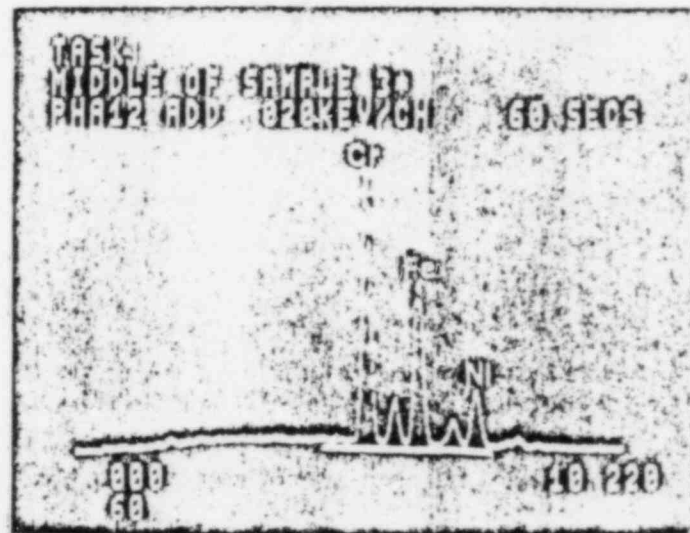
Figure 17. EDS scan of fracture face for Cr/Fe ratio (Cr/Fe - 1.61)

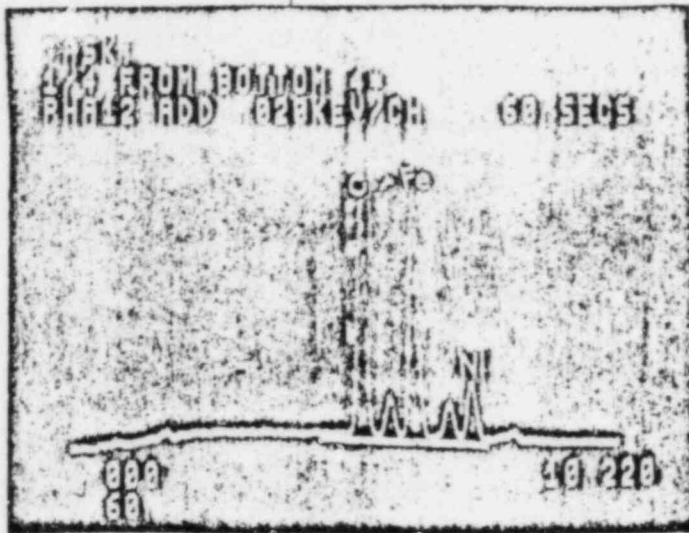
Figure 18. EDS scan of fracture face for Cr/Fe ratio (Cr/Fe - .957)

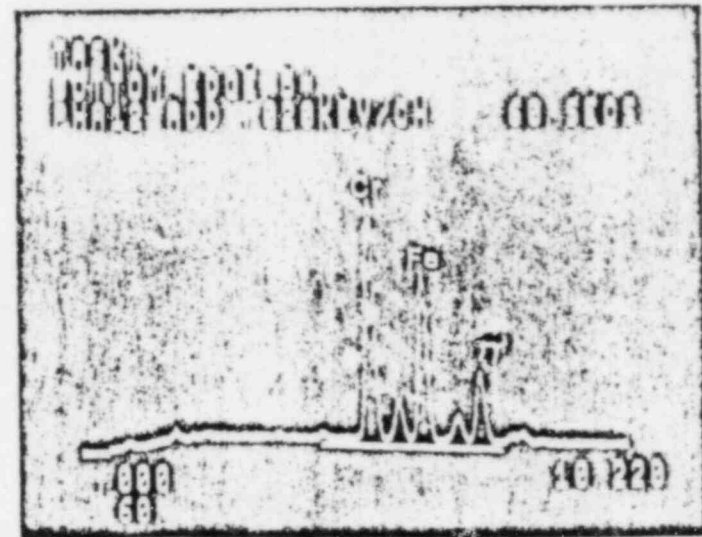
Figure 19. EDS scan of fracture face for Cr/Fe ratio (Cr/Fe - 1.417)

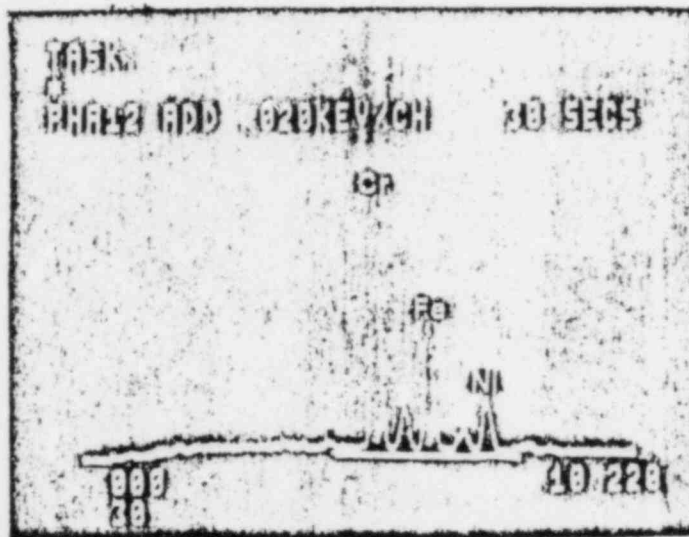
Figure 20. EDS scan of shank fracture face for Cr/Fe ratio (Cr/Fe - 2.0)

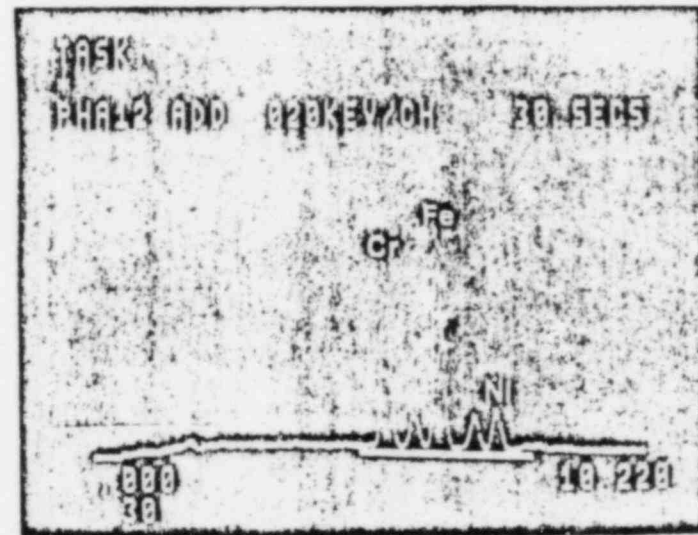
Figure 21. EDS scan of shank fracture face for Cr/Fe ratio (Cr/Fe - .839)

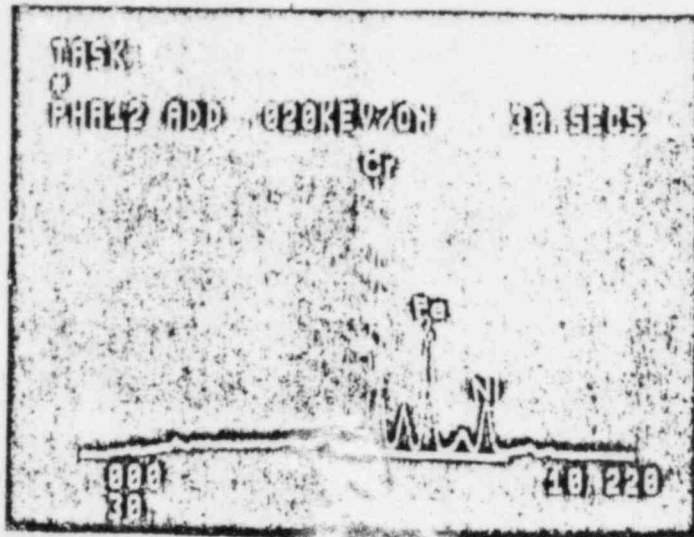
Figure 22. EDS scan of shank fracture face
for Cr/Fe ratio (Cr/Fe - 2.027)

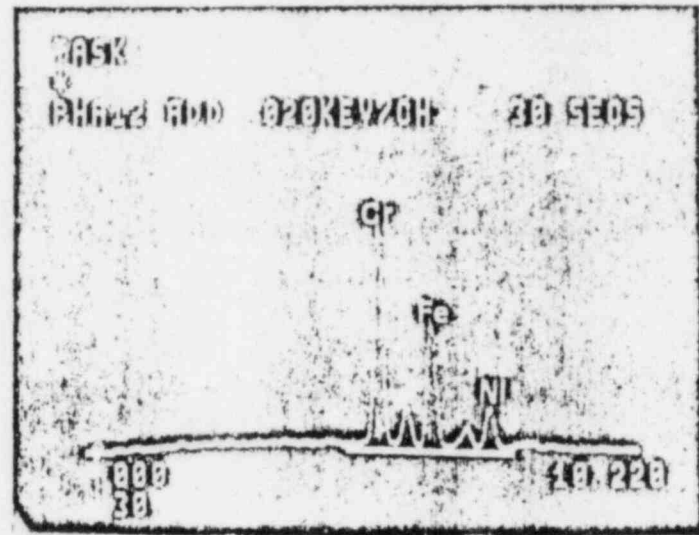
Figure 23. EDS scan of shank fracture face
for Cr/Fe ratio (Cr/Fe - 2.025)

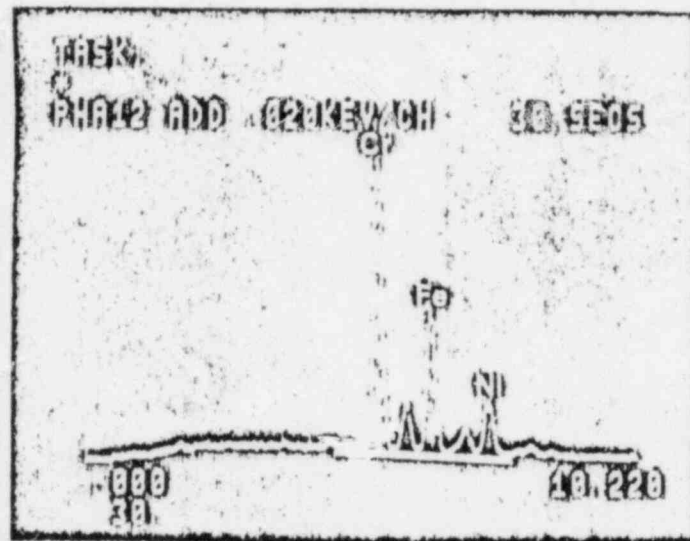
Figure 24. EDS scan of shank fracture face
for Cr/Fe ratio (Cr/Fe - 1.743)

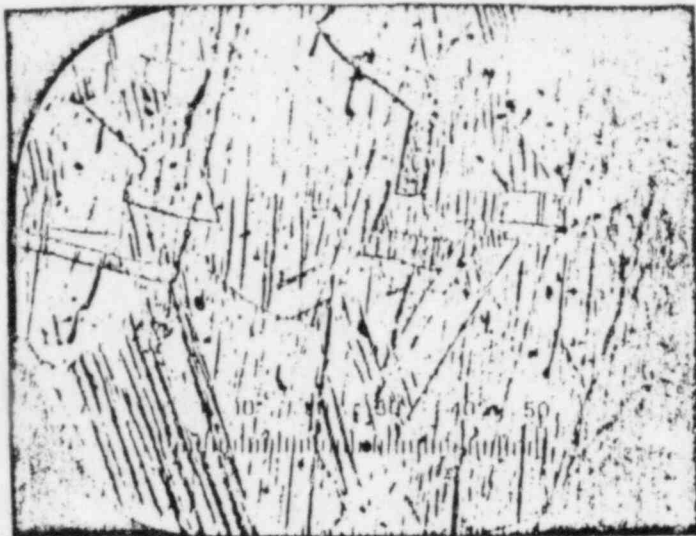
50X
Figure 25. Optical photomicrograph of shank
bolt after ASTM A-262 test
(Div.= 0.001mm)

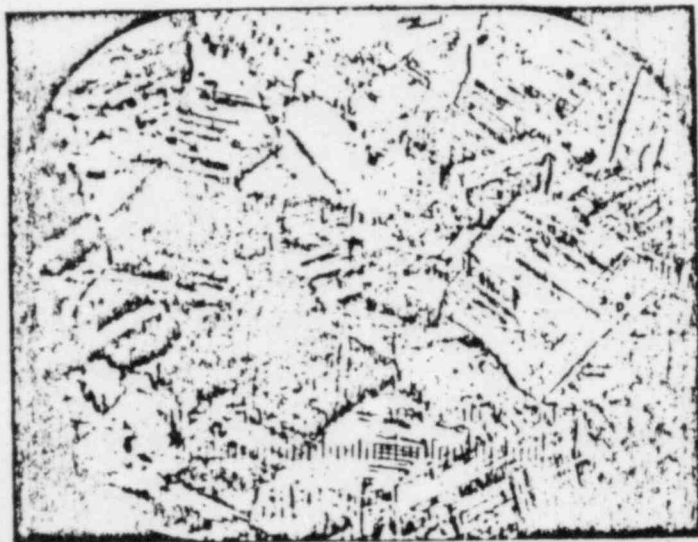
50X
Figure 27. Low magnification photo of a
cold work area of bolt head
(Div.=0.001mm)

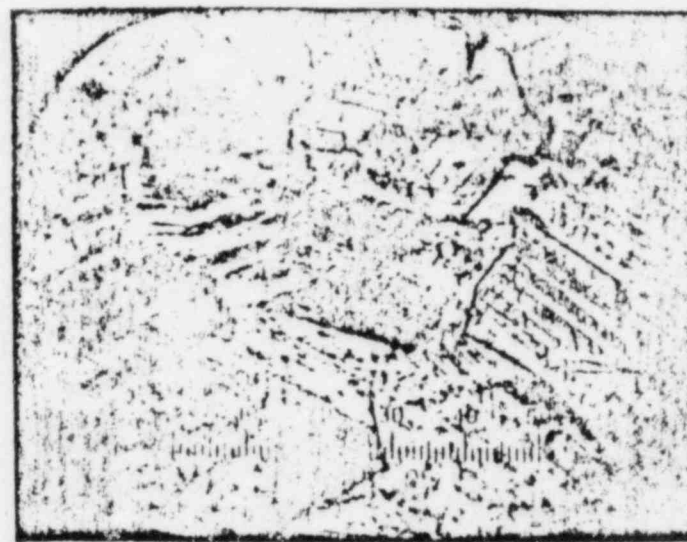
100X
Figure 28. Higher magnification photo of
the cold work area
(Div.=0.0005mm)

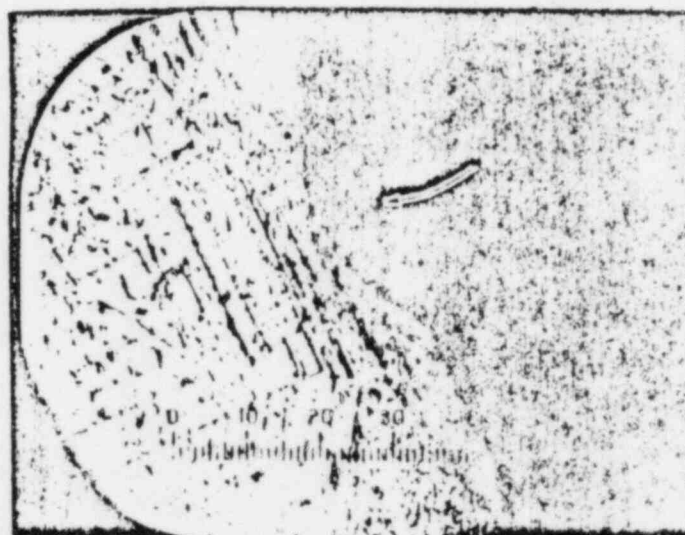
100X
 Figure 32. Higher magnification photo of Figure 29
 (Div =0.00025mm)
