# WOLF CREEK

## LICENSEE EVENT REPORT (LER)

FACILITY NAME (1) **Wolf Creek Generating Station** DOCKET NUMBER (2) **0 5 0 0 0 4 8 2 1** OF **0 1 8** PAGE (3)

TITLE (4) **Technical Specification Violation - Removal of Ductwork Damper Inspection Covers Results in Inoperability of Ventilation Systems**

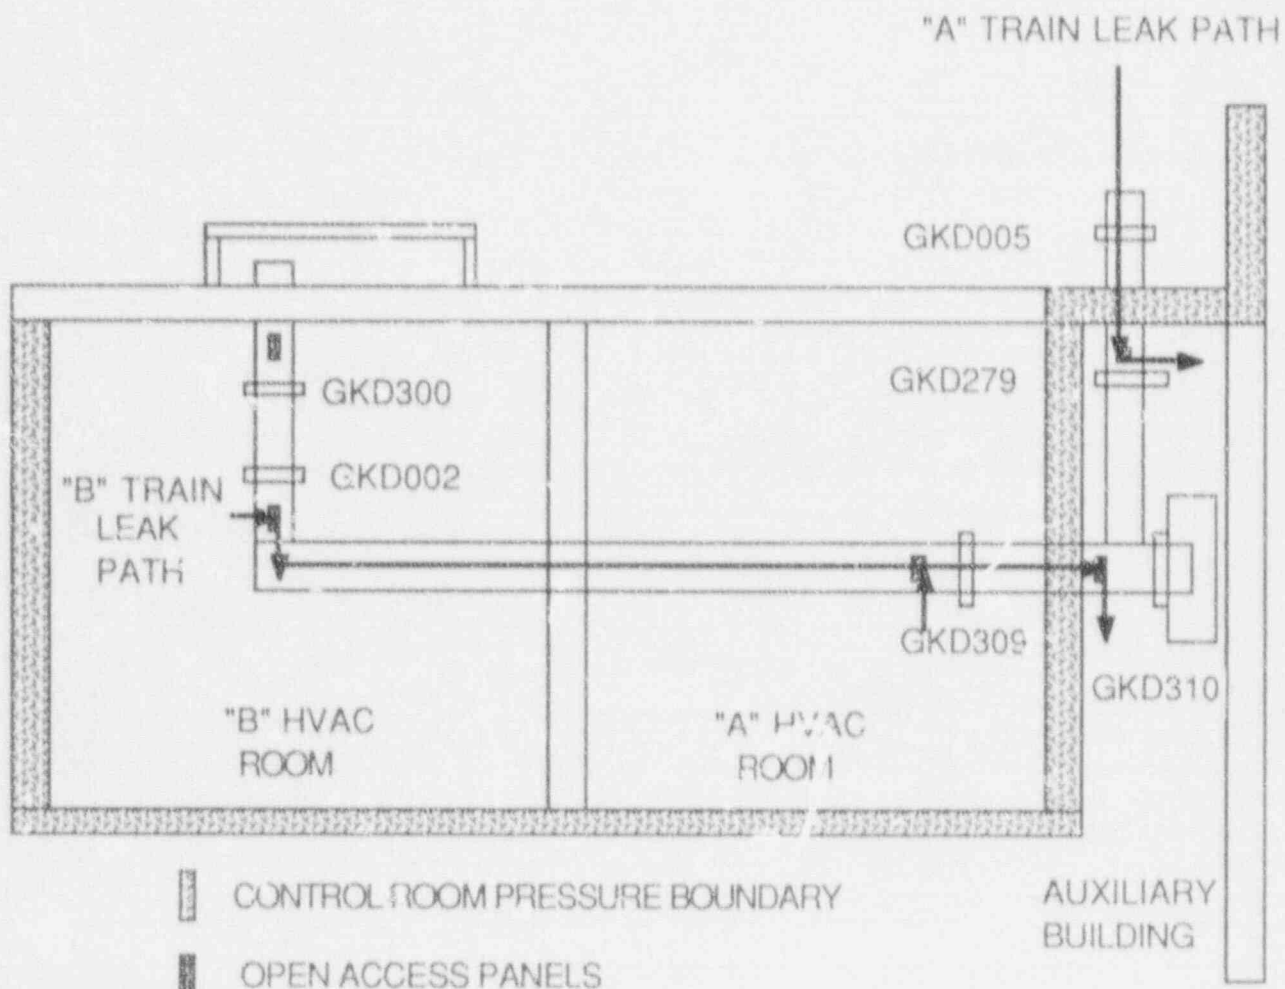
FIGURE 1

Additionally, the pressure test conducted on September 13, 1991, showed that with the five ductwork damper inspection covers removed, the Auxiliary Building EES' Train 'A' excess capabilities were not adequate to maintain the pressurization requirement of the system. In part, the Auxiliary Building EES ensures that any radioactive materials leaking from the Emergency Core Cooling System [JE] equipment within the Auxiliary Building following a loss of coolant accident are filtered prior to reaching the environment. Technical Specification 3.7.7, which is applicable in Mode 1 through Mode 4, requires that two independent Emergency Exhaust trains to be operable. With one EES train inoperable, T/S 3.7.7 requires restoration of the inoperable train to operable status within seven days or be in at least Hot Standby within the next six hours and Cold Shutdown within the following 30 hours. The T/S Surveillance Requirement 4.7.7.b.1 requires demonstrating operability of the EES at least once per 18 months by verifying that each train maintains the Auxiliary Building at a negative pressure of greater than or equal to one-quarter inch Water Gauge relative to the outside atmosphere during its operation. As with the CREVS, evaluation of the pressure test results and the location of the removed ductwork damper inspection covers by engineering personnel concluded that similar results would be expected for the Auxiliary Building EES Train 'B'. Therefore, it was concluded that with the five ductwork damper inspection covers removed, both trains of the Auxiliary Building EES were inoperable. Because T/S 3.7.7 does not contain an action statement for both Auxiliary Building EES trains inoperable, this condition also should have resulted in entry into T/S 3.0.3.

LEAK PATHS BETWEEN THE AUXILIARY BUILDING  
AND CONTROL ROOM PRESSURE BOUNDARY
