NORTH ANNA POWER STATION

Report No. 50-339/91-010-00

LICENSEE EVENT REPORT (LER)

CONDENSER AIR EJECTOR ISOLATION AND SUBSEQUENT BYPASSING OF FLOW TO THE RADIATION MONITOR

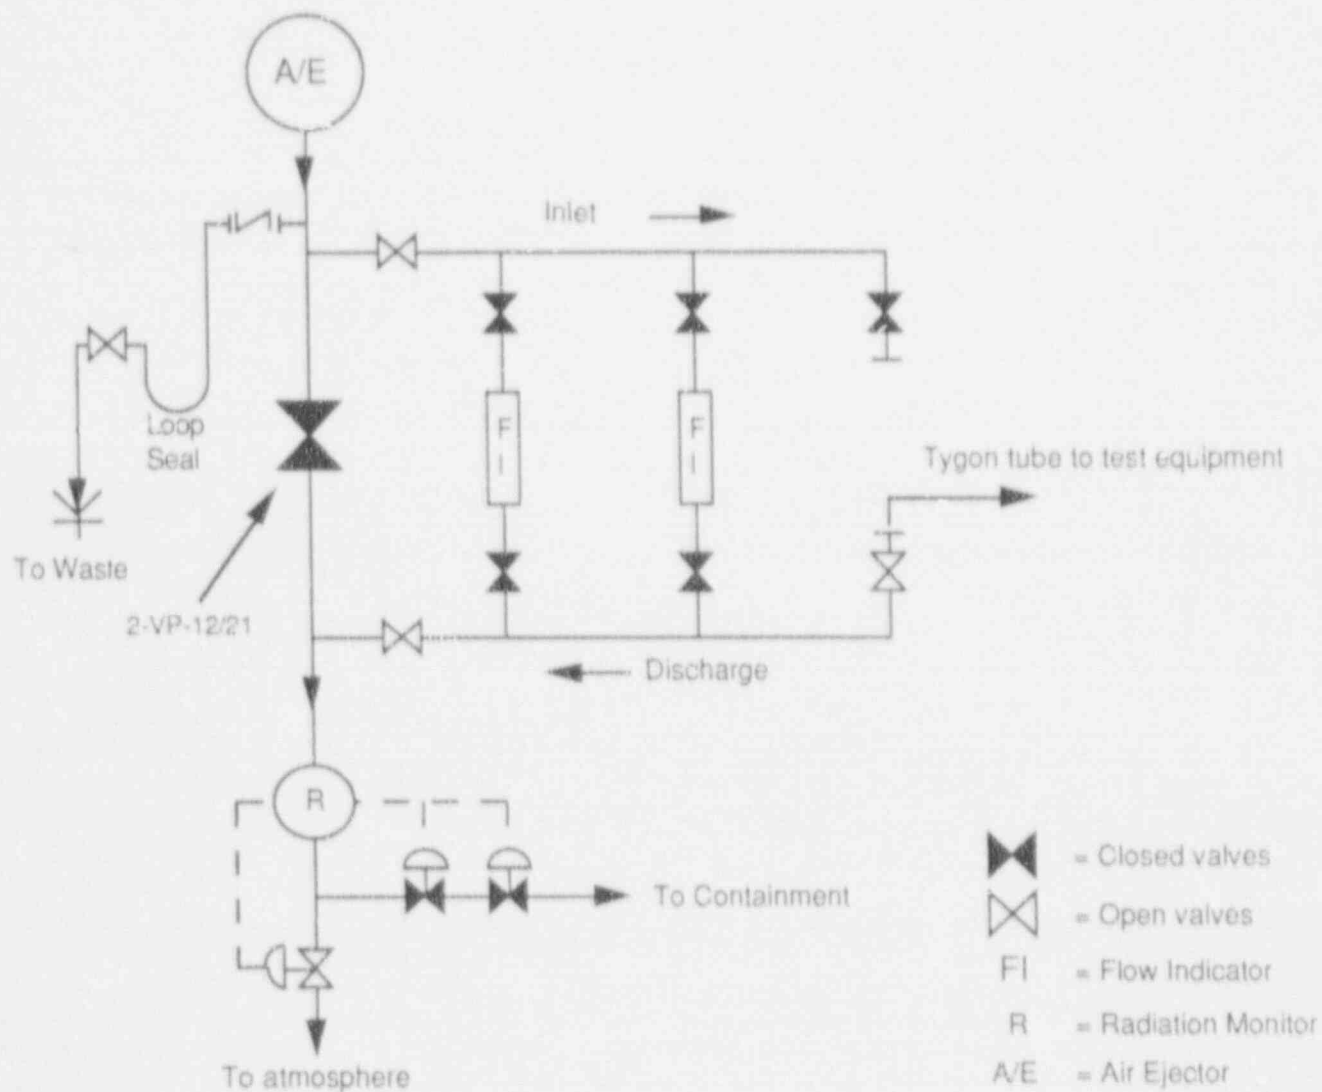
AS FOUND ALIGNMENT ON 10/06/91 - 2000 HRS

Prior to 0800 hours, on 10/06/91, maintenance and contract test personnel requested operations support to perform secondary plant condenser air inleakage inspections. The test crew then proceeded to the air ejectors (EISS System Identifier SH, Component Identifier EJ2R) and began setting up the test equipment. At 0800 hours the operator met with the test crew to begin the inspections and noted that 2-VP-12 and 2-VP-21 (EISS System Identifier SH, Component Identifier EJ2R-13V) were already closed (normally open). The test equipment was connected to the air ejector flow path and the discharge from the test equipment aligned to vent into the turbine building.

Inspections by the test crew and the operator continued and at one point the operator was assigned to another task. Upon completion of testing, the test equipment was disconnected by contract personnel. The test crew did not notify the Operations Shift Supervisor that testing was completed. At 2000 hours a Shift Technical Advisor, while investigating low background radiation levels on the air ejector radiation monitor (EISS System Identifier SH, Component Identifier MON), discovered that air ejector flow was bypassing the radiation monitor. This alignment resulted in the automatic divert feature, of the air ejector exhaust to containment on a Hi-Hi Radiation Monitor signal, being defeated. Reference the drawing on page 4 of 4 for the as found valve alignment (There are two air ejectors, only one is shown for simplicity). The resultant discharge flow was through a loop seal to the turbine building atmosphere. Precautionary sampling showed that the total radioactive effluent release, whole body, to the turbine building was calculated to be a small fraction of the allowable effluent release limit. A four hour report pursuant to 10CFR50.72 (b)(2)(iii)(C) was made to the NRC at 2204 hours on 10/06/91.

The air ejector discharge flow path was directed to the radiation monitor and the test connections were isolated. An Abnormal Procedure (AP-54) was entered due to the unplanned radioactive gaseous release as a precautionary measure. The Health Physics Department calculated the total release activity to be a small fraction of the effluent release limit.

Operating Procedures 1 & 2-OP-30.6 Secondary Plant Air In-leakage Inspections have been revised to include aligning air ejector discharge to local detection equipment and subsequent return to normal alignment with flow through the radiation monitor at all times.
