SUBJECT: SUMMARY OF THE OPERATING REACTOR EVENTS
MEETING ON JUNE 21, 1983

Subject: STUD FAILURE IN REACTOR COOLANT SYSTEM PRESSURE BOUNDARY-BOLTED CLOSURES (Update)

DEGRADED STEAM GENERATOR MANWAY STUDS

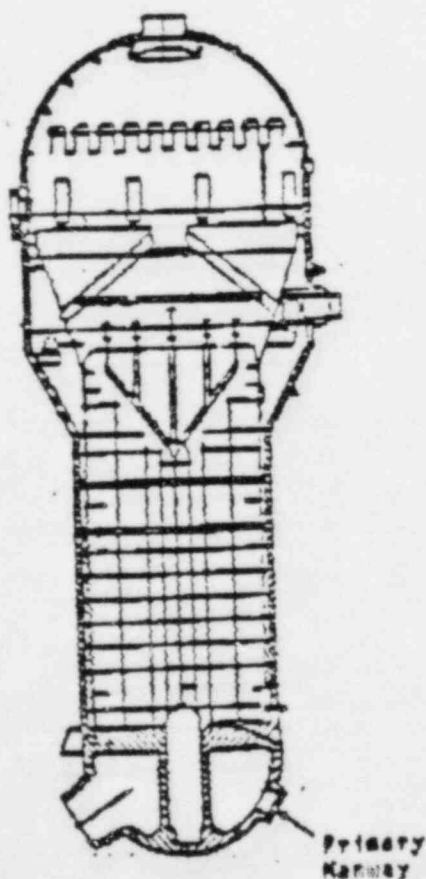
Discussion: The steam generator primary manway flange consists of a retaining plate, Flexitallic gasket, and a manway cover fastened with twenty (20) equally spaced SA-540 Grade B24 studs. In-situ inspection of other Maine Yankee SG primary manway studs by UT tests indicates that the problem is restricted to the #2 SG cold leg manway.

Six studs, including two that had failed, have been received by C-E for metallographic and chemical examination. Initial results indicate the presence of molybdenum and sulfur in the lubricant on the stud threaded surface. The fracture surfaces show an intergranular failure mode with a large number of cracks perpendicular to the fracture plane, indicative of stress corrosion cracking. Further testing is in progress.

Recommendation: Leakage through primary system bolted closures should be corrected as soon as practicable. Caution should be exercised to assure that closure studs and fasteners are not subjected to chemical contaminants such as halogens or sulfur bearing compounds. Planned maintenance activities should include cleaning of studs, fasteners and stud holes with stainless steel wire brushes and alcohol or acetone solvents. Consideration should be given to non-destructive examination of studs using methods such as magnetic particle or ultrasonic testing when chemical contaminants or leakage have been present. C-E recommends that graphite and mineral oil (50/50 mixture) be used as a lubricant for SG primary manway studs. Stud torque limitations as specified in the steam generator instruction manuals should be observed. C-E will provide additional information regarding procedures to improve manway joint closure integrity in a later publication.
