January 31, 1984

Subject: Response to Enforcement Letter and Notice
of Violations, dated December 12, 1983
File: 84-070-026

Arizona Public Service Company (APS), Project Manager and Operating Agent for the Palo Verde Nuclear Generating Station (PVNGS) and licensee under CPPR-141 issued in Docket No. 50-528, submits herewith its response to the enforcement letter, dated December 12, 1983, from the Regional Administrator, Region V, and to Sections I.A. and II of the Notice of Violations (Notice), dated December 12, 1983, transmitted with such letter. The allegations made in Sections I.A. and II of the Notice stem from the unannounced inspection of Palo Verde Unit 1 in September, 1983, by the Region V Construction Assessment Team (CAT).

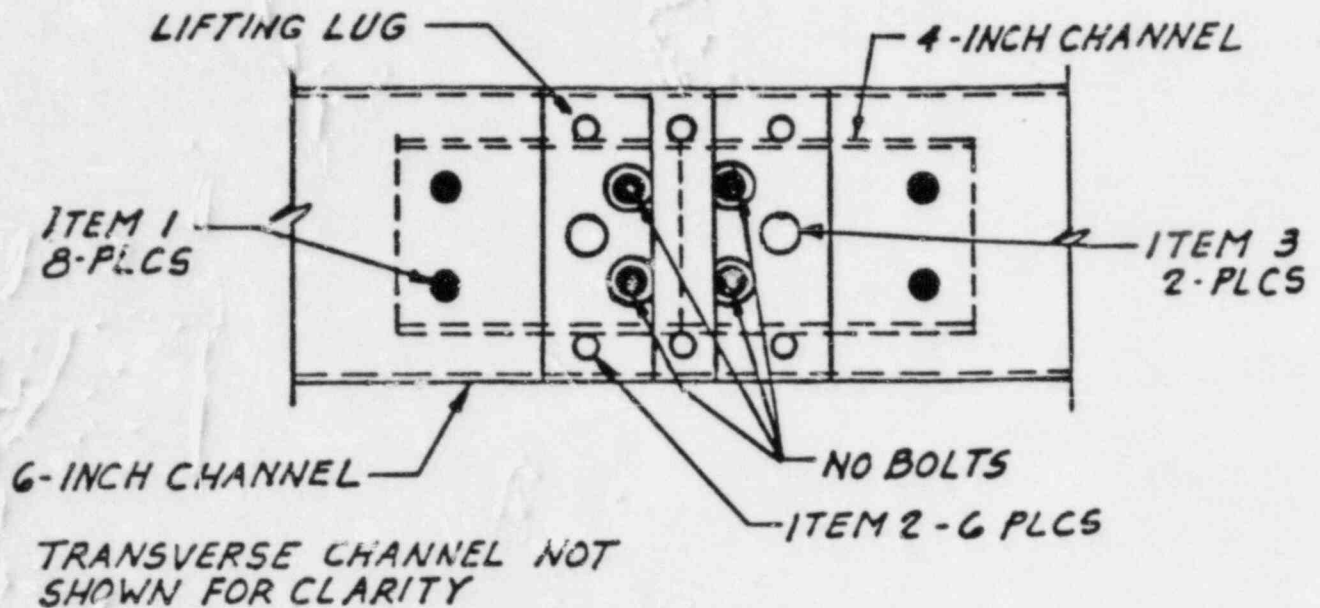
FIGURE 1 - FRONT LIFTING LUG ASSEMBLY (Two per cabinet)

Item 1 - Holes for 3/8 inch diameter mounting bolts which attach the C4 support girt to the C6 base. These bolts are required after lifting lug removal.

Item 2 - Mounting holes for the lifting lugs attachment bolts. No bolts are required after lifting lug removal.

Note A - After lifting lug removal 2-5/8-inch diameter bolts (Item 3) may be installed as a substitute for the 4-3/8-inch diameter bolts (Item 1).

- 5.1 A PCN to WPP/QCI 258.0 will be issued by January 31, 1984.
- 5.2 Design Change Packages 1SE/2SE/3CE-PH-035 will be completed prior to fuel load in each unit.
- 5.3 The final report for DER 83-84 will be issued by May 15, 1984.
- 5.4 The four 3/8-inch diameter bolts and two 5/8-inch diameter bolts for Unit 1 MCC's will be installed prior to fuel load.

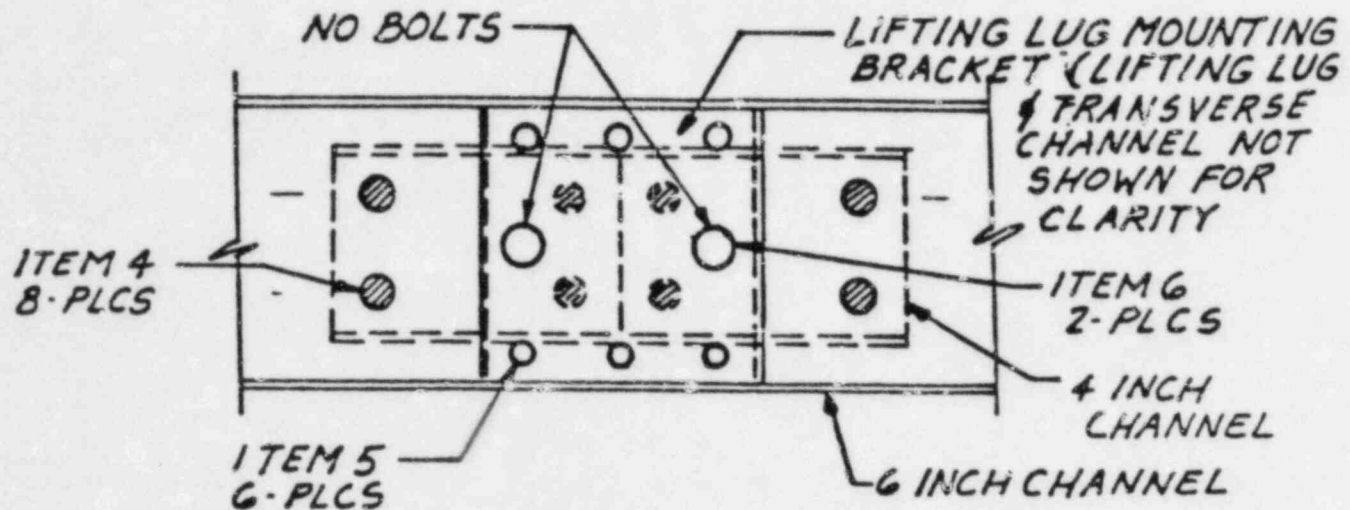
FIGURE 2 - BACK LIFTING LUG LOCATION (Two per cabinet)

Item 4 - Holes for 3/8-inch diameter mounting bolts which attach the C4 support girt to the C6 base (See Note B).

Item 5 - Mounting holes for the lifting lug attachment bolts. No bolts are required after lifting lug removal.

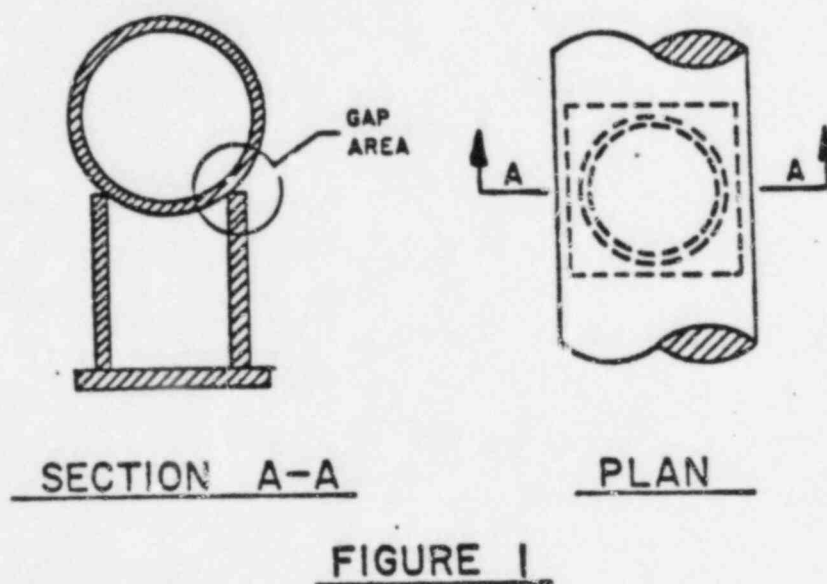
During the NRC inspection of the Safety Injection System, 12 pipe supports were found which did not meet the criteria of the design drawing and applicable tolerances allowed by Procedure WPP/QCI 201.1. The basic concern seems to involve the size and quality of welds which were performed by the craft and accepted by Quality Control. In reviewing the violations, many of the problems are a result of unclear procedures for inspecting welds. Along circumferential areas of piping, problems

arise when a pipe stanchion or a pipe lug is prepared to fit up to a pipe (see Figure 1).

As shown in Section A-A of Figure 1, the normal fit-up of pipe spools and support stanchions leaves a gap between the inside and outside diameters of the stanchions. Although the design drawing specified the pipe spool to support stanchion attachment weld to be an all-around

fillet weld, this attachment weld was in many cases made by filling in the gap between the spool and the stanchion. This method of welding is structurally equivalent to the fillet weld specified on the design drawing.
