TEST RESULTS REPORT

PROCEDURE NO. 92HF-1ZZ01

PROCEDURE TITLE PRECORE INSTRUMENTATION CORRELATION

DATES OF TEST PERFORMANCE 05/16/83 through 07/01/83

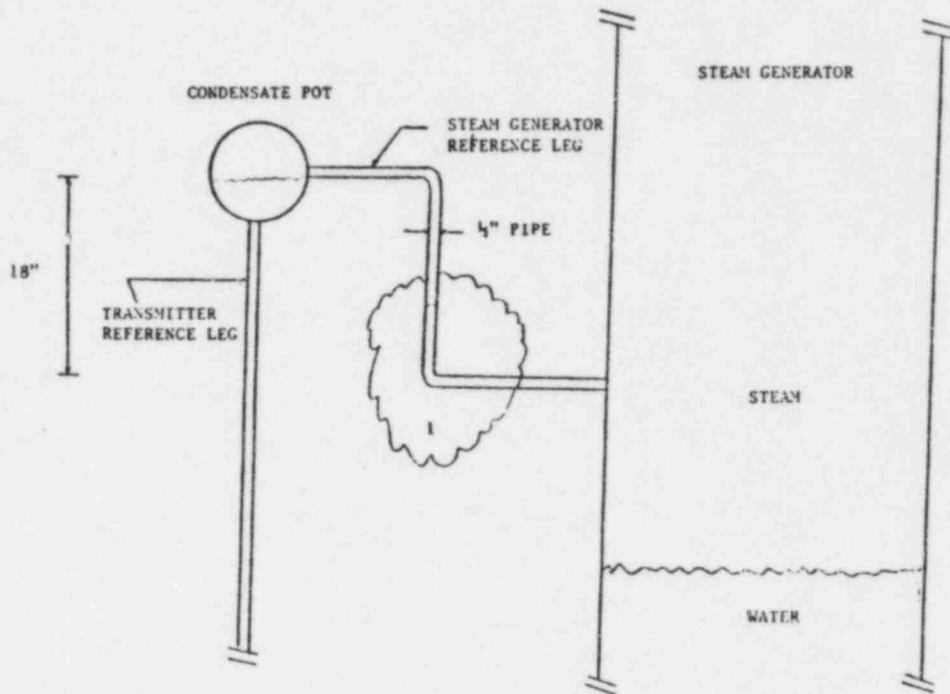
AS BUILT

- (1) Retest Package 1 - Due to the extent of steam generator level problems experienced during test conduct, the level transmitter condensate pots on Steam Generator 2 were modified per DCP 1SJ-SB-0Z1 (See Figure 1.0). The intent was to verify this fix on Steam Generator 2 prior to implementing it on Steam Generator 1. Retesting was done at all test plateaus, except "ambient conditions" to prove the modification. All level indicators passed retest except SGB LI 1124B which had a level transmitter problem previously documented per SFR 1SB080 and NCR 1SJ2011. This level transmitter was replaced per Work Order 14839 and retested satisfactorily per Retest Package 2.

STEAM GENERATOR LEVEL TRANSMITTER CONDENSATE POT PROBLEM/RESOLUTION

Note (1): This design allowed water to buildup in the reference leg between the steam generator and condensate pot.
