Subject: NUCLEAR PROJECT NO. 2
10CFR50.55(e) REPORTABLE CONDITIONS: #223, STANDBY
LIQUID CONTROL SYSTEM (SLCS); AND #260, STANDBY SERVICE
WATER FLOW PROBLEMS

WASHINGTON PUBLIC POWER SUPPLY SYSTEM
NUCLEAR PROJECT NO. 2
DOCKET NO. 50-397
LICENSE NO. CPPR-93
10CFR50.55(e) CONDITION #223
STANDBY LIQUID CONTROL SYSTEM (SLCS)

WASHINGTON PUBLIC POWER SUPPLY SYSTEM
NUCLEAR PROJECT NO. 2
DOCKET NO. 50-397
LICENSE NO. CPPR-93
EVALUATION OF POTENTIAL 10CFR50.55(e) CONDITION #260
STANDBY SERVICE WATER FLOW PROBLEMS

INTERIM REPORT

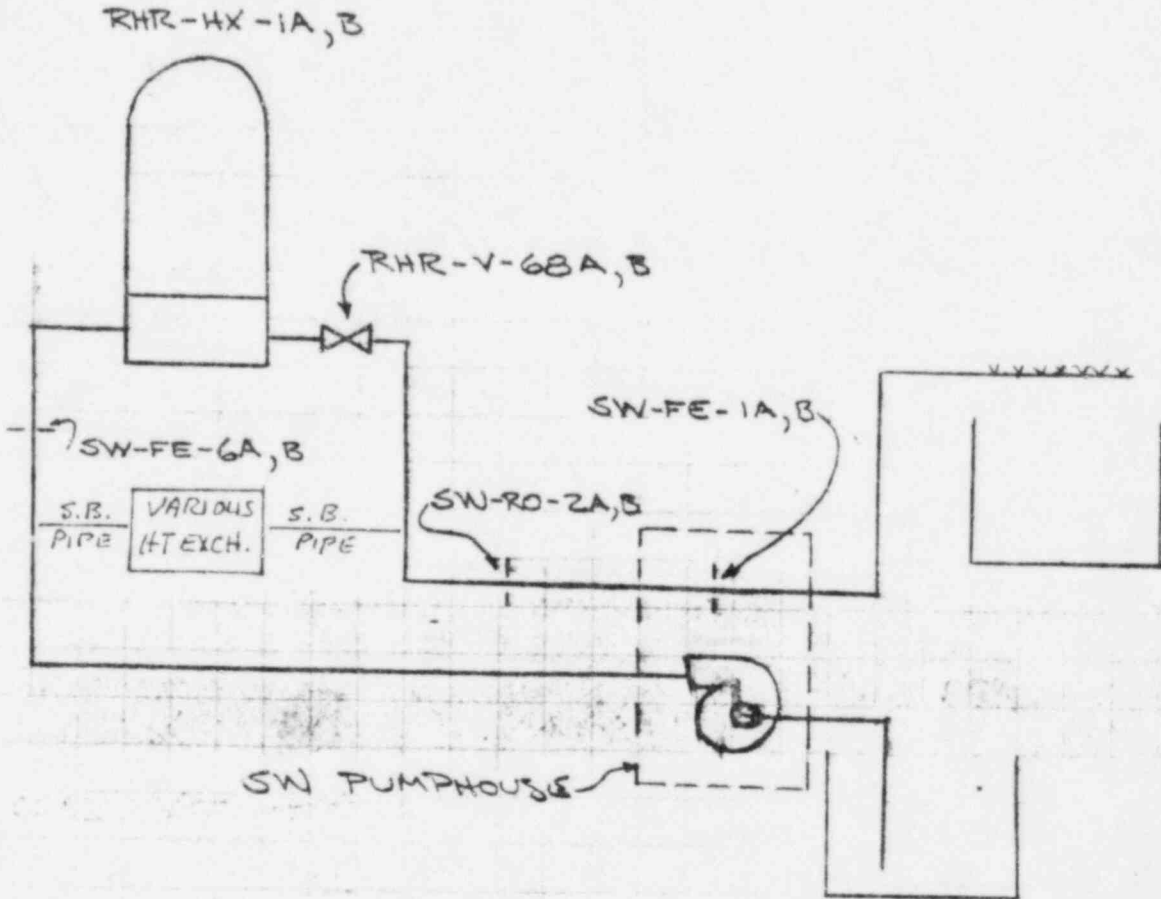
FIGURE 1

Startup testing identified insufficient flow to several heat exchangers in Standby Service Water (SW) loops A and B.

The primary cause of this deficiency is due to corrosion product buildup on the inside surface of the pipe. The material buildup reduces the pipe flow area and increases resistance resulting in a low flow condition. In addition, errors in the original system pressure drop calculations have been identified. The calculations should have been considered preliminary until all system design information was available. In revising the calculation to the latest design/as-built configuration several cases have been identified where the calculated available pressure head will not provide the required design flow rate.

The Standby Service Water System (58.0) was chemically cleaned to remove the deposited material. Subsequent testing and inspection has identified that excessive fouling still exists and that additional cleanup is required.

The system pressure drop calculations are being revised to reflect the latest design configuration. The calculations that have been revised to date indicate the existing system components can be adjusted to provide the required pressure head. This can be achieved by throttling the RHR heat exchanger discharge valves (RHR-V-68A, B) and enlarging the removable orifices (SW-FE-1A, B) in the return lines located in the SW pump houses (Figure 1). If system design changes are identified as necessary to correct the deficiency, they will be implemented as required.
