UNITED STATES OF AMERICA
NUCLEAR REGULATORY COMMISSION

APPLICATION OF TEXAS UTILITIES
GENERATING COMPANY, ET AL. FOR
AN OPERATING LICENSE FOR
COMANCHE PEAK STEAM ELECTRIC
STATION UNITS #1 AND #2
(CPSES)

Docket Nos. 50-445
and 50-446

TESTIMONY OF CASE WITNESS
MARK A. WALSH

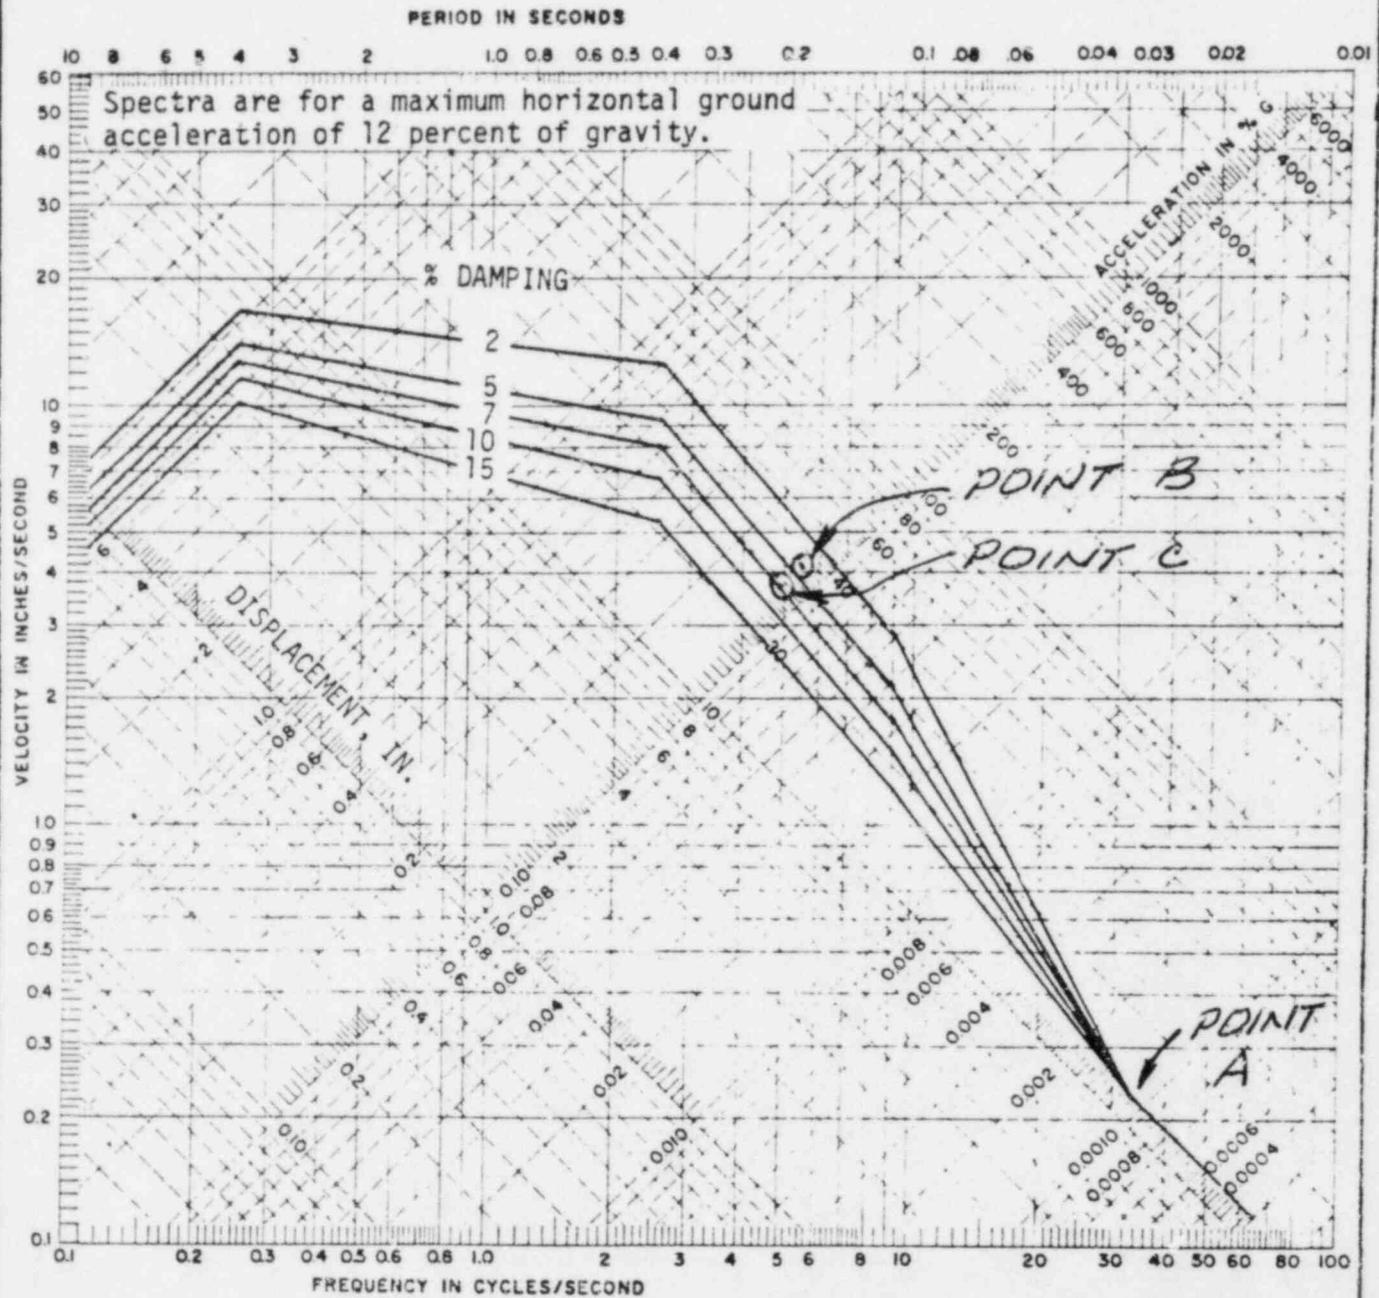
DESIGN RESPONSE SPECTRA
FOR HORIZONTAL SAFE
SHUTDOWN EARTHQUAKE

2 The load which causes the displacement is from the weight of the support
3 and the tray with its contents. The weight is in the horizontal direction
4 and is actually the mass times the acceleration due to gravity that is contri-
5 buting to the horizontal displacement. When a support is rigid, the seismic
6 acceleration it will experience is .12 g's at ground level, and this is in-
7 dependent of damping.

8 Now consider a support that displaces 1/8 of an inch (.125 inches) using
9 4% damping its horizontal acceleration at ground level is 35% of gravity, as
10 indicated on Attachment A as point B. With 7% damping, its horizontal accelera-
11 tion would be 28% of gravity. It is apparent that the higher damping will
12 produce smaller seismic loads. But equally apparent is the acceleration
13 from a rigid condition equalling 12% of gravity goes to 28% of gravity with 7%
14 damping, in essence the seismic load will double.
