Inspection of Jacket Water Pumps  
from Transamerica Delaval Diesel  
Engines, SNPS, FaAA No. PA07396  
Shoreham Nuclear Power Station - Unit 1  
W.O. 44430/48923

FAILURE ANALYSIS REPORT - EF-3060

## FAILURE ANALYSIS - ROTOR POLE 7; ROTOR 17404267

ANALYSIS OF THE REPLACEMENT CONNECTING ROD BEARINGS  
FOR EMERGENCY DIESEL GENERATORS, FATIGUE LIFE PREDICTION  
SHOREHAM NUCLEAR POWER STATION

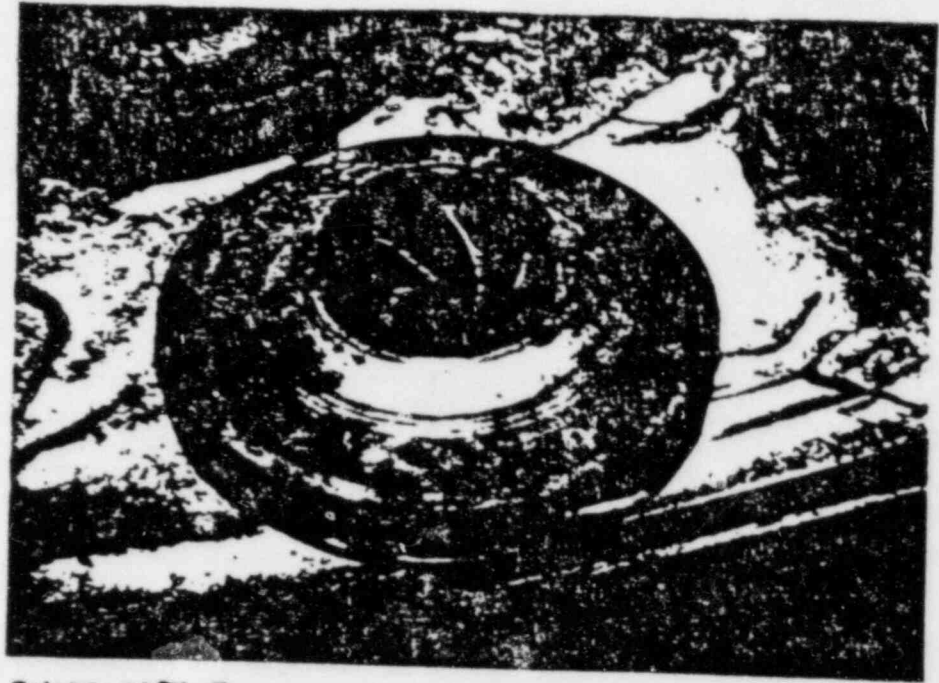
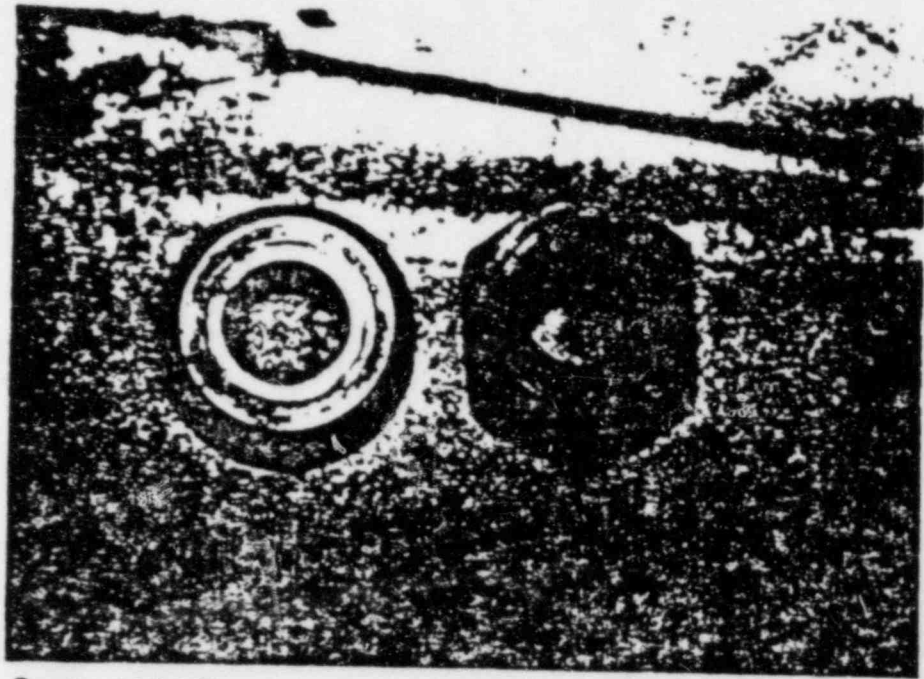
PHOTOGRAPH 3

The significant components of the DG 102 pump include the impeller, shaft, retaining washer and nut which are shown in Photographs 3 through 5. The impeller is fabricated from a ferrous material, specified as ductile iron. There was no evidence of cracking of the impeller, although some casting porosity was observed and there was some corrosion debris at internal portions of the impeller vanes.

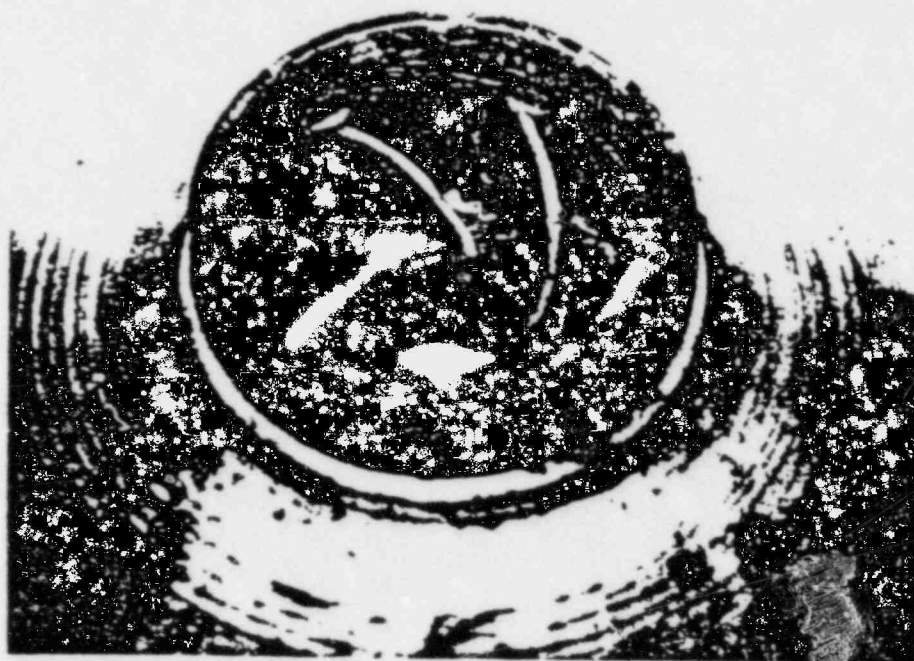
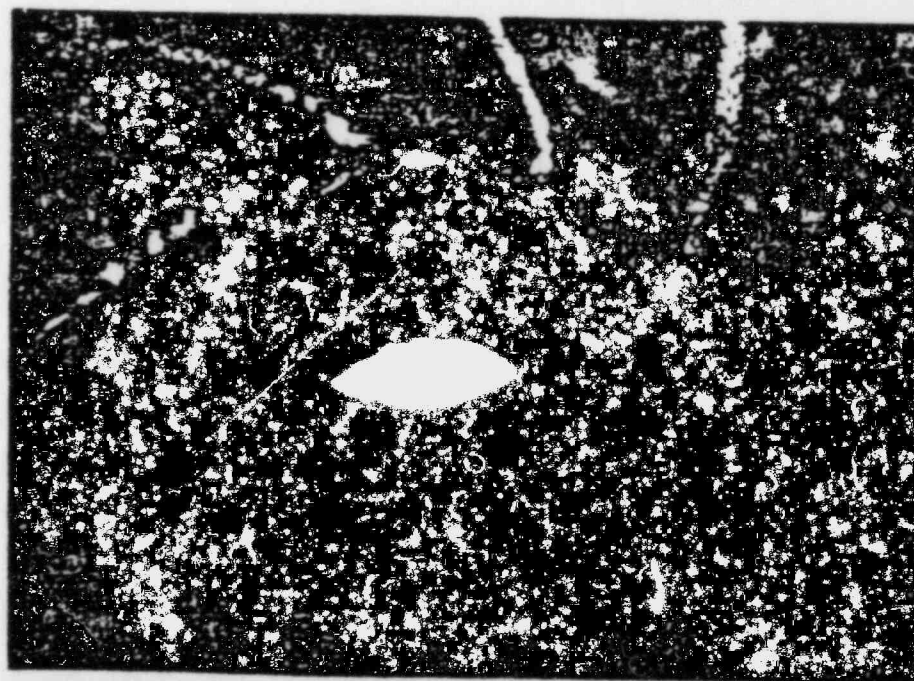
PHOTOGRAPH 6

Impeller damage was confined to the bore of the hole where it is press fit to the shaft and the bearing surface at the periphery of the hole where the retaining washer contacts. These areas are shown in Photographs 6 and 7. The bore of the impeller hole was severely scored at two major locations consistent with major scoring of the shaft. There was minor damage to the remainder of the impeller bore. The surface around the hole, on the suction side of the impeller, has been severely scored as a result of relative rotation between impeller and retaining washer (Photograph 7).

There was a circumferential lip approximately 1/32 inch in height around the hole, resulting from metal distortion as the impeller rotated relative to the washer. The lip was relatively uniform in height around the hole periphery. There was, however, no visual evidence of heat damage to the bore of the impeller or the hole periphery, suggesting the relative rotation between shaft and impeller occurred for only a short period of time.

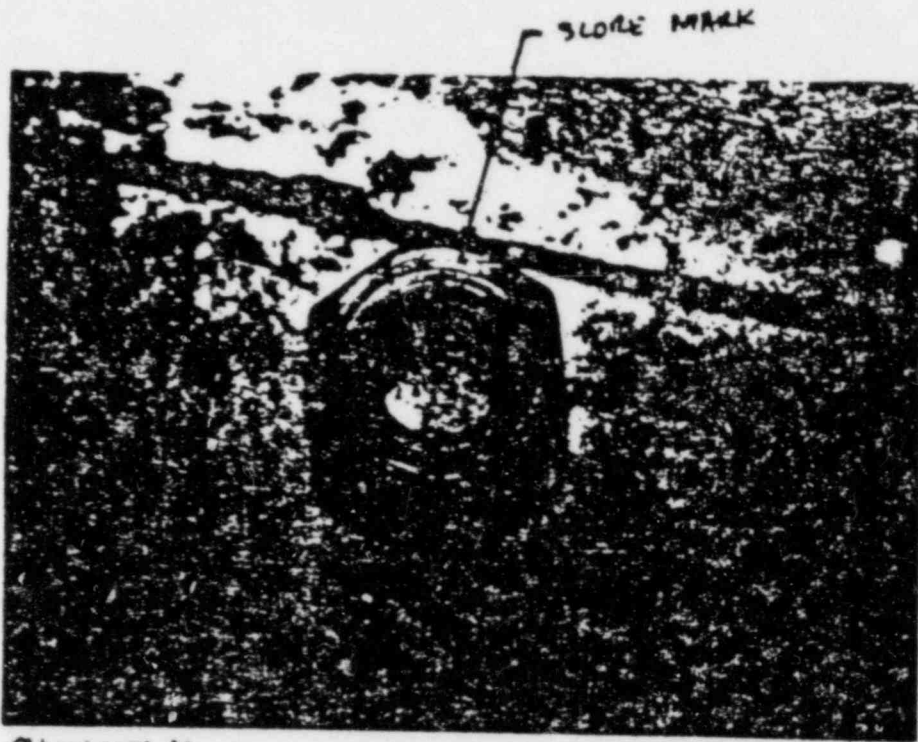
PHOTOGRAPH 11

Photograph 11. The direction in which this mark was produced indicates that the nut/shaft rotated as a unit in their normal driven direction relative to the retaining washer. This suggests the washer rotated with the impeller for at least a portion of one revolution. The washer surface which was in contact with the nut had a circumferential score mark consistent with the damage seen on the nut as shown in Photograph 12.

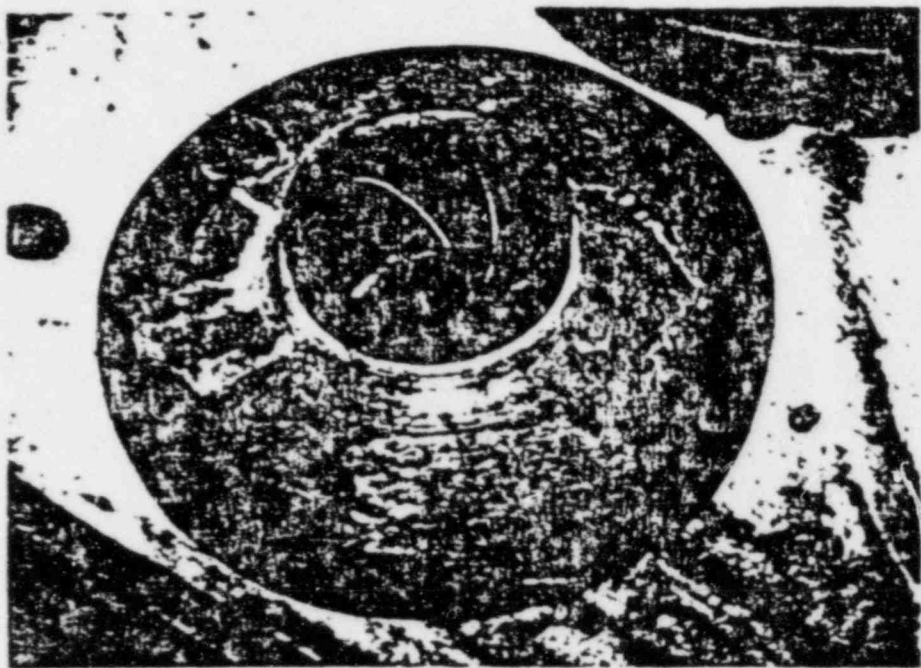
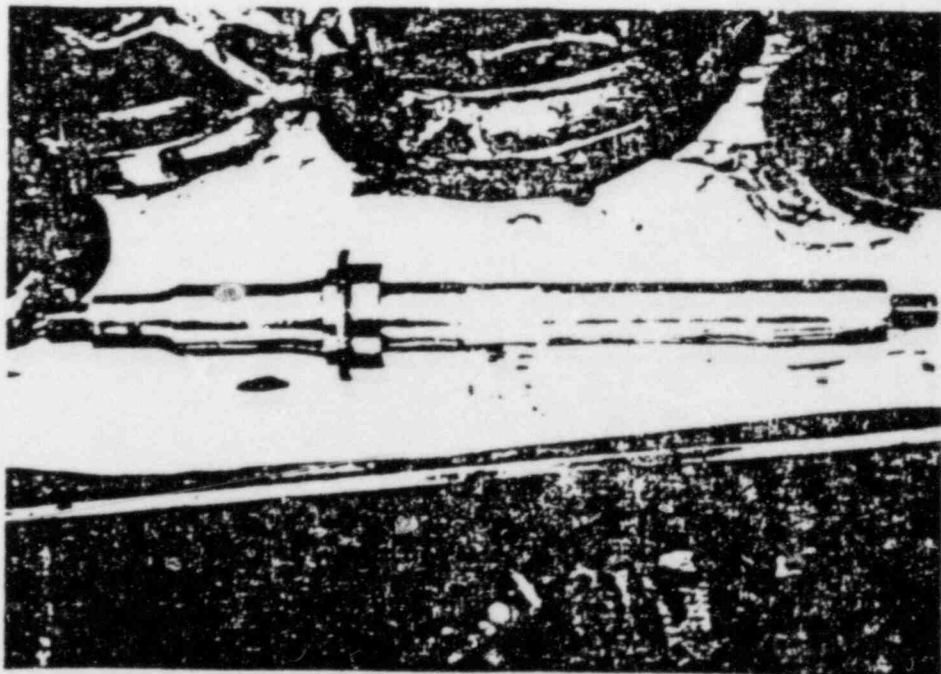
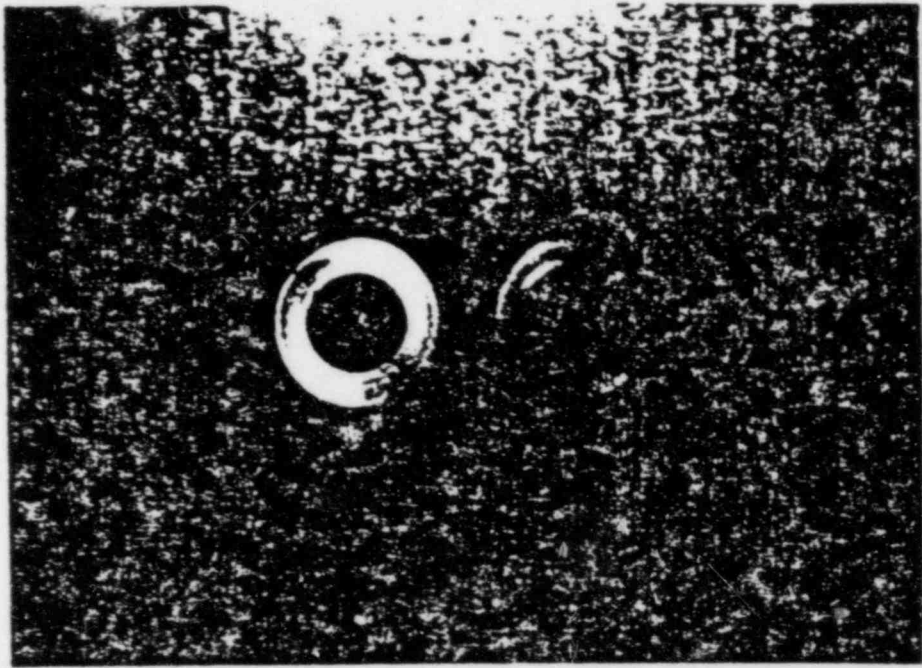
PHOTOGRAPH 13

The various components of consequence from the Unit 103 pump are shown in Photographs 13 through 15. There was some corrosion in the vanes of the impeller as well as areas of casting porosity

similar to those seen in the pump from Unit 102. However, the impeller bore was in excellent condition with no scoring or other evidence that there was any relative rotation with the shaft. The machining marks were still evident and the bore surface was very smooth (Photograph 16). The bearing face on the suction side of the impeller showed no evidence of wear from the retaining washer.

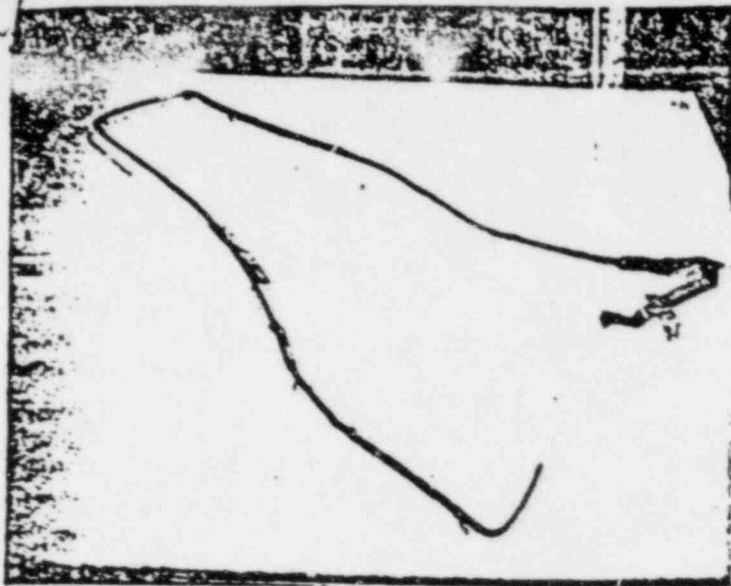
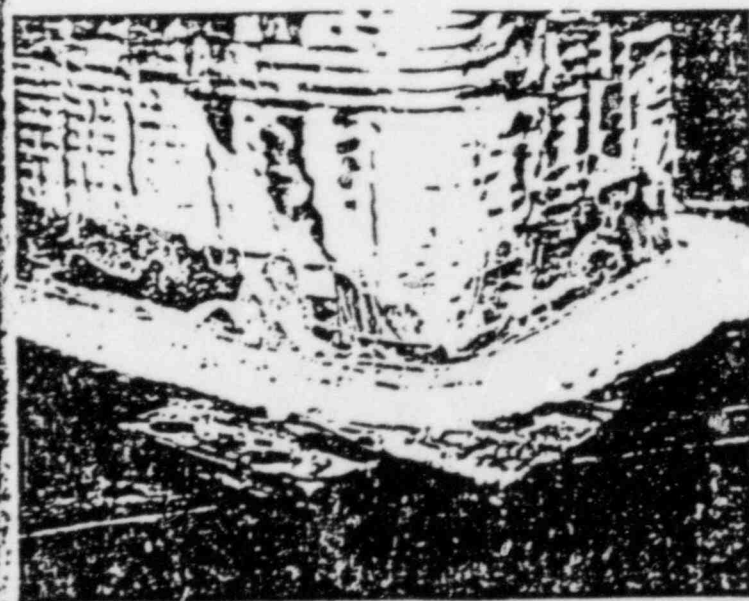
FIGURE 1

- 2.1 Rotor 17404267 was found to have a ground by LILCO personnel during an inspection of diesel engine problems.
- 2.2 This rotor was shipped to PP-EP for repairs under our Service No. 4-4138. It arrived 10/5/83. The incoming inspection report (Appendix A) showed clearly a ground to Pole #7.
- 2.3 Pole #7 was removed from the shaft and a diagnostic test set-up. The diagnostic apparatus is a 1000W resistance in series with the 120 VAC feeder and the pole. Smoke from the ground was marked with an arrow on the head. The outer layers of wire were stripped from the pole down to the first turn. The first turn of wire was gently removed and the grounded spot located at the left rear corner. The three reference photos show: Figure 1 - the first turn. The ground is at the left rear corner. Figure 2 - A close up of the burnt wire. Figure 3 - the grounded spot on the pole body.

- 2.4 The insulating paper was removed from the pole body and a sharp corner was found at the spot of the ground. The sharp corner was located at the edge of the insulating washer which is why it did not cause a ground in manufacturing but required the vibration from running to wear through insulation.

- 3.1 Based on the evidence described above, the failure of ground insulation of winding on Pole #7 was caused by accelerated wear of the pole body insulation due to normal self-induced vibration of the equipment. The rate of wear was accelerated by the improperly blended radius of the coil support edge, resulting in a severe concentration of pressure on the pole body insulation material.

- 4.1 Chipped washers on poles were repaired as per ER-6.1.
- 4.2 Pole #7 was completely cleaned and the sharp corner carefully smoothed. It was then rewound and vacuum-pressure impregnated in MV-10.15 (Isochem S-100). It is current PP-EP practice to use a wire insulation of heavy enamel plus single daglass instead of double daglass as this substantially reduces the possibility of interturn shorts. This change was made on the new winding. The insulating paper now used is DMD which is preferred to "Duroid" used on the original pole.

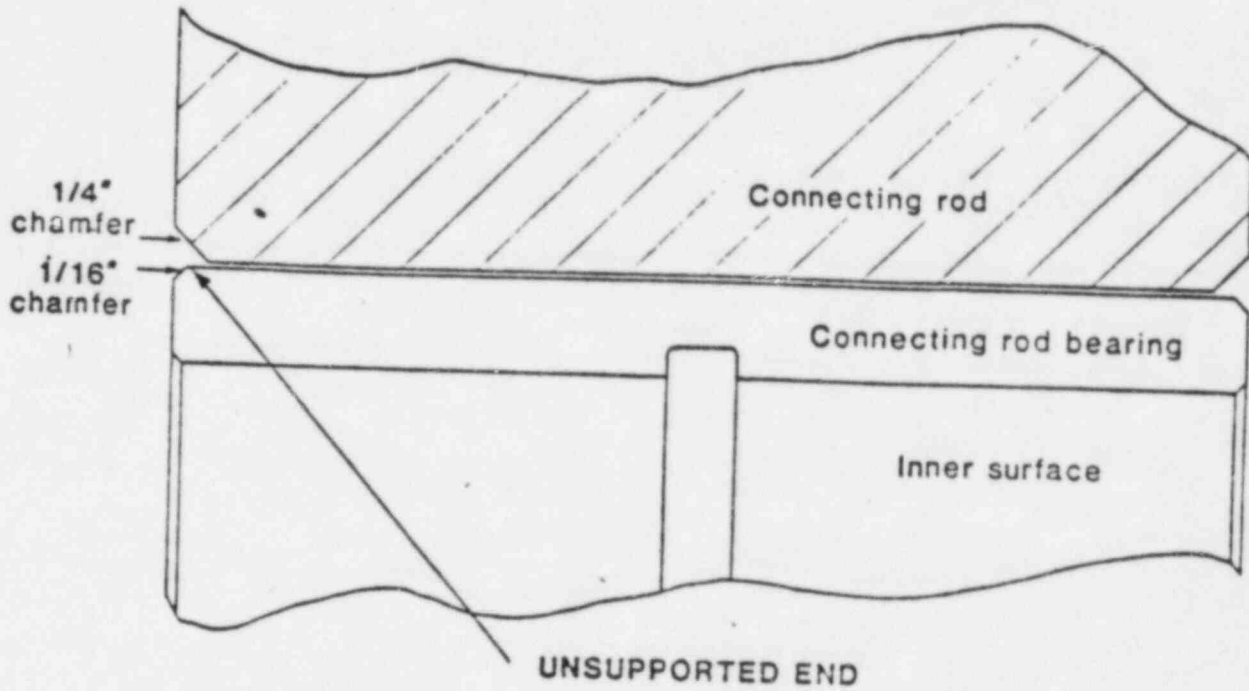
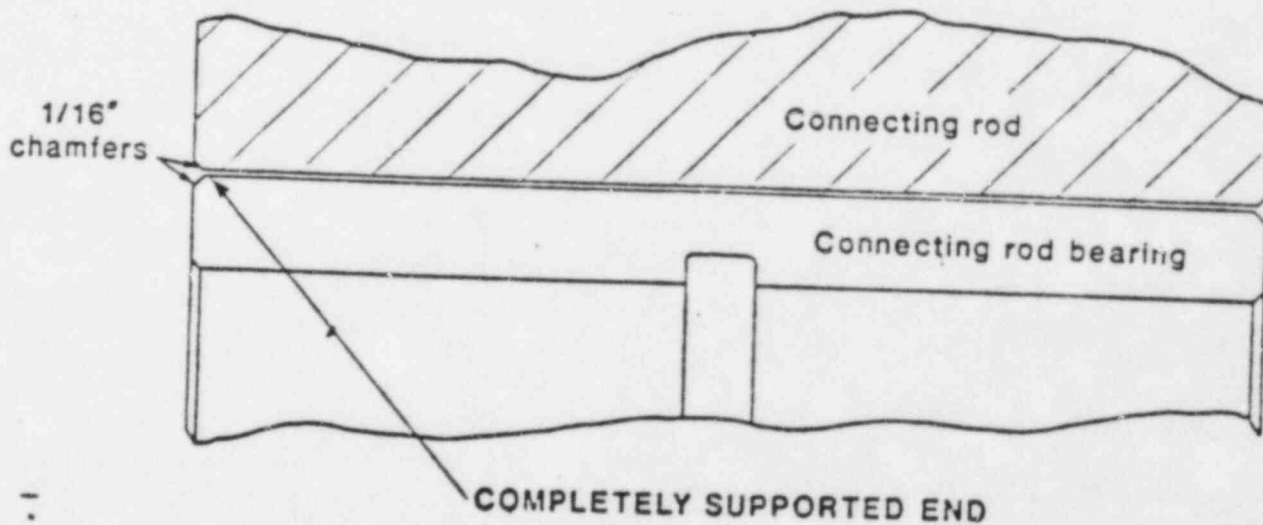
Figure 1. Bearing: Connecting rod configuration with original 11" journals.

Calculations have demonstrated that the major contributor to the cracking of the original connecting rod bearings in the TDI Enterprise diesel engines was the unsupported bearing end, the result of a 0.25 inch chamfer in the connecting rod bore.
