FACILITY NAME (1) PALISADES NUCLEAR PLANT	DOCKET NUMBER (2) 05000255	LER NUMBER (6)			PAGE (3)	
		YEAR	SEQUENTIAL NUMBER	REVISION NUMBER		
		84	-001	-00	2	OF 16

I. EVENT DESCRIPTION

DOCKET 50-255 - LICENSE DPR-20 -
PALISADES PLANT - LICENSEE EVENT REPORT 84-001 (LOSS OF COMMUNICATIONS)

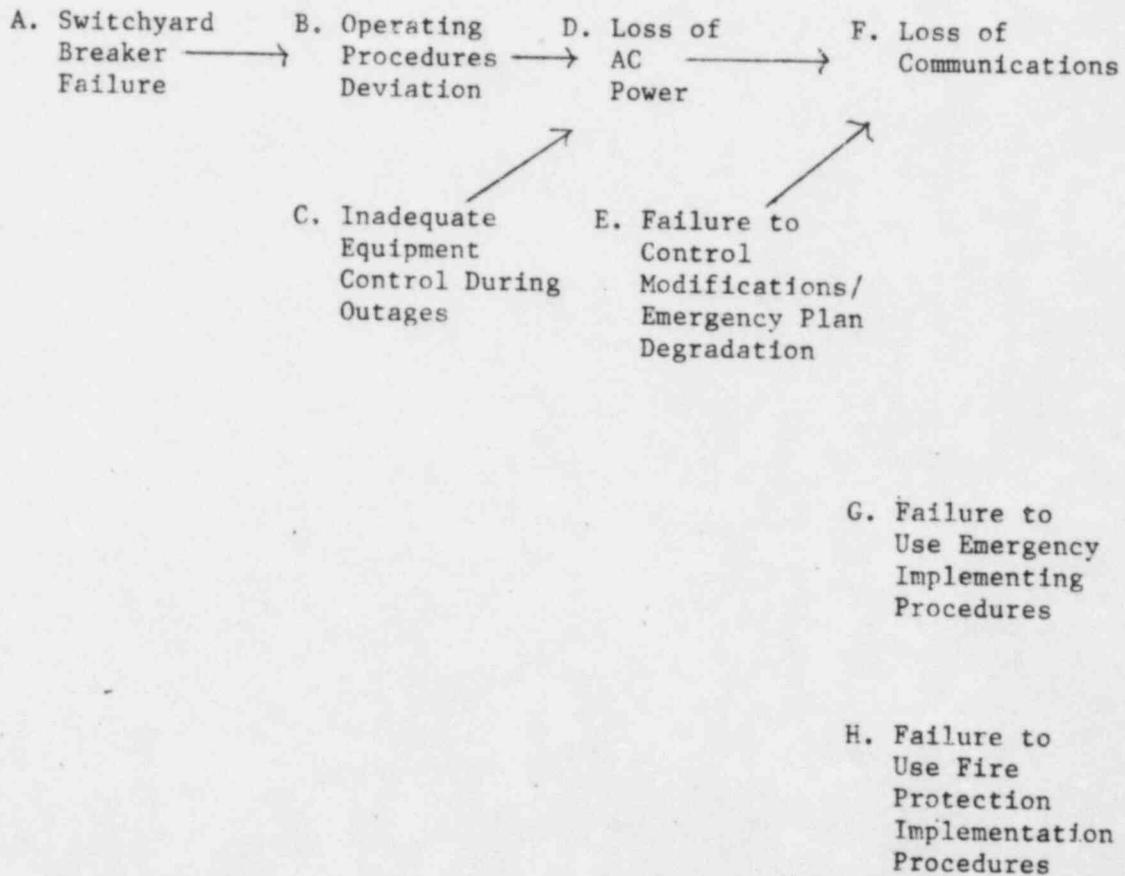
FIGURE 1

Loss of Communications
Sub-events
