Subject: Final Report - DER 82-61
A 50.55(e) Reportable Condition Relating to Reactor Coolant
Pump Diffuser Ring Cap Screws May Fail And Damage Pump
File: 84-019-026; D.4.33.2

FINAL REPORT - DER 82-61
DEFICIENCY EVALUATION 50.55(e)
ARIZONA PUBLIC SERVICE COMPANY (APS)
PVNGS UNITS 1, 2, & 3

TITLE: REACTOR COOLANT PUMP DIFFUSER BOLT FAILURE SUMMARY

Metallurgical Investigation
of
Diffuser/R.C.P. Casing Bolt
Failures
(791350)

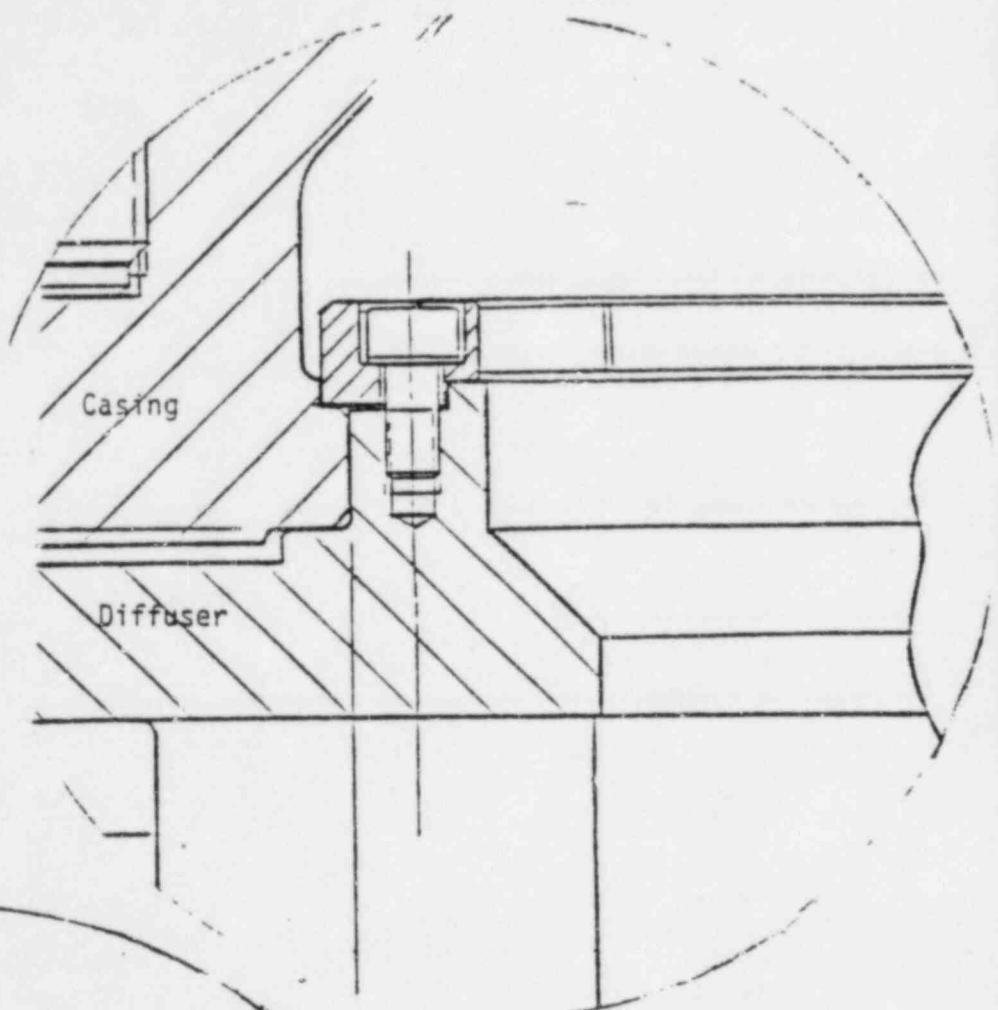
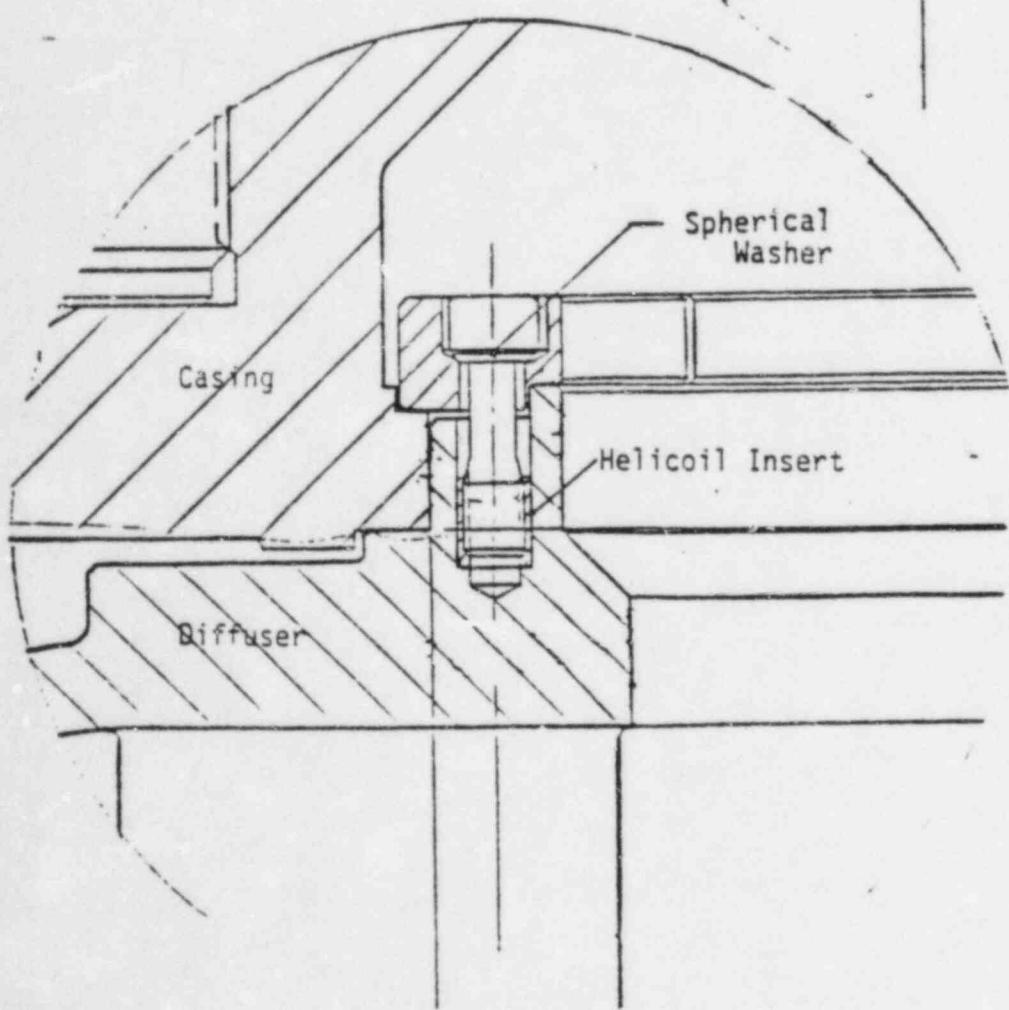
DIFFUSER/CASING
BOLTED CONNECTION

The bolt failure in Reactor Coolant Pump #1 was originally identified as failure due to improper mechanical assembly procedures. Engineering felt, at the time, that a spherical washer, necked down bolt, and a higher strength bolting material would result in a more conservative bolted connection. The original diffuser-to-casing bolting connection is shown in Figure 1. The bolts were M20 x 40 made from ASTM A193-47 Grade B6 material. The re-designed bolts (M20 x 65 Unbrako KS-17 material) are also shown in Figure 1.

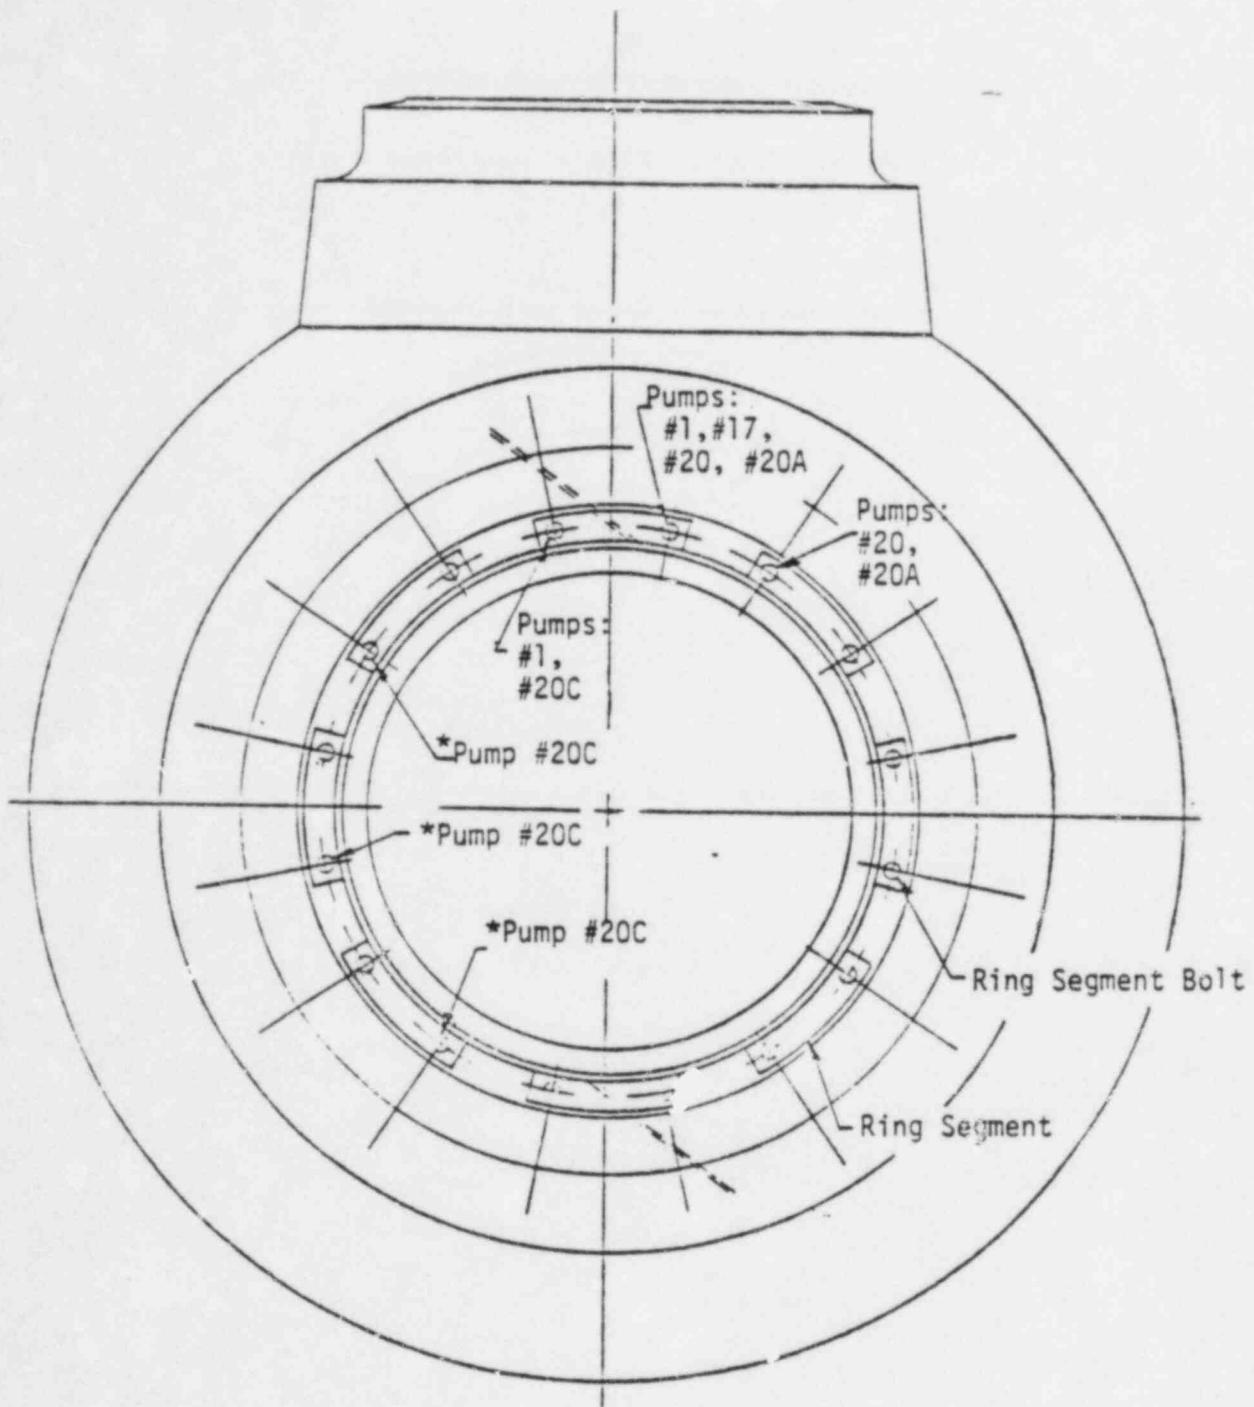
1. The bolt failures occurred within a sector of 1130 to 0130 to the discharge nozzle center (See Figure 3).
2. The bolt failures occurred with diffusers supplied from two different vendors.
3. Failures occurred with virgin bolts.

The metallurgical examination of the broken bolts indicated that the failures were related to hydrogen induced stress corrosion. However, the location of the reported bolt failures (see Figure 3), did not show the randomness expected if the failure mechanism were initiated by hydrogen induced stress corrosion in combination with the normal loadings reviewed in Part I.

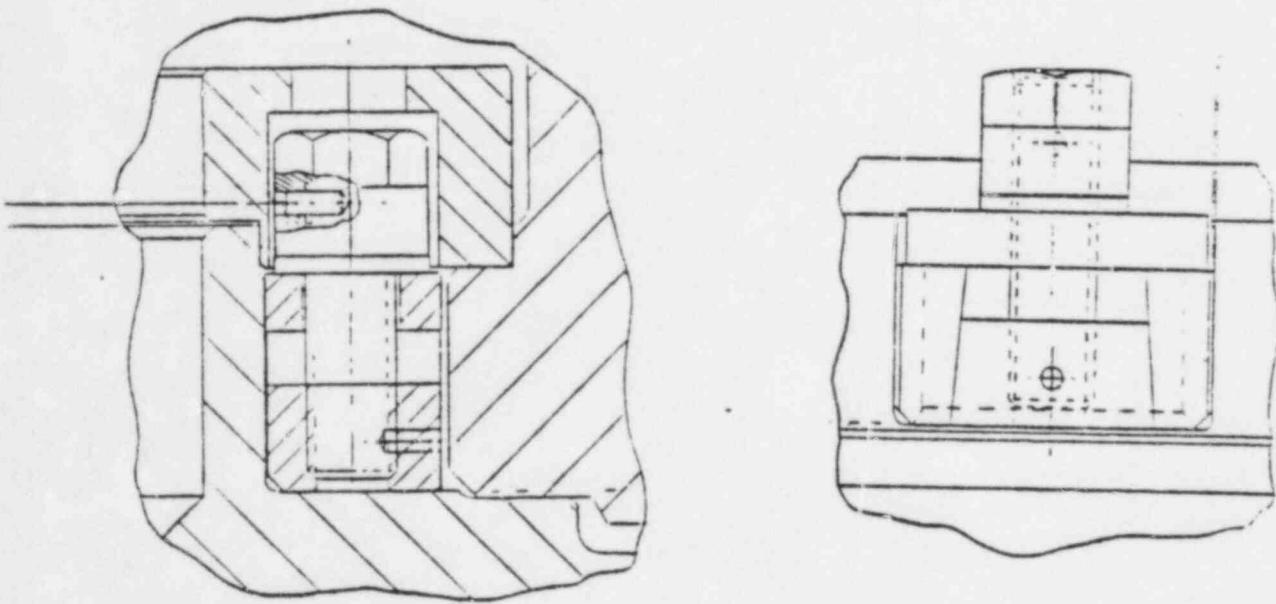
DIFFUSER WEDGE ASSEMBLY

The resultant moments on the diffuser half tended to pivot the diffuser outermost edges about a keyway in the diffuser. These loading conditions were greatly reduced by physically supporting the two diffuser halves against each other as the resulting moment is directed towards the hydraulic centerline of the diffuser. This physical support was achieved by using two wedges (see Figure 4) positioned in the gap between the two diffuser halves.

1. Continue to use Type 410 bolting material with a modified heat treatment procedure.
2. Position the five vane diffuser half on the right hand side of the pump casing to minimize the induced stress levels in the bolts.
3. Install diffuser wedges to limit the movement of each diffuser half.

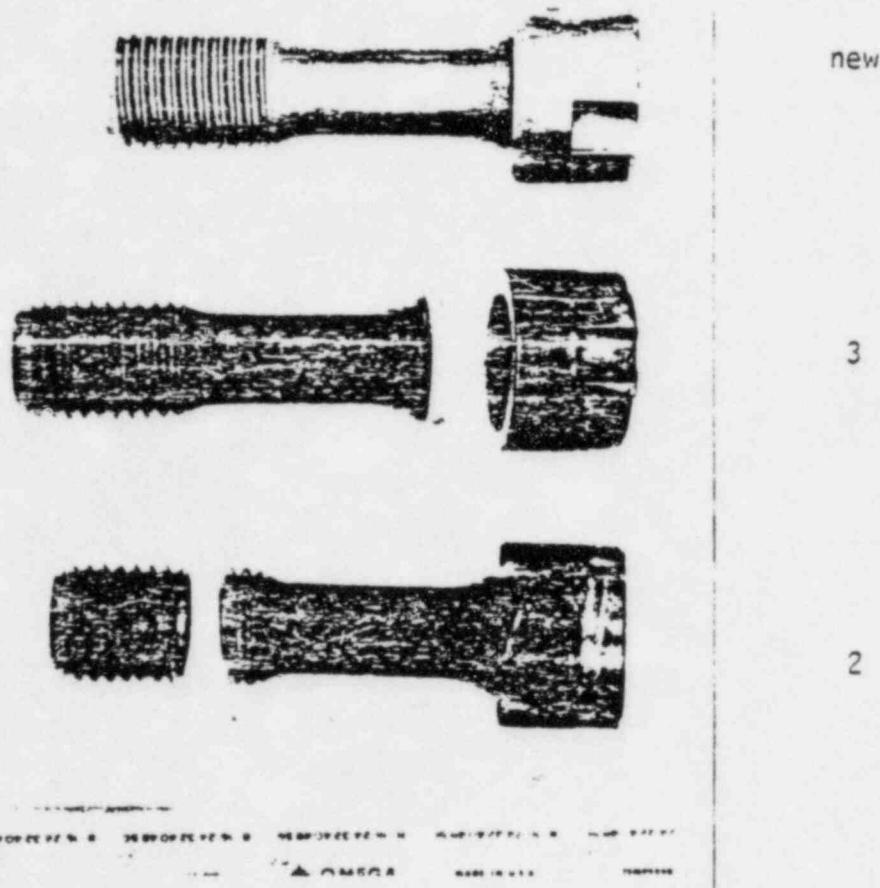
Fig. 1 Broken Bolts No. 2 and 3

Bolt No. 2: broken in thread, oxidized fracture (see Fig. 1)

Bolt No. 3: broken in fillet shank to head, oxidized fracture (Fig. 1)
