Subject: Palo Verde Nuclear Generating Station  
Bechtel Job 10407  
Reinspection of Nuclear Pipe Hangers (Q Class)  
File: K.38.02

PALO VERDE NUCLEAR GENERATING STATION UNITS 1, 2, & 3  
CONSTRUCTION INSPECTION PLANNING FOR  
JOB NO. 10407

# CAT Team Inspection - Narbut

#### IV. 4. Hangers and Supports including Snubbers and Restraints

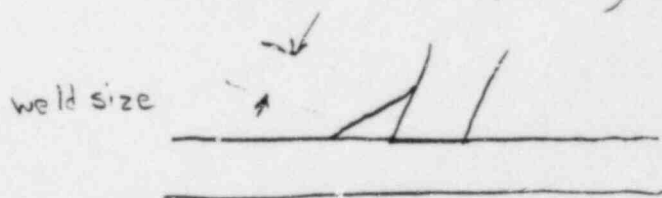
- Support SI-176-H003 was found to have an undersize weld. The skewed ( $120^\circ$ ) fillet weld of item A to the containment insert measured  $\frac{1}{4}$  inch rather than the required  $\frac{5}{16}$  inch. The support weld was accepted on 7/14/80.

Further discussions with the Lead QC Engineer for Pipe Supports and the Lead Welding Engineer disclosed that the Welding Engineer had given verbal instructions to the QC Engineer that were contrary to the AWS D.1.1 code requirements for measuring the size of skewed fillet welds. Hence this undersize weld may be considered caused by

improper engineering information. It follows that all skewed fillet welds may require reinspection to the proper criteria.

At Palo Verde the QC Engineer states welds are "measured" <sup>as shown below</sup> ~~there~~ (it is not clear how this is "measured" since there is no access to <sup>one of</sup> the ~~the~~ measurement points):

~~It is clear that~~ To "measure" by the Palo Verde method to a given size (e.g.  $\frac{5}{16}$  inch on a  $120^\circ$  weld) will result in an undersize weld by the Code definition (in this case by  $\frac{3}{64}$  inch)

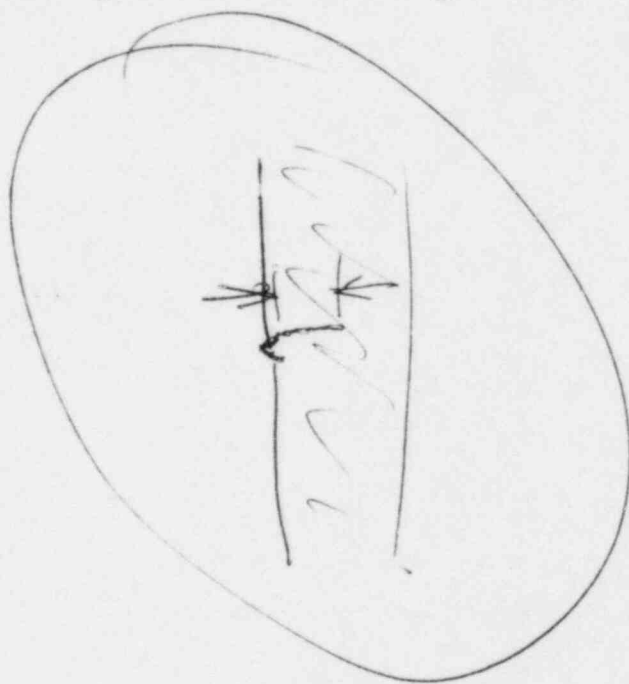
SI 100-H010

- Support SI-100-H010 was observed to have an apparent lap in the weld of item 33 to the pipe. This was a vendor weld. Minor slag was also present in the toe of the weld. ~~The licensee~~ These conditions would have precluded a satisfactory ~~liquid penetrant~~ liquid penetrant examination by the vendor. The vendor records show the weld was liquid penetrant examined and accepted on 12/4/77 (Job 2810, ~~SI~~ Piece 1-SI-100-S-009, "F" No 261) ~~The vendor~~ <sup>visual indication on the</sup> The NRC inspector had the weld re-examined by licensee personnel by liquid penetrant examination in his presence. The liquid penetrant examination resulted in an <sup>unacceptable linear</sup> indication.

Linear  
Indication  
requires  
buffing
