Subject: Construction Assessment Inspection of Palo Verde Unit 1

1. Appendix A - Executive Summary
2. Appendix B - Notice of Violation
3. Appendix C - Notice of Deviation
4. Inspection Report 50-528/83-34

NOTICE OF VIOLATION

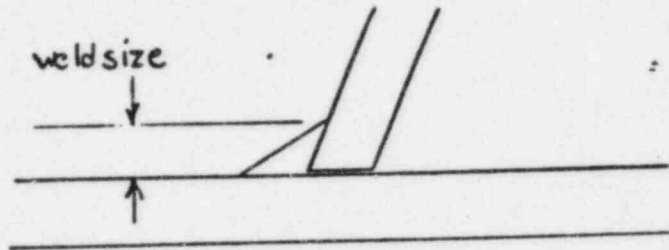
The AWS D.1.1 Code 1974 shows, in Figure 2.7.1, that skewed fillet welds are measured thus:

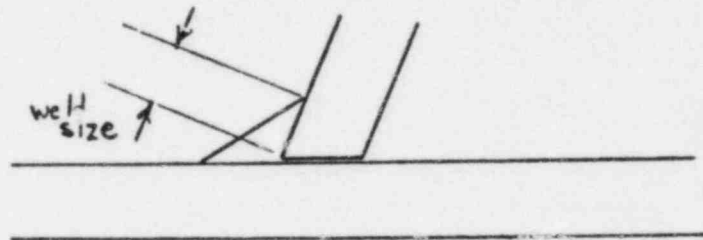
At Palo Verde the QC Engineer states welds are "measured" as shown below (it is not clear how this is "measured" since there is no access to one of the measurement points):

To "measure" by the Palo Verde method to a given size (e.g., $5/16$ inch on a 120-degree weld) will result in an undersize weld by the Code definition (in this case by $3/64$ inch). Nonetheless, QC inspectors are required by WPP/QCI 201.1 to inspect to AWS D.1.1 criteria for this weld. The AWS D.1.1 criteria are clear and are not superseded by verbal instructions from engineering.

The failure of welding QC to identify pipe support weld conditions which are not in accordance with the drawing or welding code requirements is an apparent violation of NRC regulations (~~Enforcement Item 50-528/83-34/XX~~). X

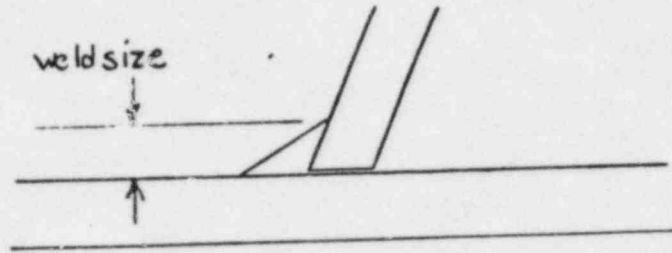
The AWS D.1.1 Code 1974 shows, in Figure 2.7.1, that skewed fillet welds are measured thus:

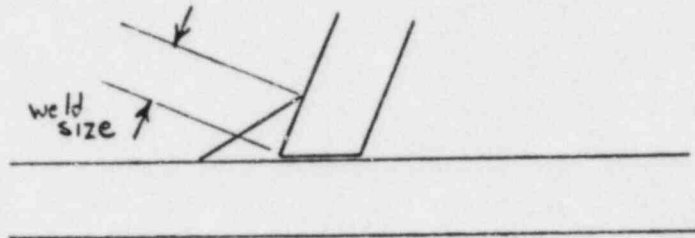
At Palo Verde the QC Engineer states weld are "measured" as shown below (it is not clear how this is "measured" since there is no access to one of the measurement points):

To "measure" by the Palo Verde method to a given size (e.g., 5/16 inch on a 120-degree weld) will result in an undersize weld by the Code definition (in this case by 3/64 inch). Nonetheless, QC inspectors are required by WPP/QCI 201.1 to inspect to AWS D.1.1 criteria for this weld. The AWS D.1.1 criteria are clear and are not superceded by verbal instructions from engineering.

The failure of welding QC to identify pipe support weld conditions which are not in accordance with the drawing or welding code requirements is an apparent violation of NRC regulations(OII 50-528/83-34-02).

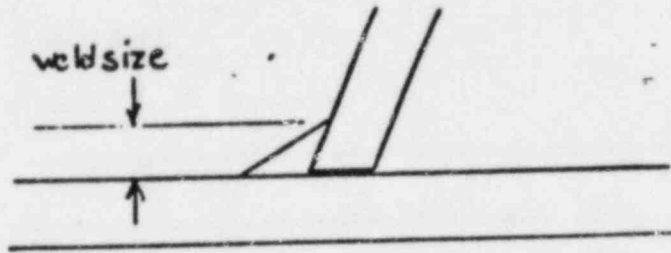
The AWS D.1.1 Code 1974 shows, in Figure 2.7.1, that skewed fillet welds are measured thus:

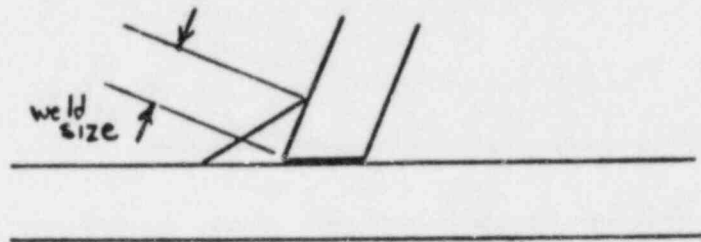
At Palo Verde the QC Engineer states weld are "measured" as shown below (it is not clear how this is "measured" since there is no access to one of the measurement points):

To "measure" by the Palo Verde method to a given size (e.g., 5/16 inch on a 120-degree weld) will result in an undersize weld by the Code definition (in this case by 3/64 inch). Nonetheless, QC inspectors are required by WPP/QCI 201.1 to inspect to AWS D.1.1 criteria for this weld. The AWS D.1.1 criteria are clear and are not superceded by verbal instructions from engineering.

The failure of welding QC to identify pipe support weld conditions which are not in accordance with the drawing or welding code requirements is an apparent violation of NRC regulations(OII 50-528/83-34-02).
