TENNESSEE VALLEY AUTHORITY

Enclosed is our response to your July 29, 1983 letter to H. G. Parris regarding Inspection Report Nos. 50-259/83-i2, -260/83-12, -296/83-12. The enclosed response is supplemental to our original response dated May 23, 1983 regarding the location of dose rate instruments on the 565 elevation. As stated in our original response, we still deny the violation occurred and the enclosed information supports that denial.

SUPPLEMENTAL RESPONSE - NRC INSPECTION REPORT NOS.
50-259/83-12, 50-260/83-12, and 50-296/83-12
R. C. LEWIS' LETTER TO H. G. PARRIS
DATED APRIL 22, 1983

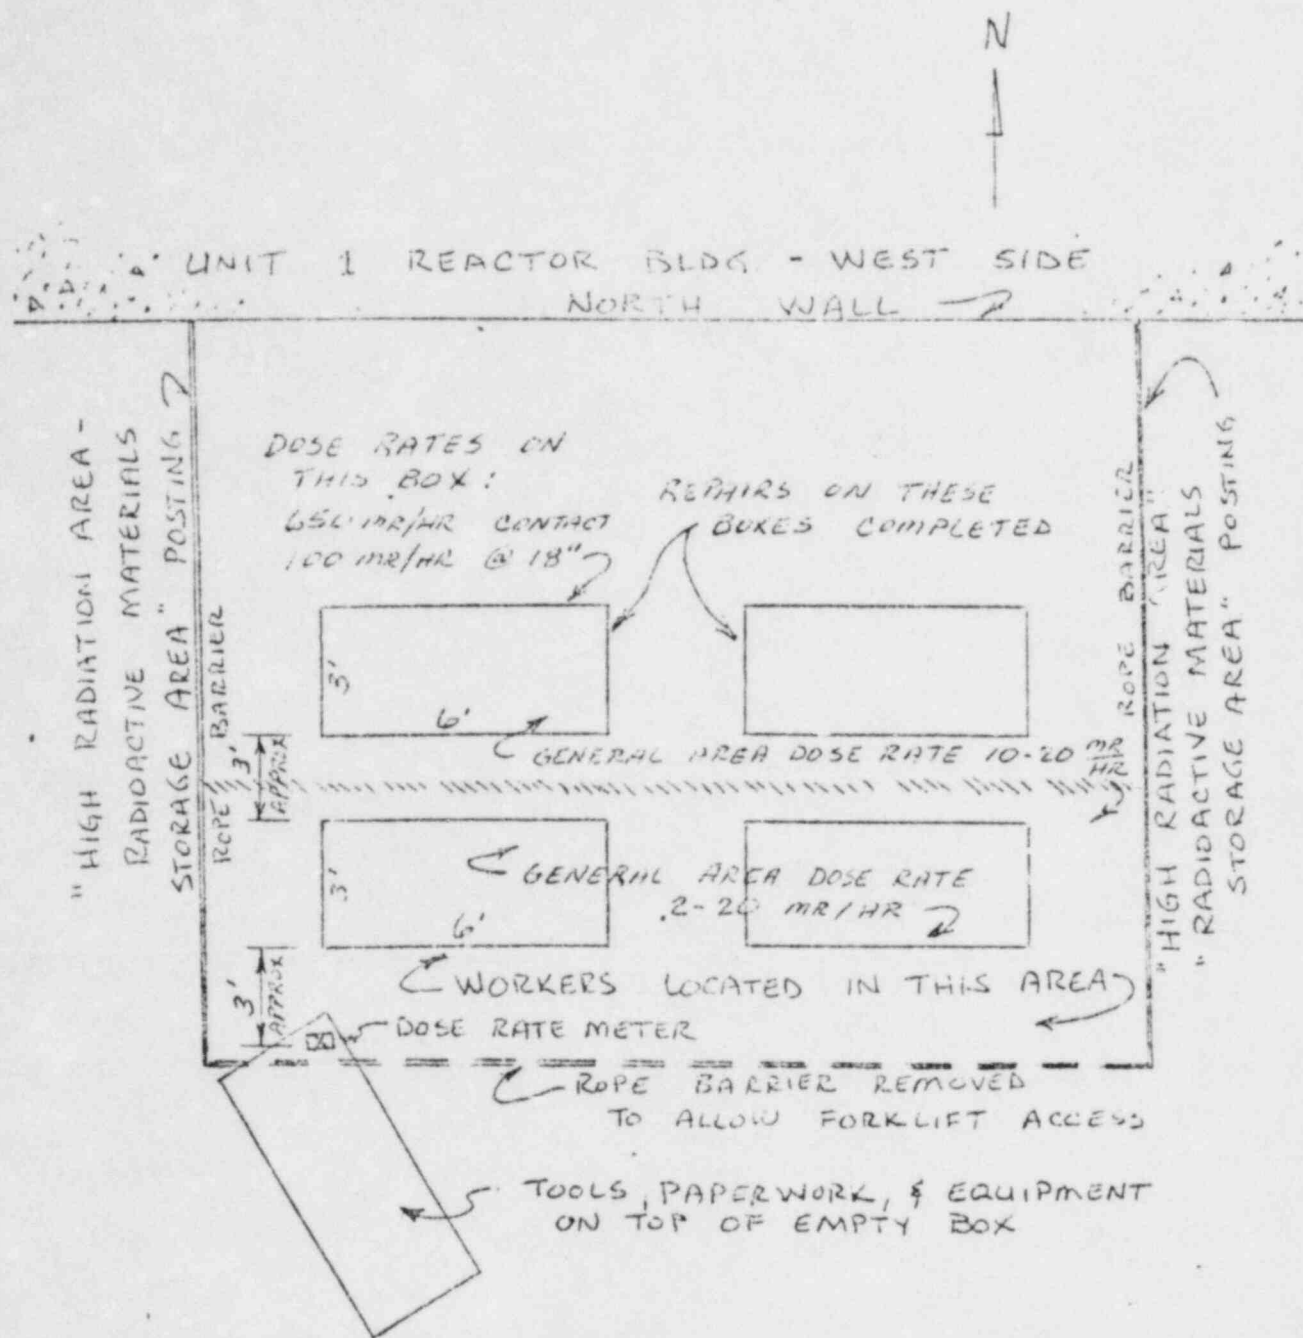
To move one of the boxes from the high radiation area (see attached sketch), the south rope barrier was moved. As shown on the sketch, the dose rate meter was in the edge of the area before the rope barrier was moved. After the rope barrier was moved, it was apparently difficult to tell that the dose rate meter was in the zone. As stated in TVA's previous response, positive access control to the area was being provided. The difficulty in determining exactly where the high radiation rope barrier had been resulted in the initial response that the instrument had been placed outside the zone during box movement when the meter had actually remained

in the zone. An interview was held with the involved carpenter on August 25, 1933, who provided the information used to prepare the attached sketch which clarifies the dose rate meter was in the zone and available to the workers.

To the best of our knowledge the above represents the area described
on March 24, 1983.

One of the causes of this event was the utilization of survey meters which are hand-held and must be set down when the worker must use both hands. TVA has significantly increased the number of small dose rate instruments which can be carried in an individual's pocket or attached to his clothing. This will reduce the potential for future similar events.
