THE CINCINNATI GAS & ELECTRIC COMPANY

September 22, 1983 LOZ-83-0154

RE: WM. H. ZIMMER NUCLEAR POWER STATION - UNIT 1 10CFR50.55(e) ITEM M-92, CRD VENT VALVES 1C11F101 AND 1C11F102 W.O. 57300, JOB E-5590, FILE NO. 956C, M-92

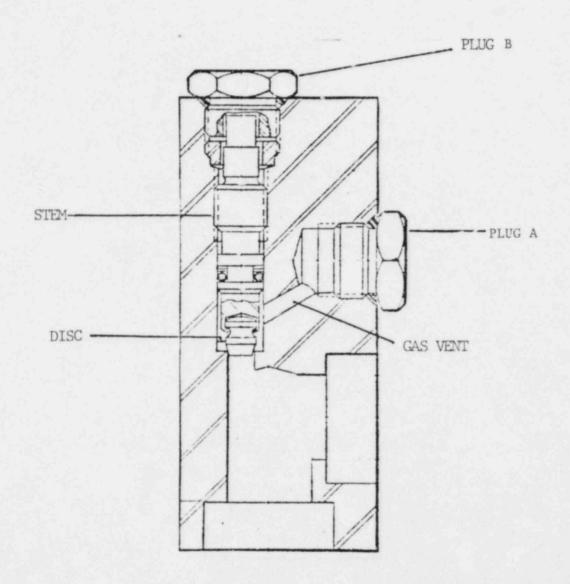
During a review of past Nonconformance Reports, a condition was identified with Control Rod Drive (CRD) high point vent valves on the Hydraulic Control Units. The valves, 1C11F101 and 1C11F102 (137 of each), were subject to valve stem and valve body damage due to material galling and application of excess torque in the open or closing direction. The vendor drawing, applicable to this situation, did not permit the use of any form of lubricant. This fact combined with a valve design which employs 316 stainless steel to 316 stainless steel threaded joints, resulted in galling, excessive friction and the need to apply additional torque to move the valve stem. This situation caused valve stem twisting, stem breakage and deformation of the stem material at both the operator (key wrench end) and the valve disc end. The original concern was a failure mechanism that could cause indeterminate leakage of control rod drive water.

Referring to the accompanying diagram, venting is accomplished in accordance with an approved procedure, by use of a temporary hose connected to Port "A" (after first removing the plug), removal of the plug from Port "B" and, using a special valve key, slowly opening the valve.

In addition, a design change has been approved and been implemented, permitting the use of "Never-Seez" lubricant and changing of valve elastomers to viton, a material compatable with the approved lubricant. These changes will also be incorporated in appropriate maintenance and spare parts documents.
