UNITED STATES
NUCLEAR REGULATORY COMMISSION
REGION I
475 ALLENDALE ROAD
KING OF PRUSSIA, PENNSYLVANIA 19406-1415

Subject: Millstone Unit 2 Inspection 91-18

SUBJECT: Millstone Unit No. 2
Evaluation of Pressure Gages for
PDCR-2-112-79.

SUBJECT: Evaluation of Pressure Gages
for PDCR-E-112-79: PI 8403, 8408, 8401,
6743, 6745, 6747, 3046, 3048, 3050, 3051,
3053, 3055, 3057, 7436, 7462, 8859, 8863.

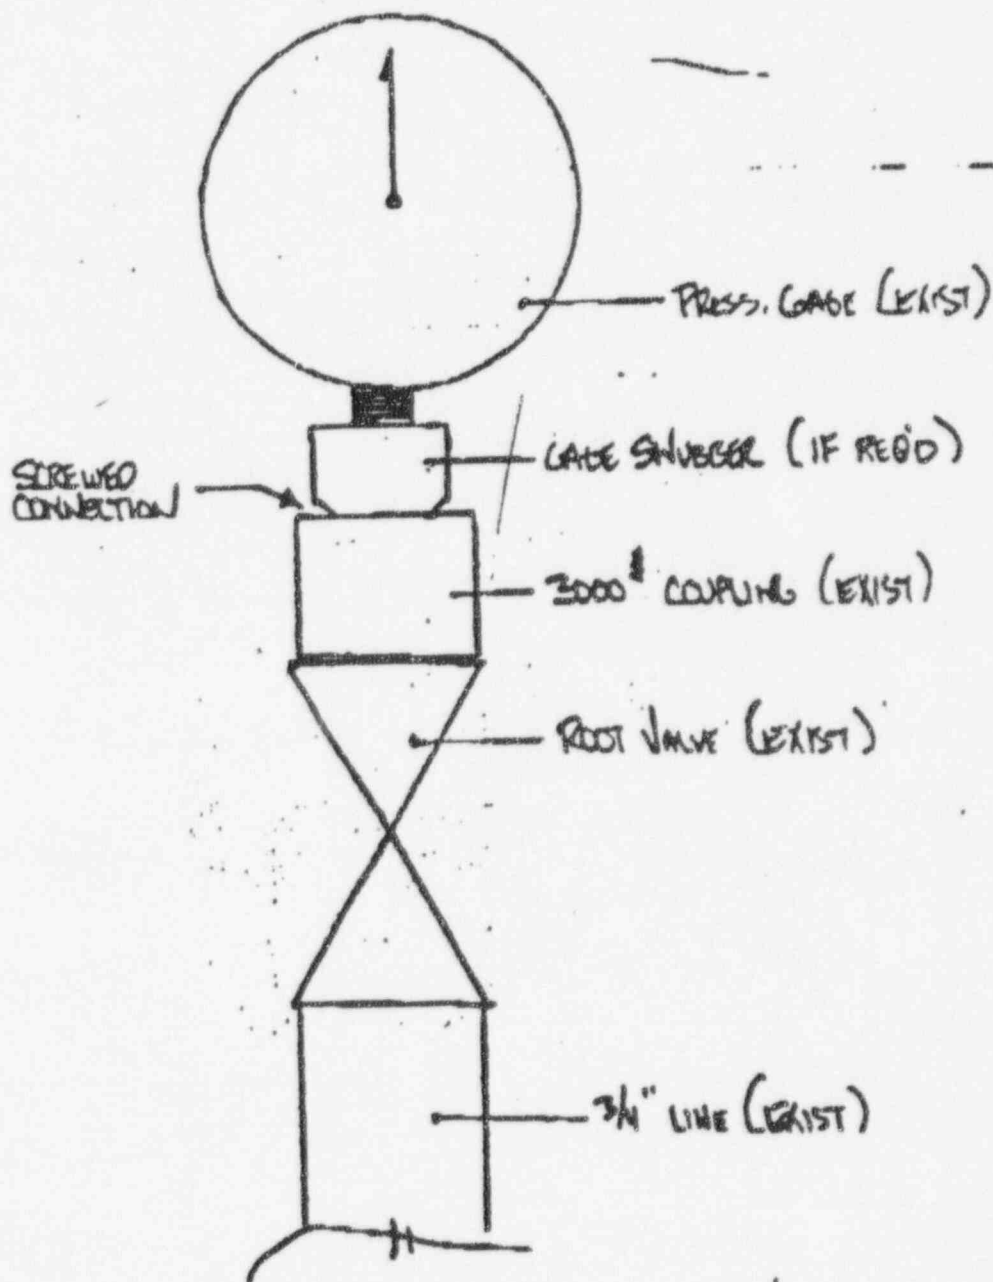
FIGURE NO. 14

The pressure gages were installed under reference 1. The pressure gages were installed using several unnecessary fittings, couplings and valves. No apparent design criteria was used. The present configuration is not in accordance with established plant design criteria. However, by engineering judgement, a postulated DBE seismic event would not result in a structural failure that would compromise the integrity of the associated piping system. It is recommended that the present configurations be modified to ensure acceptable system stresses that meet the current design standards.

The pressure gage assemblies should be modified such that the gage and snubber fitting be assembled directly to the coupling fitting adjacent to the root valve. The attached Figure No. 14 shows the proposed typical configuration for all the pressure gages with the exception of PI 3053. The configuration of PI 3052 is shown on the attached Figure No. 15.

In summary, it is recommended that the pressure gages be modified according to Figures 14 and 15. The root piping and pressure gage fittings have been evaluated in the modified condition for all applicable load cases. All calculated stresses are within the Code allowable limits as defined in ASME III, 1974 Edition and are documented in reference 2.

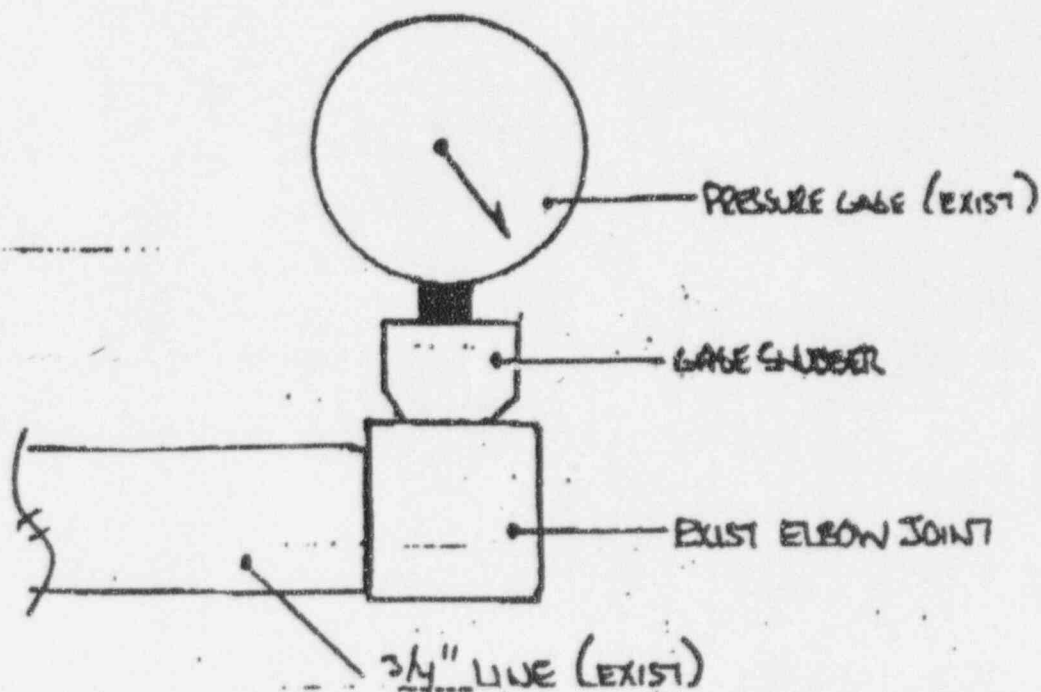
FIGURE NO. 15

PI-3053
