FAILURE ANALYSIS OF  
CAPSTAN SPRINGS  
P/N 1801613-01

METTEK REPORT  
NO. PSC130911

September 14, 1983  
METTEK Report  
No. #PSC130911

SHOCK ARRESTOR CAPSTAN SPRING SERVICE REPORT

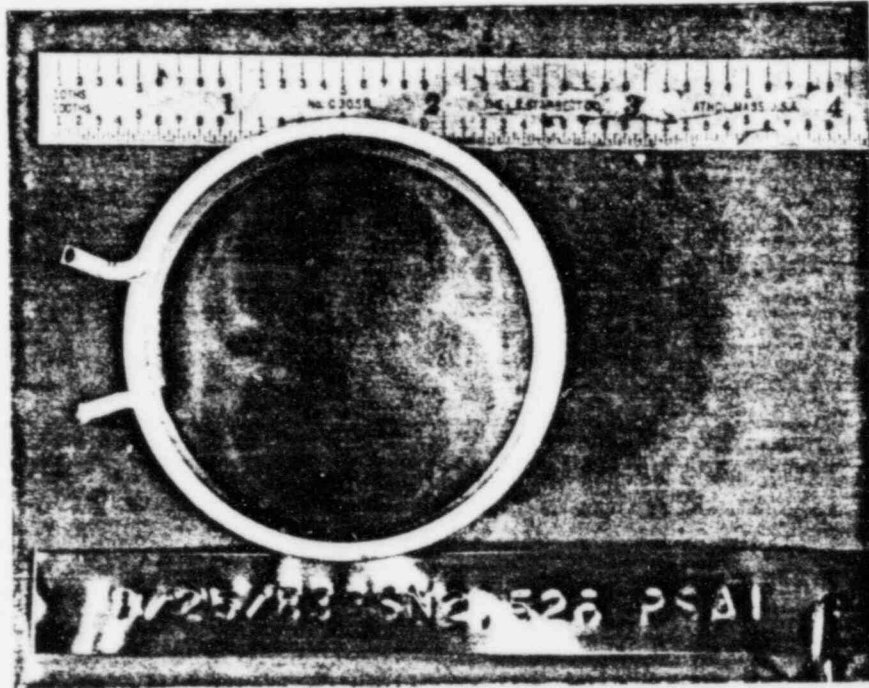
Figures 1-8 illustrate the S/N 21526 spring and the burnish marks on the inside face of the tang just above the formed radius. Visual examination under 40X binocular microscope did not reveal any cracks in this spring. The burnish marks are caused by rubbing against the spring enclosure during cycling of the spring. The microsection prepared through one of the two tangs did not reveal any incipient cracks. A hardness survey was conducted on this spring and the results are shown in Table I. This shows that the core hardness was about HRC 43-46 while near the surface of the formed radius the hardness was HRC 46-50. This converts to an approximated tensile range of 220 to 260ksi. Figure 4 shows the surface of the tang on the back side or unloaded side. No burnish marks are present.

FIGURE 1. Spring S/N 21526.

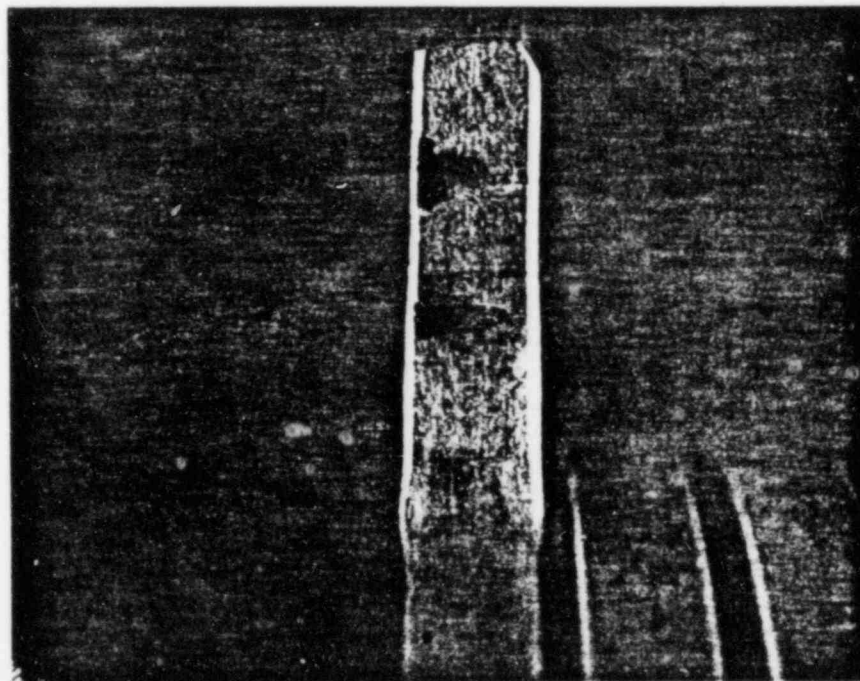
FIGURE 2. Inside face of tang S/N 21526.

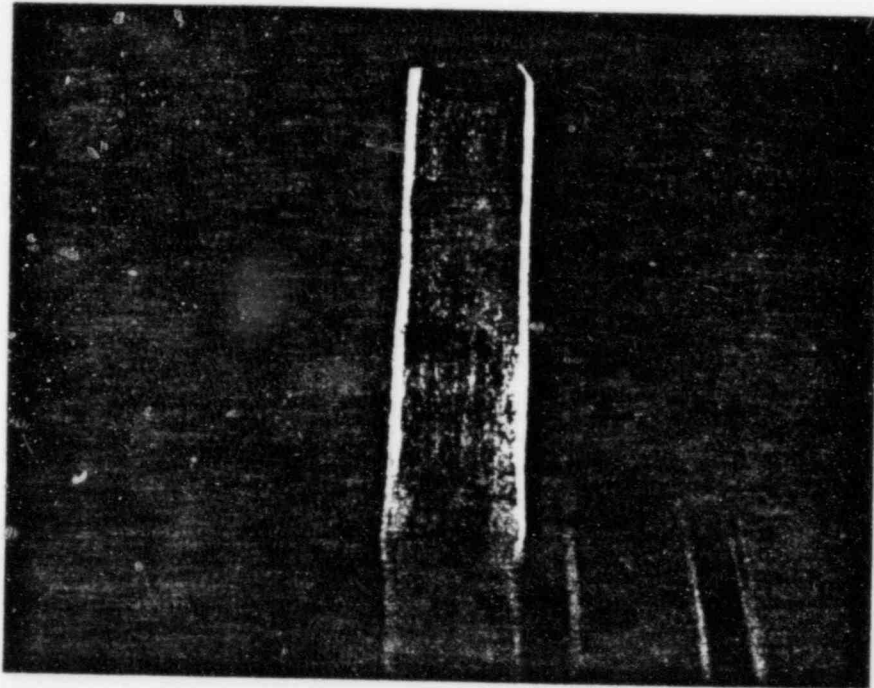
FIGURE 3. Inside face of tang S/N 21526.

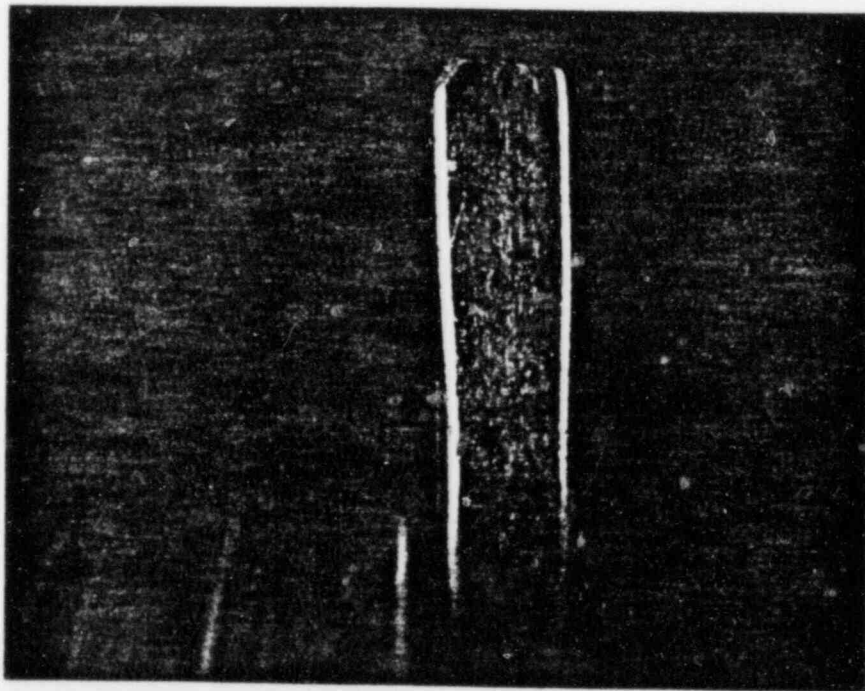
FIGURE 4. Outside face of tang S/N21526.

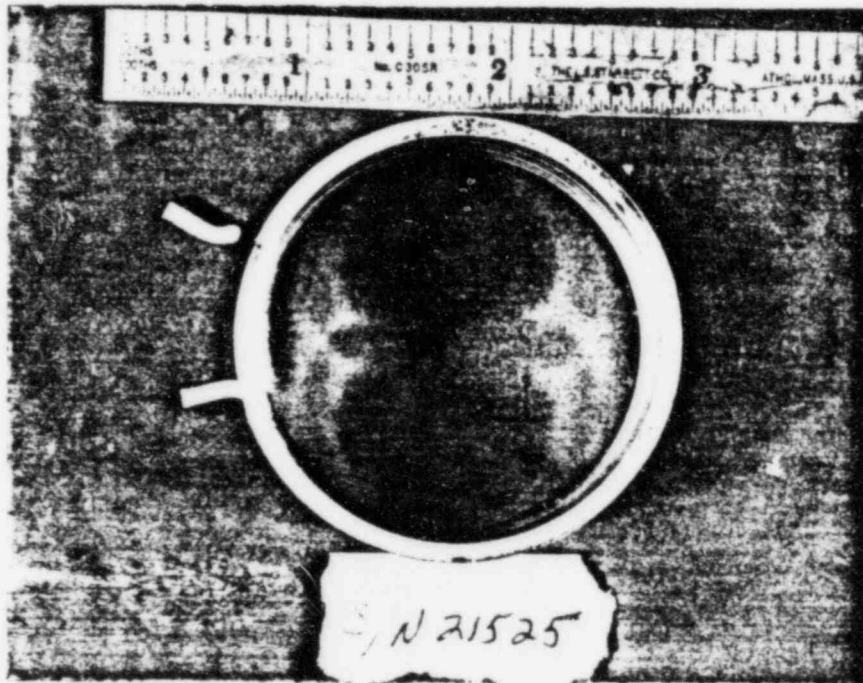
Figure 5 illustrates the spring and the broken tang. Figure 6 illustrates the fracture face of this broken tang. Examination of the fracture face revealed two distinct zones A and B. In zone A near the formed radius the fracture mode was brittle in appearance while in zone B the fracture mode was dimple rupture. In addition the fracture face in zone A was tinted or discolored relative to zone B which was bright and clean. This indicates that zone A was a prior incipient crack. Dot pattern and line scans for Ag were conducted coincident with the edge at zone A. These show slight traces of Ag on the edge of the fracture. A microsection was prepared  $90^{\circ}$  to this fracture. Figure 11 shows the cross section and zone A is indicated. Figure 12 shows a trace of Ag over the edge of the fracture. This is indicative of a crack which formed either prior to or during Ag plating.

FIGURE 5. Spring as-received S/N21525.

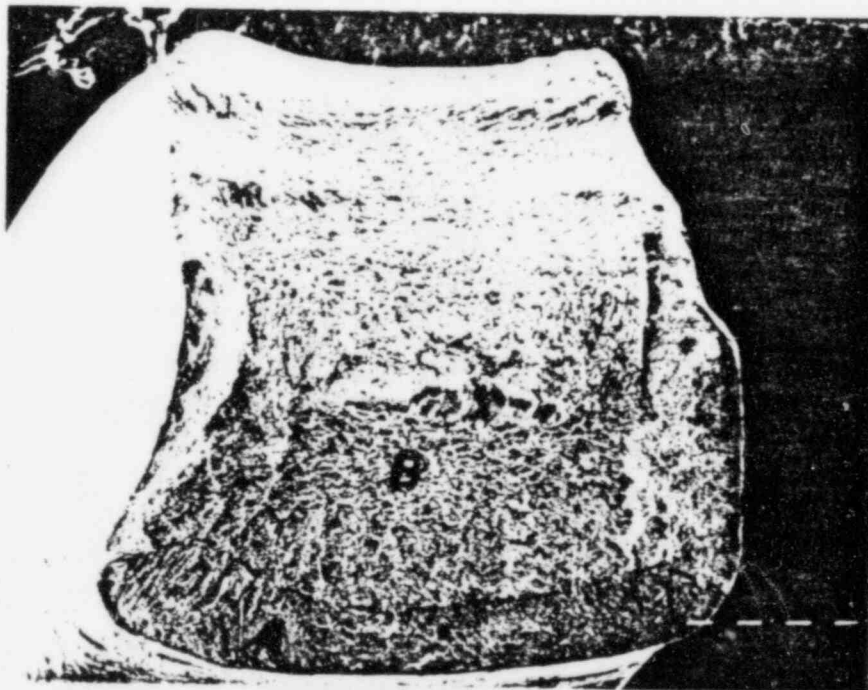
FIGURE 6. Fracture face of tang S/N 21525. 30X

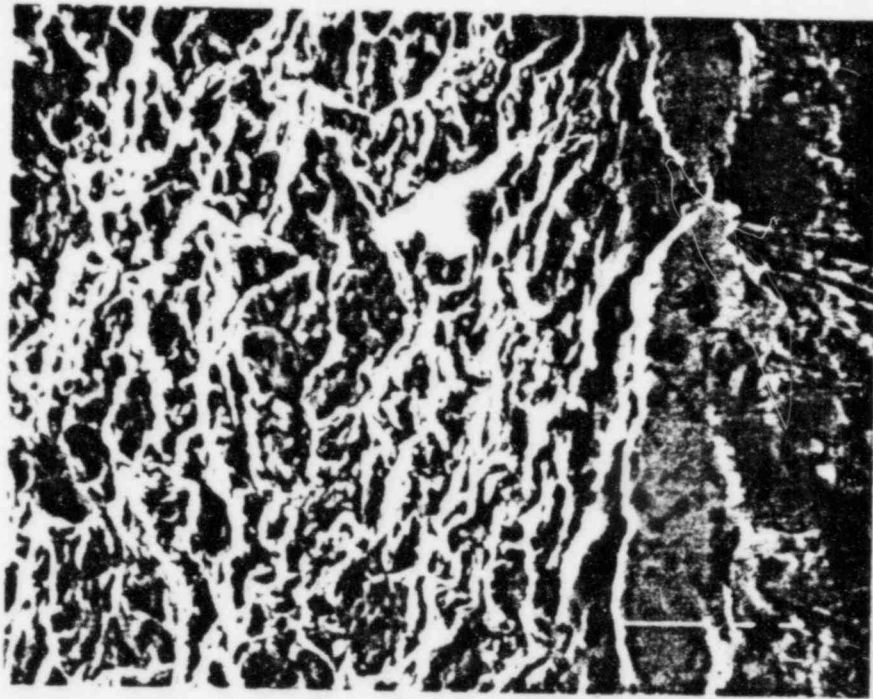
FIGURE 7. Fracture of edge Figure 6. 1000X

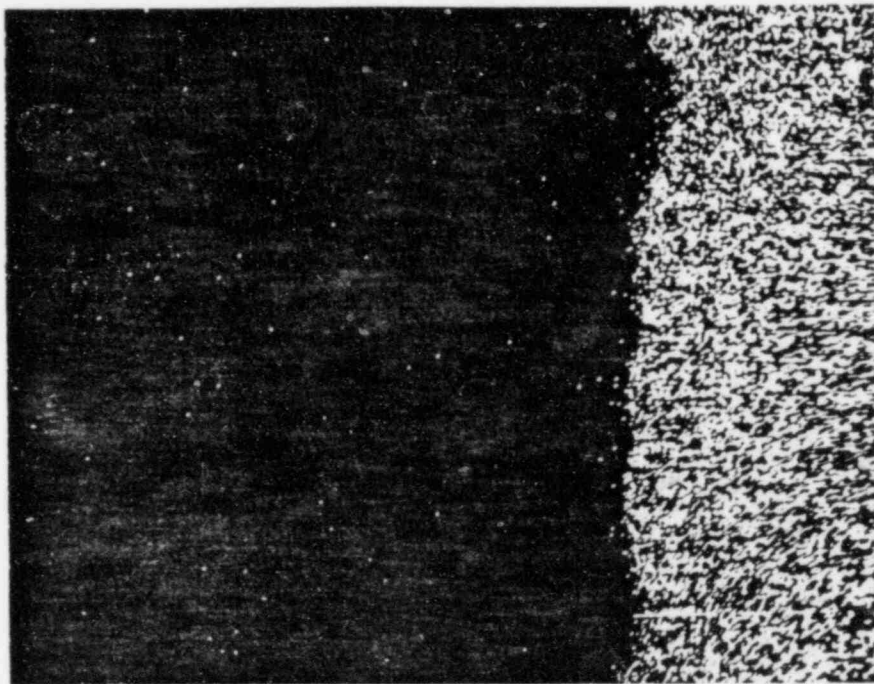
FIGURE 9. Dot pattern scan for Ag at edge. 1000X

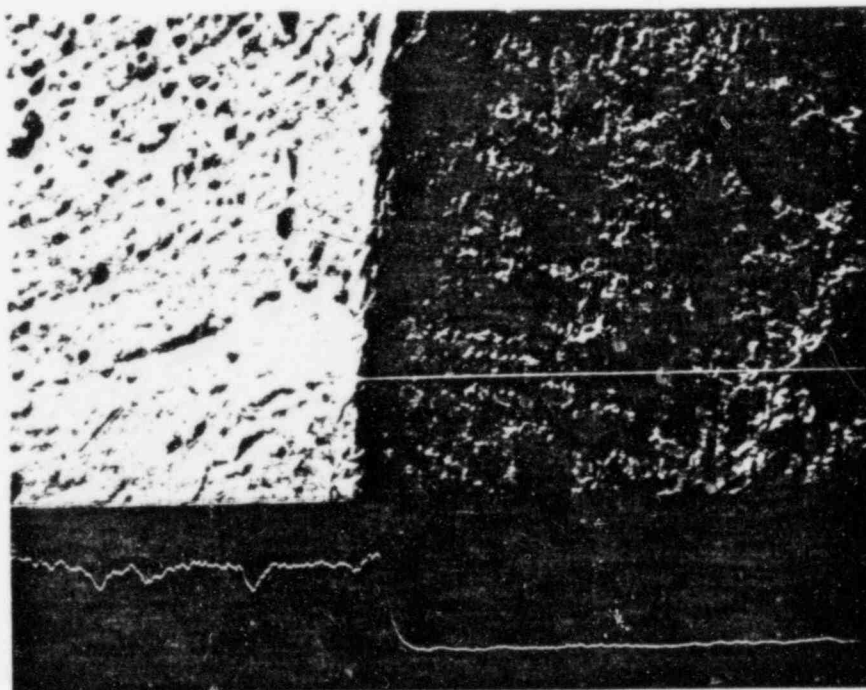
FIGURE 10. Line scan for Ag at edge. 200X

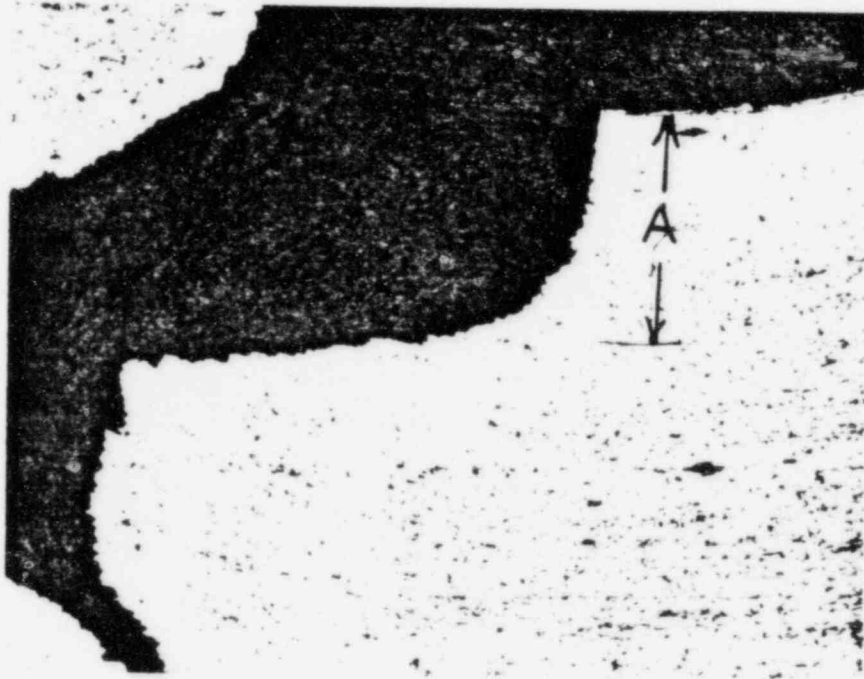
FIGURE 11. Cross section of fracture (Figure 6). 50X

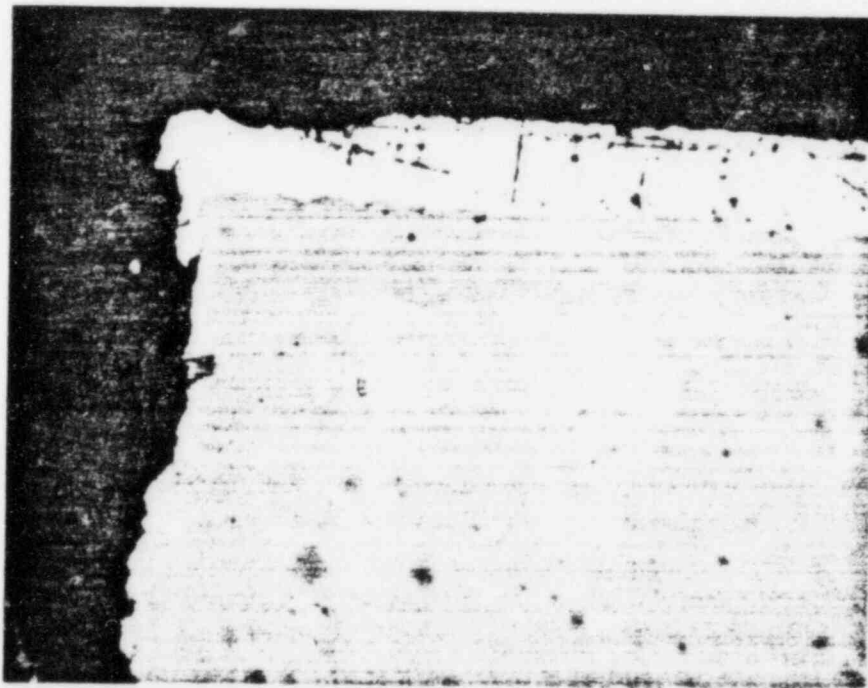
FIGURE 12. Cross section of fracture (Figure 6). 1000X

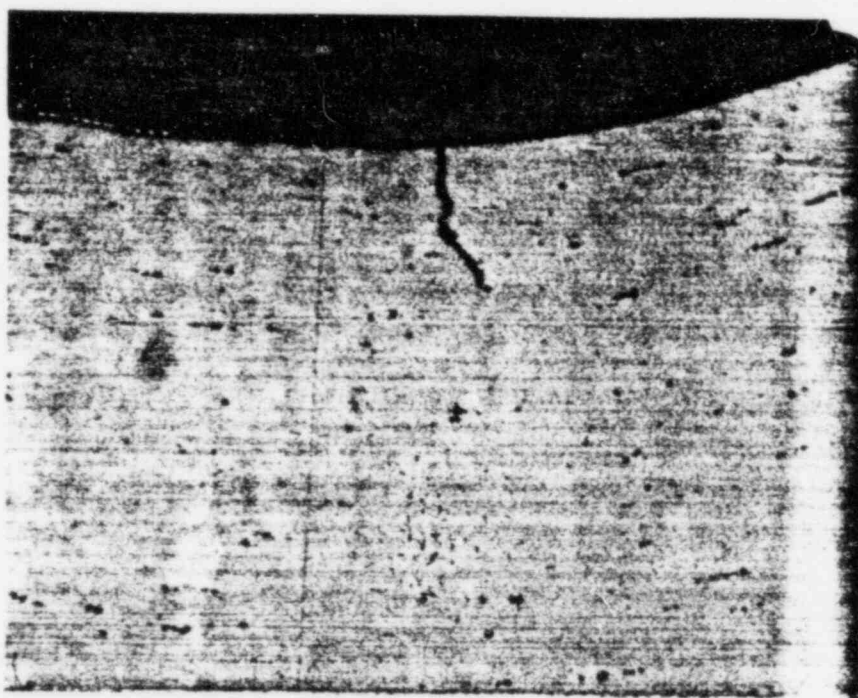
A microsection was prepared of the opposite tang which contained a partial crack. This crack is shown in Figures 13-16. The crack is relatively shallow, approximately .0075" deep at this location. The crack depth of zone A on the opposite tang was approximately .010-.020".

FIGURE 13. Cross section of incipient crack on the opposite tang S/N 21525. 100X

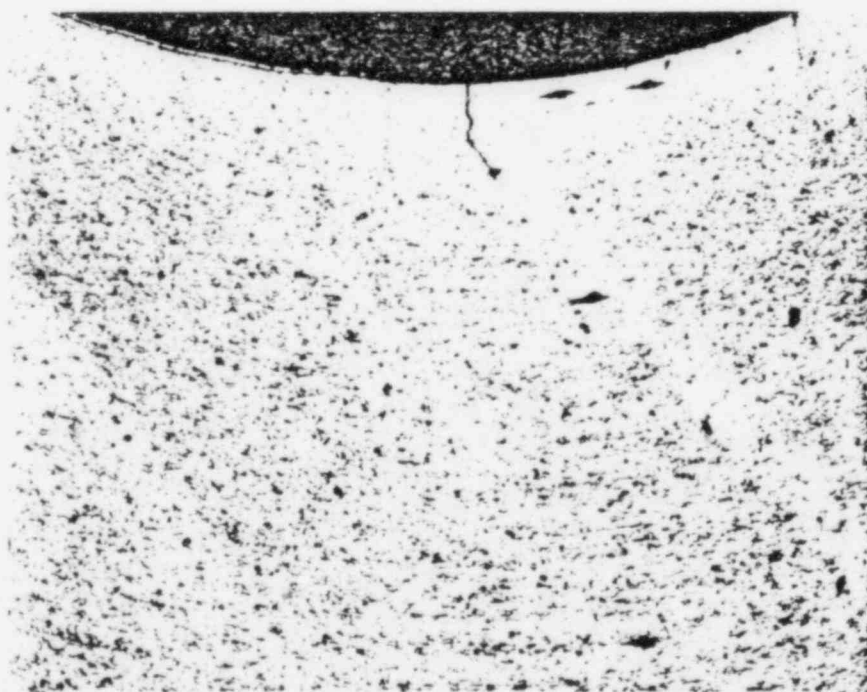
FIGURE 14. Cross section of incipient crack on the opppsite tang S/N 21525. 50X

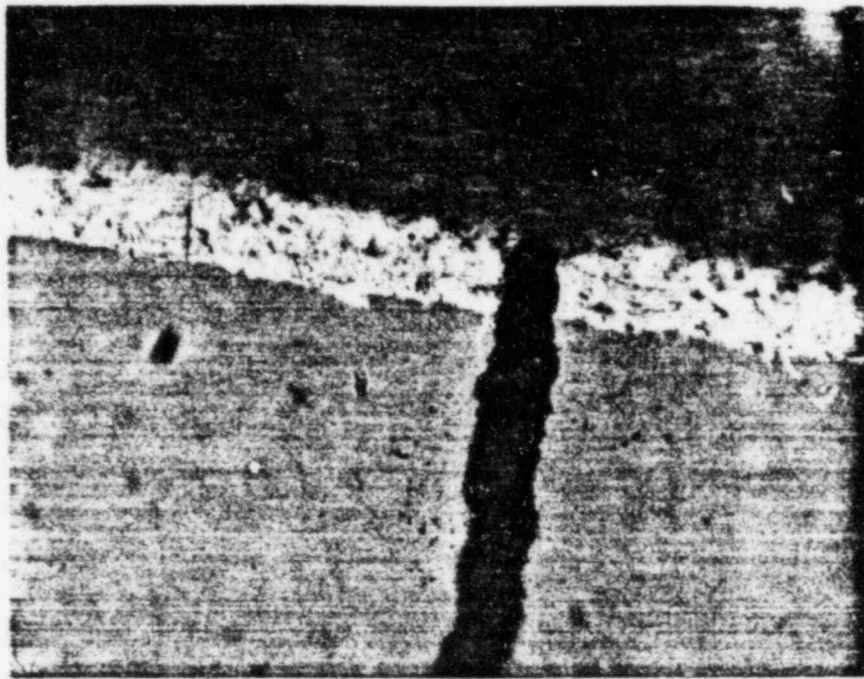
FIGURE 15. Crack shown in Figures 13 and 14. 1000X

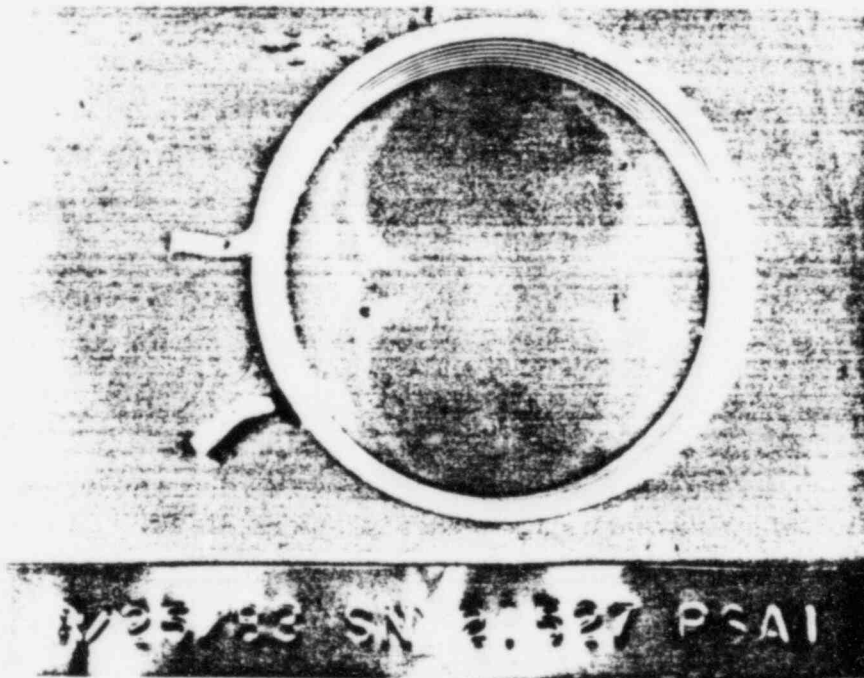
Figure 16 shows spring S/N 21527. This spring had one broken tang and one cracked tang. Figure 17 shows the broken tang. The burnish wear marks are apparent on the inside face. Figure 18 shows the fracture face and third wear burnish mark adjacent to the fracture (Figure 19). The fracture face is shown in Figures 20 and 21. In zone A the fracture face was tinted or discolored relative to zone B. A scan for Ag was conducted along the edge in zone A. The results are shown in Figures 22-24. There is a trace of Ag smeared over the edge of the fracture. The fracture mode, although not pure cleavage or intergranular, appears to be brittle in nature and does show the presence of secondary intergranular cracking. By comparison the fracture mode shown in zone B, Figure 27, is typical dimple rupture.

FIGURE 16. Spring S/N 21527 as-received.

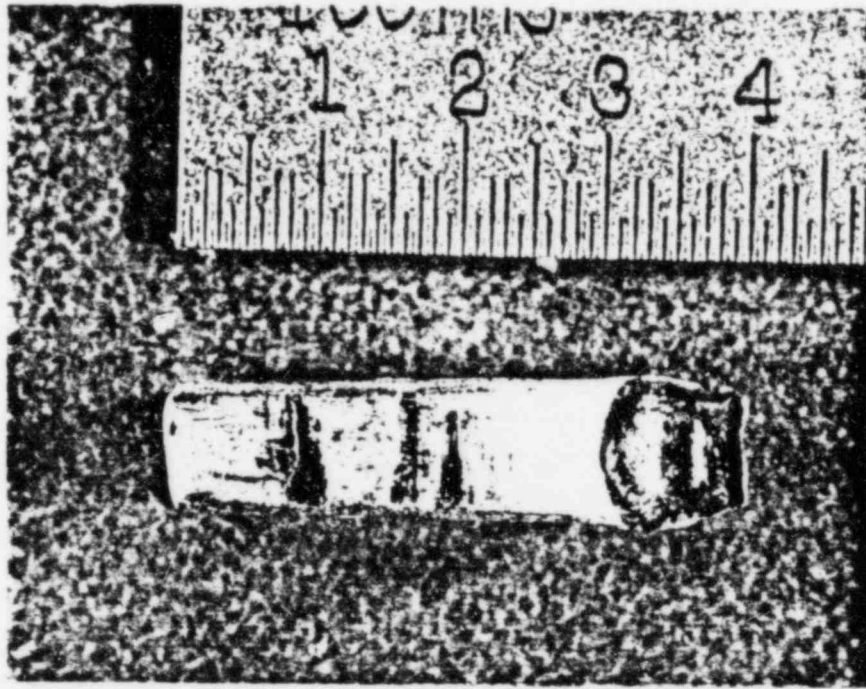
FIGURE 17. Broken tang S/N 21527.

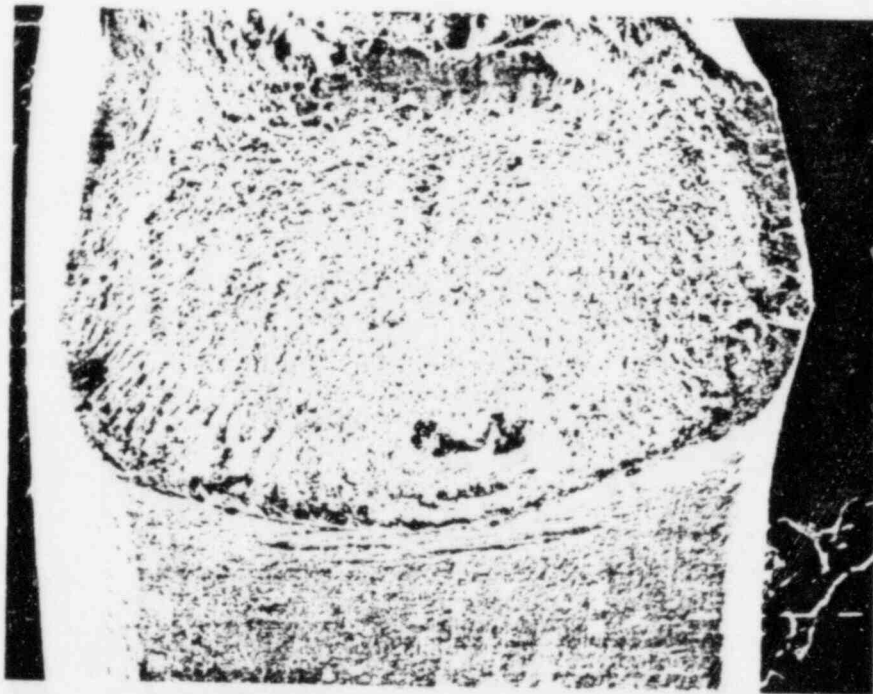
FIGURE 18. Fracture face of tang. 35X

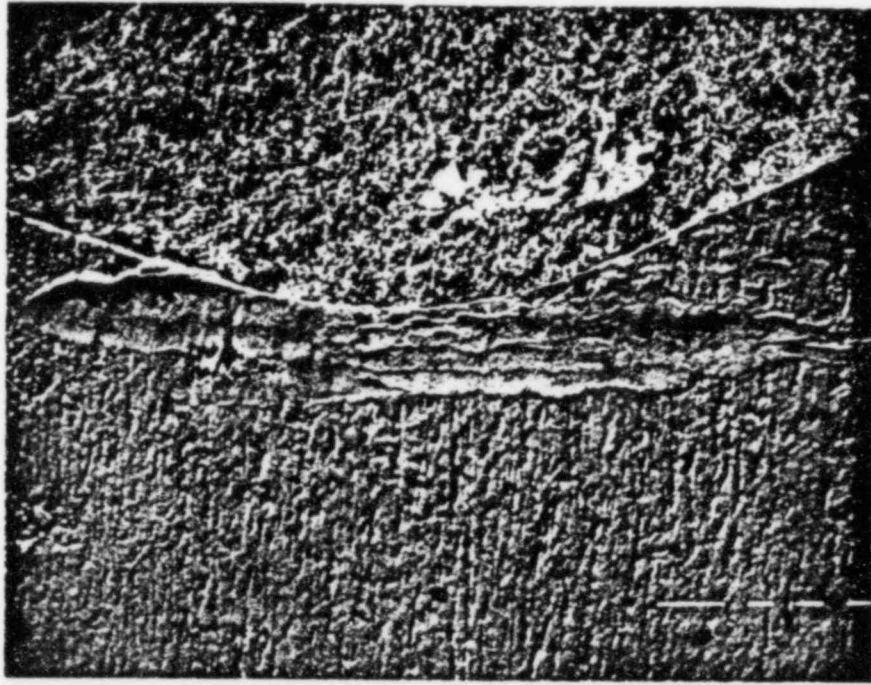
FIGURE 19. Fracture face and edge of tang. 80X

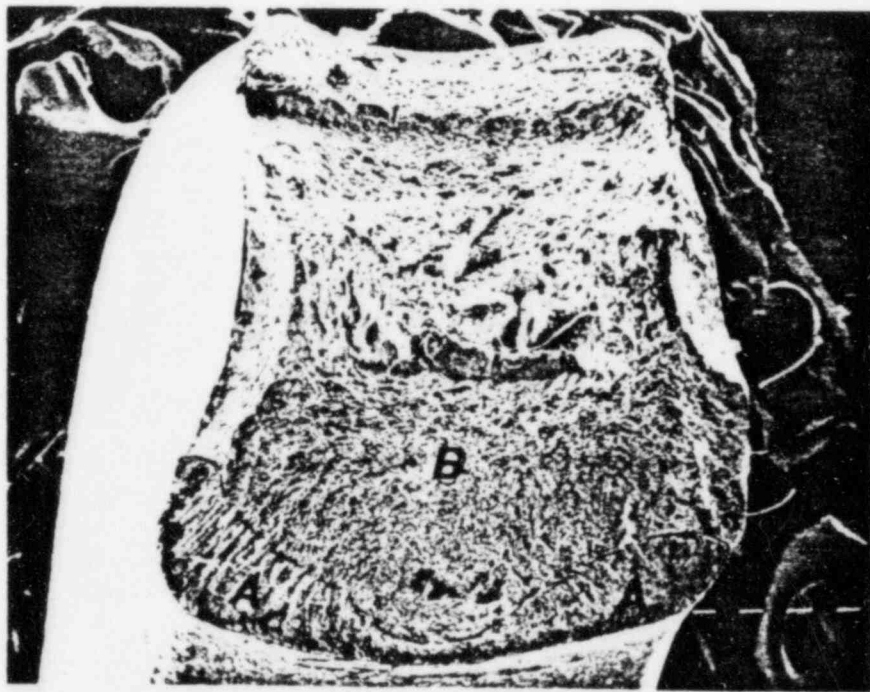
FIGURE 20. Fracture face of tang. 30X

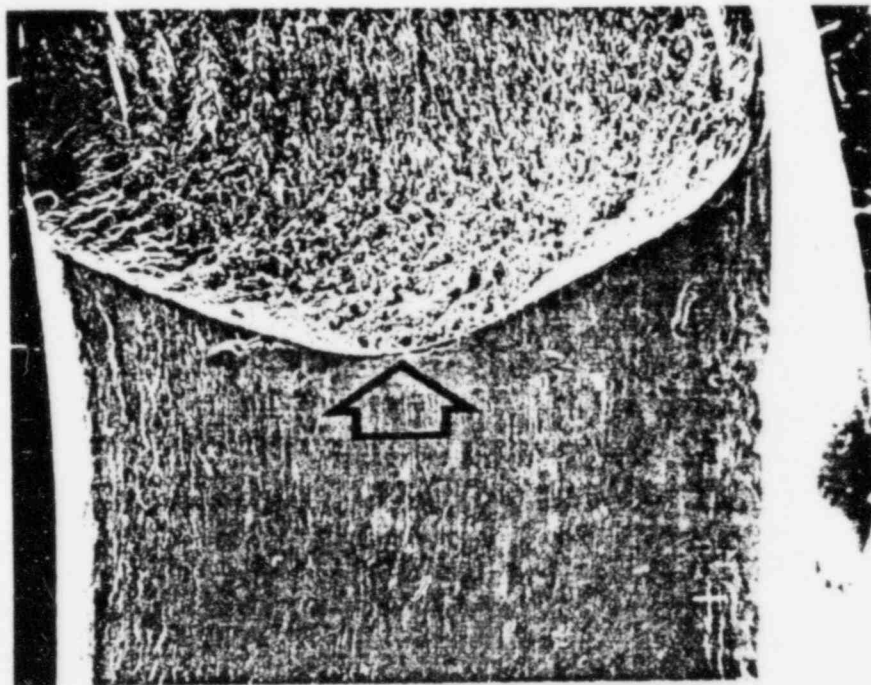
FIGURE 21. Fracture face coincident with radius of tang. 35X

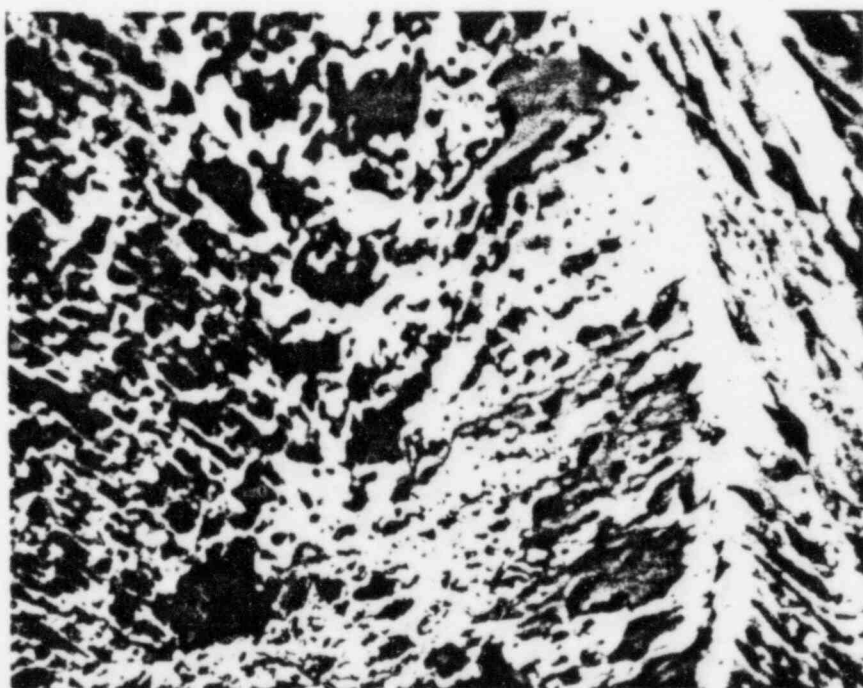
FIGURE 22. Edge of fracture (arrow Figure 21). 350X

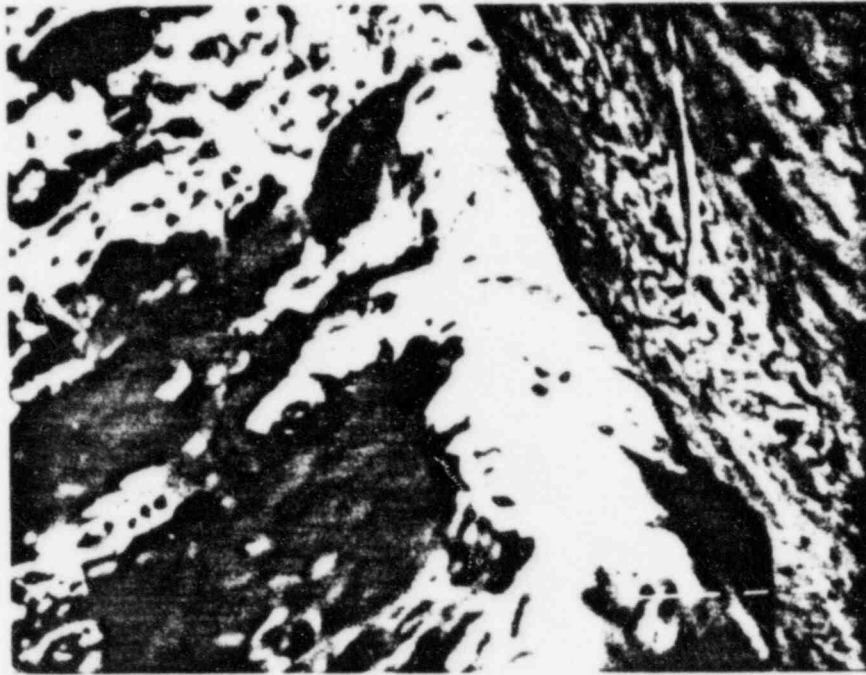
FIGURE 23. Edge of fracture (arrow Figure 21). 1100X

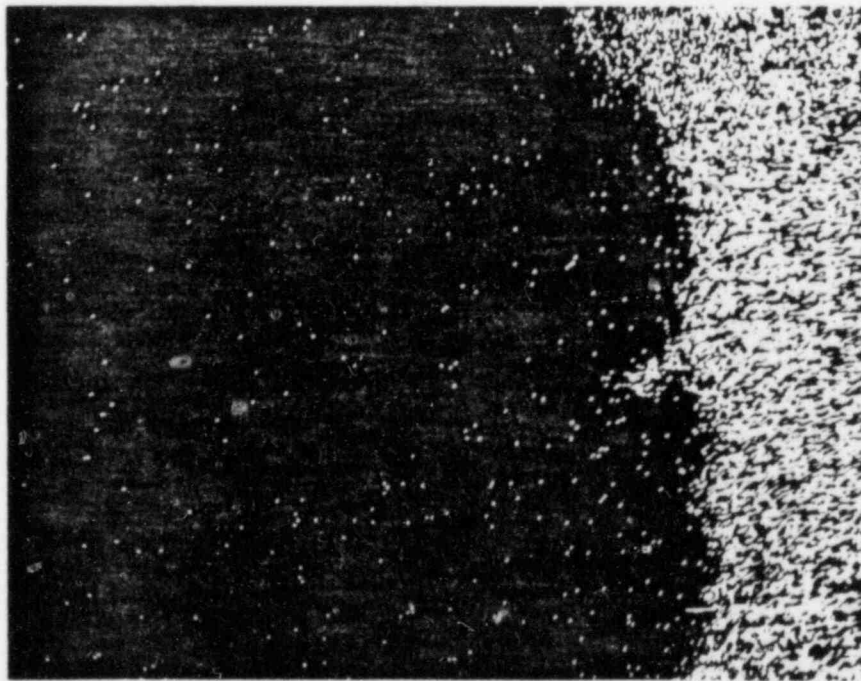
FIGURE 24. Dot pattern scan for Ag Figure 22. 350X

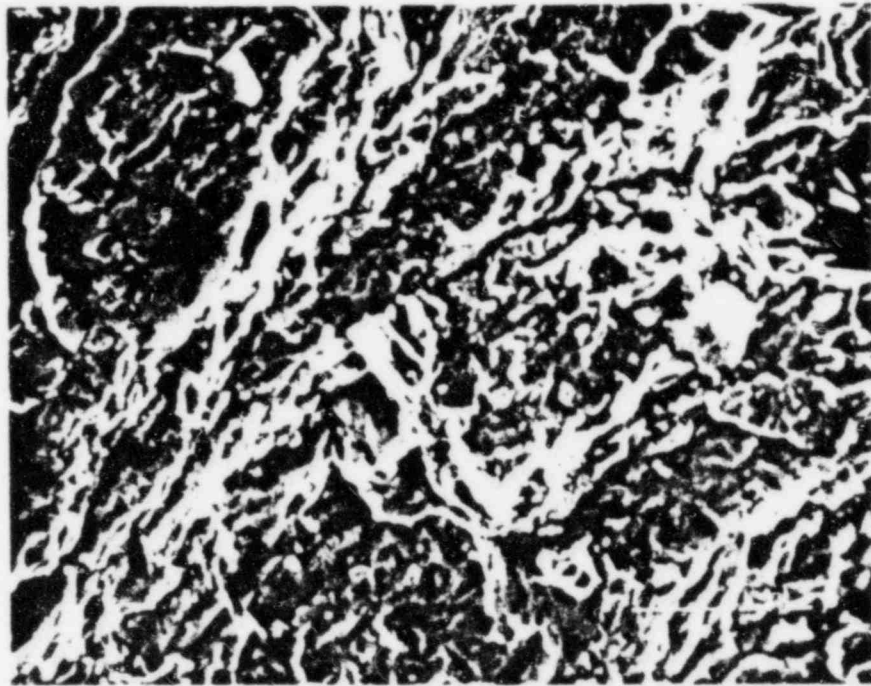
FIGURE 25. Fracture mode zone A Figure 20. 1000X

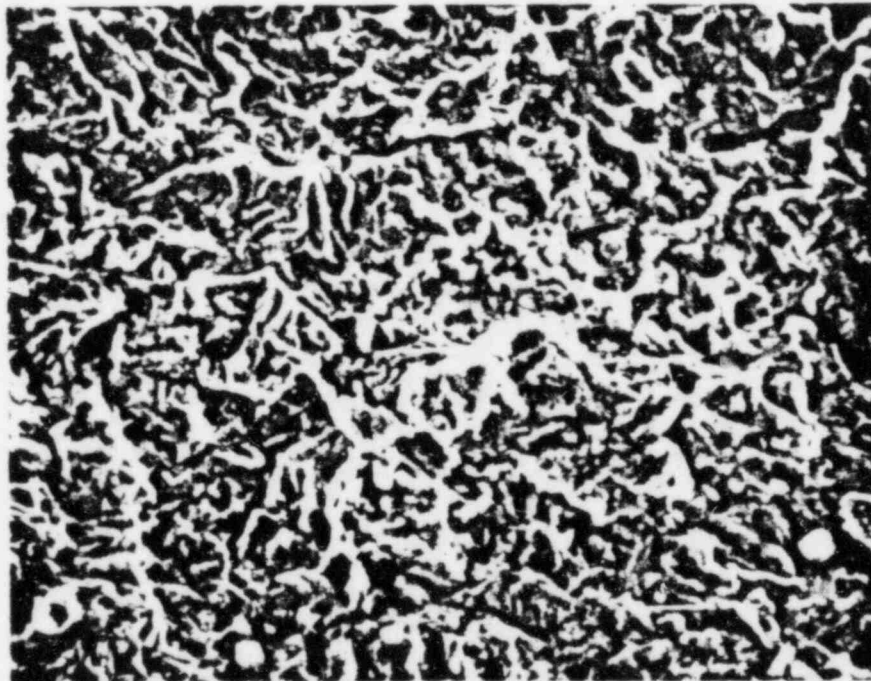
FIGURE 26. Fracture mode zone A, Figure 20. 1000X

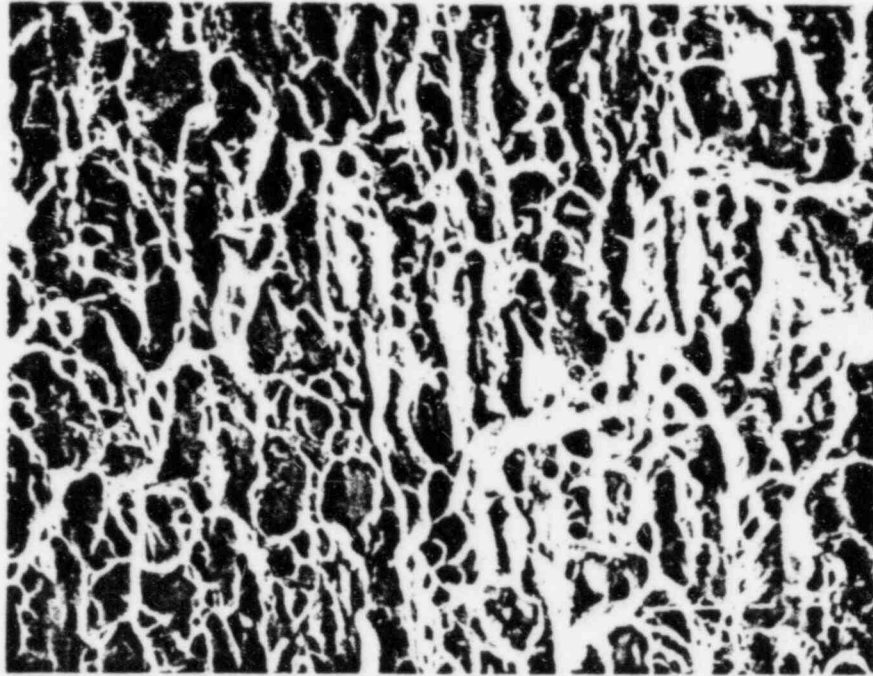
FIGURE 27. Fracture mode zone B, Figure 20. 1000X

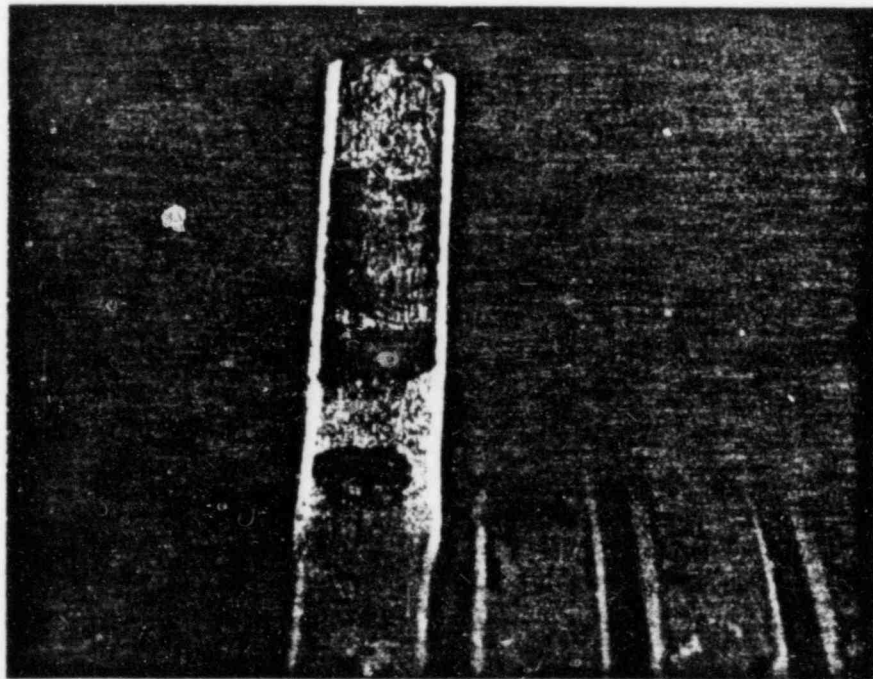
Figures 28-30 illustrate the opposite cracked tang. The burnish marks are apparent. On this tang there were burnish marks on the back side of the tang (Figure 30). It is believed that these were caused after the tang at the opposite end of the spring failed. Figure 31 shows the profile of the incipient crack at the formed radius is very similar to that found on the broken tang. When this portion of this profile the tang was broken open the fracture face at this crack was exposed. This crack is shown as

FIGURE 28. Inside face of tang S/N 21527.

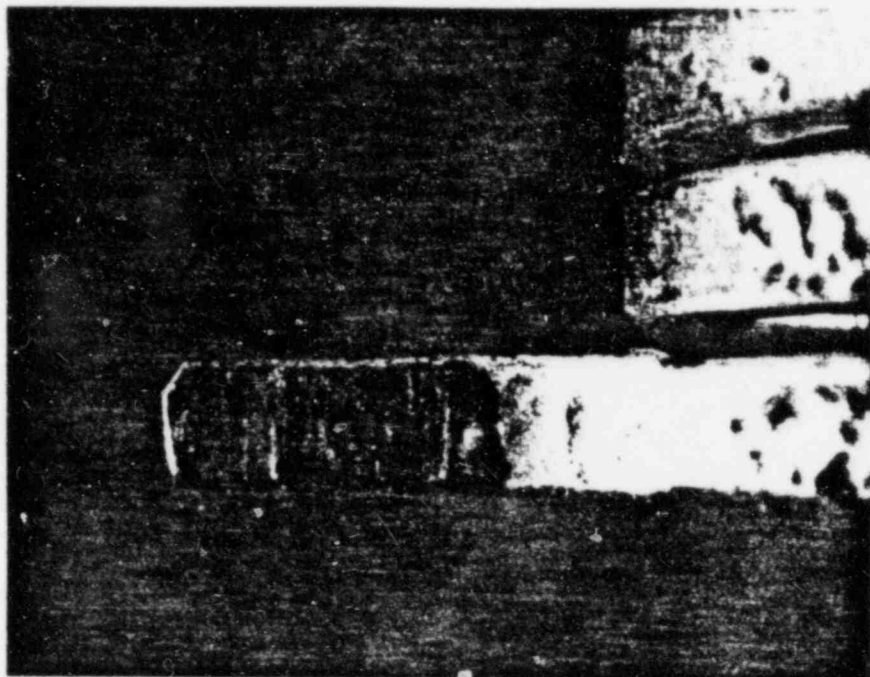
FIGURE 29. Inside face of tang S/N 21527.

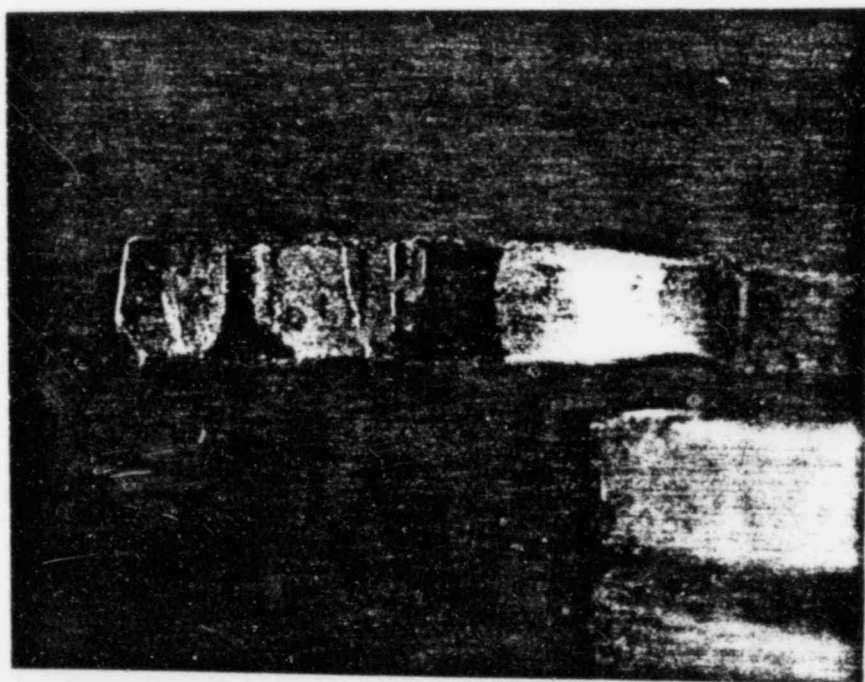
FIGURE 30. Back face of tang shown in Figure 28.

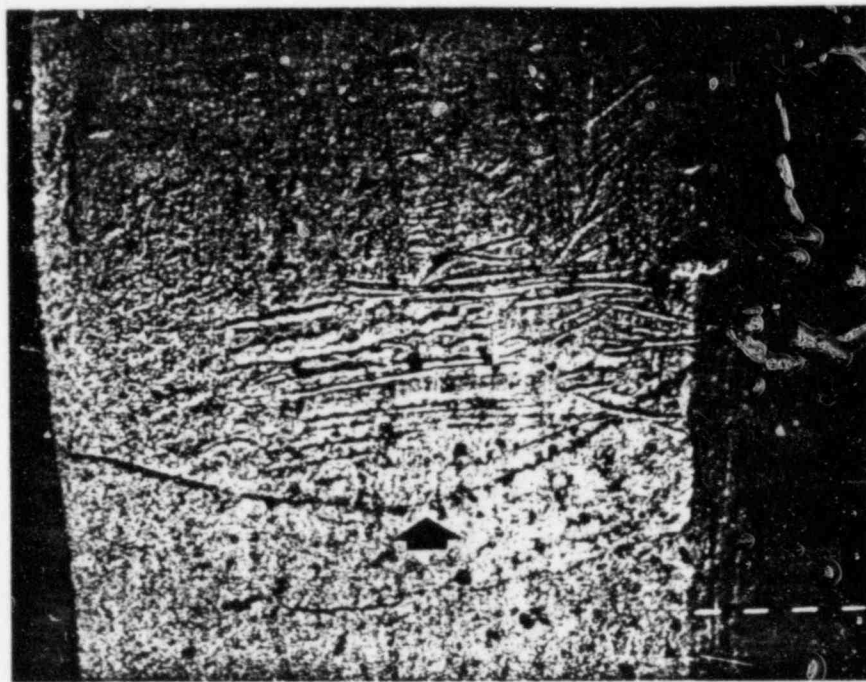
FIGURE 31. Crack at radius of tang. 35X

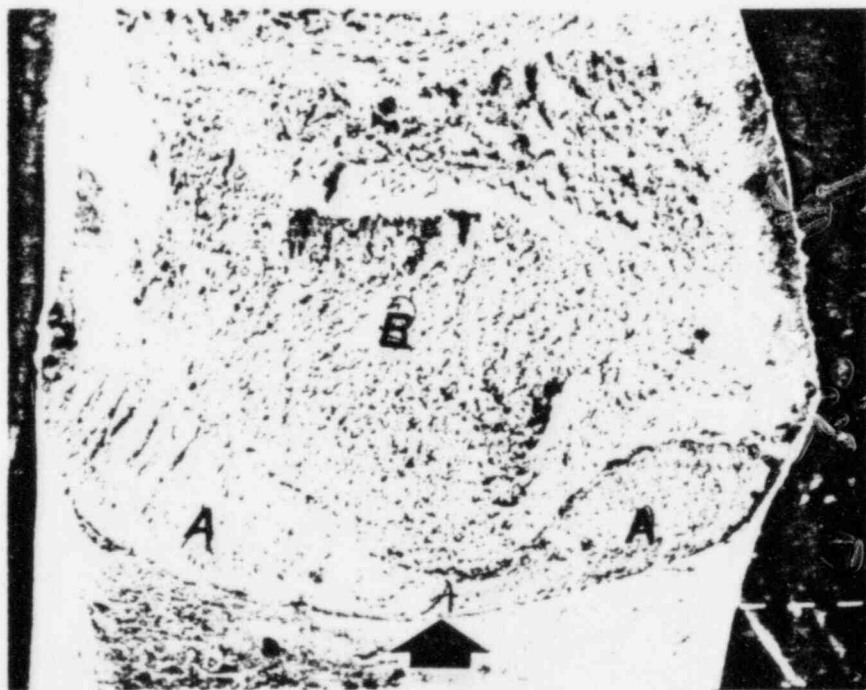
zone A Figure 32. Zone B represents the portion of the section which was mechanically broken in the lab. Zone A was tinted a yellowish color relative to zone B. A line scan for Ag was conducted in the central area of zone A and the results are shown in Figures 33 and 34. This shows the presence of Ag on the edge of the fracture face. The fracture mode in zone A is illustrated in Figures 35 and 36 while the fracture mode in zone B is shown in Figure 37. The brittle nature in zone A relative to zone B is again apparent. In addition the appearance is similar to the fracture mode found on the broken tang.

FIGURE 32. Fracture face of crack (Figure 31). 30X

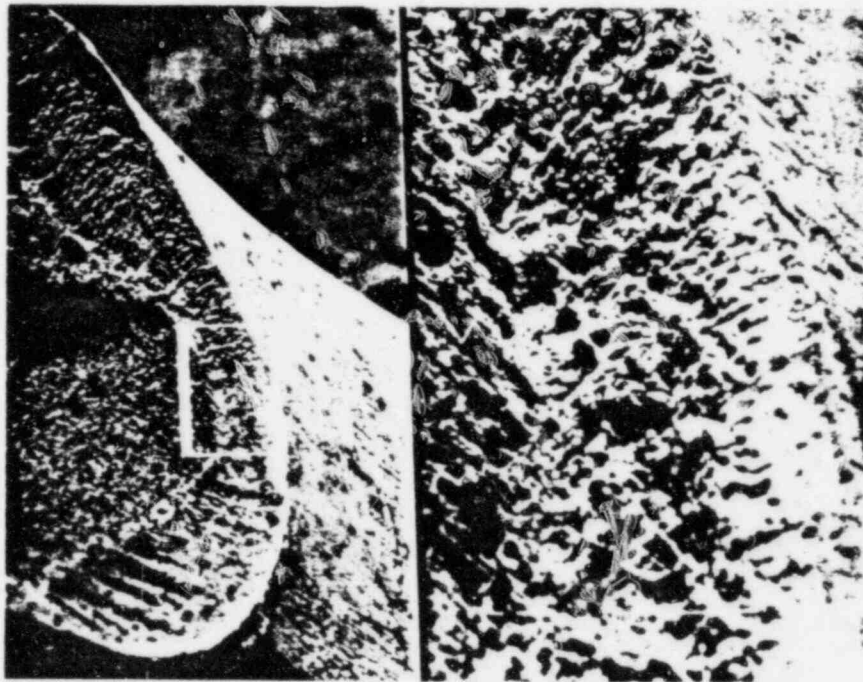
FIGURE 33. Edge of fracture (arrow Figure 32). 40X/200X

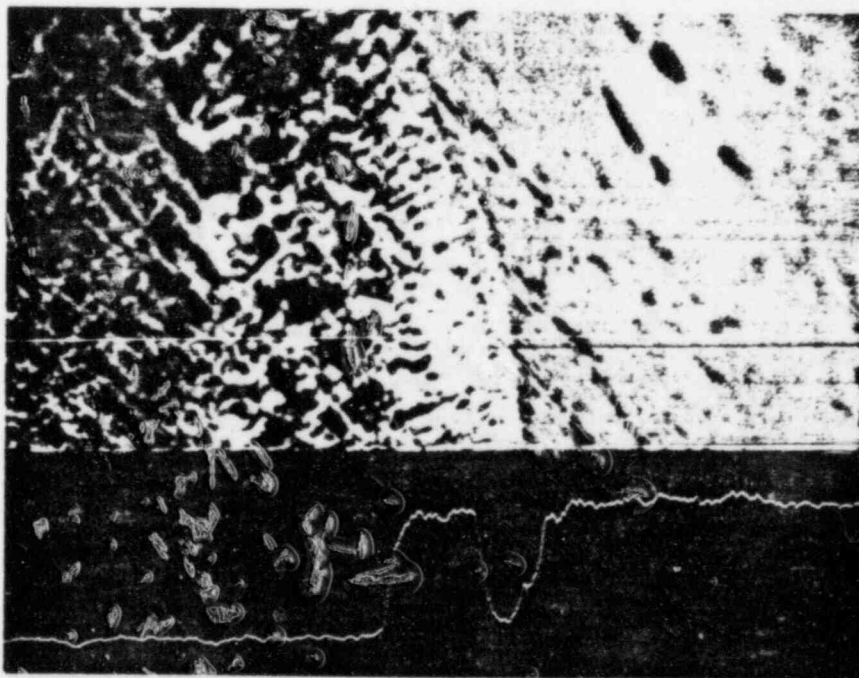
FIGURE 34. Line scan for Ag at edge. 200X

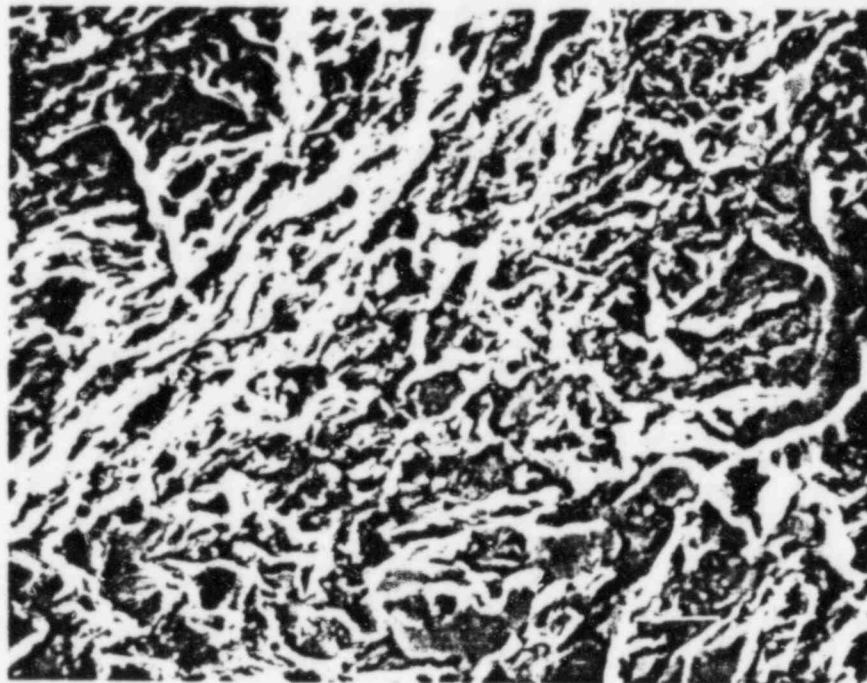
FIGURE 35. Fracture mode zone A, Figure 32. 1000X

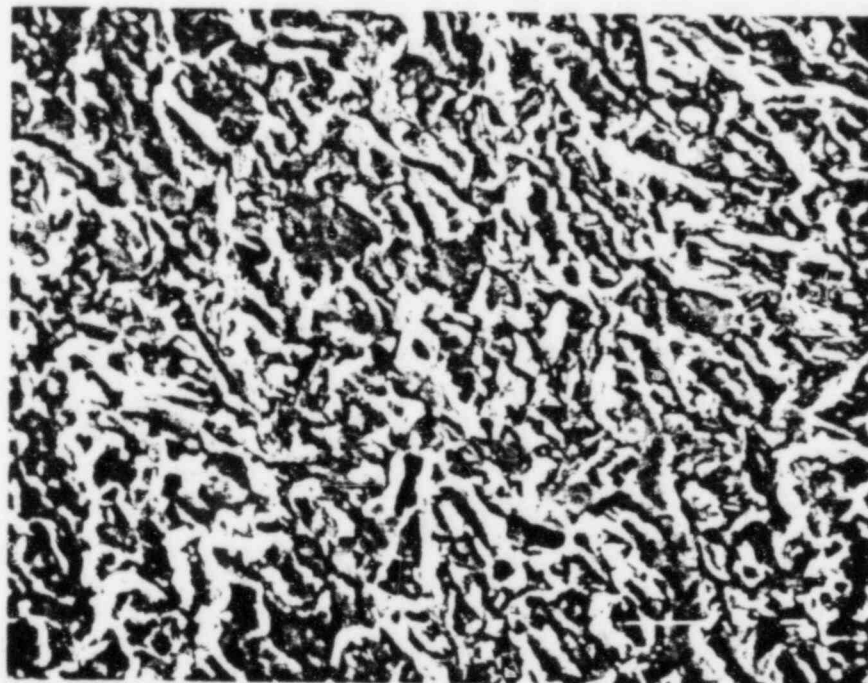
FIGURE 36. Fracture mode zone A, Figure 32. 1000X

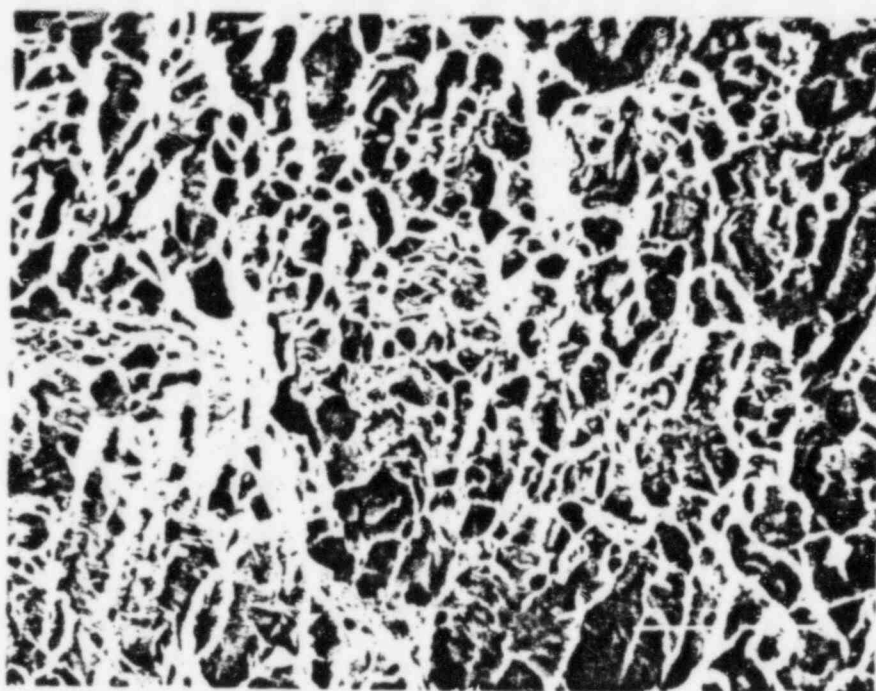
FIGURE 37. Fracture mode zone B, Figure 32. 1000X
