Beaver Valley Power Station, Unit No. 1
Docket No. 50-334, Licensee No. DPR-66
LER 95-002-00

LER 95-002-00, 10 CFR 50.73.a.2.i.B, Condition Prohibited by Technical Specifications-"Safety Related 480 Volt Bus Found Seismically Unqualified".

Safety Related 480 Volt Bus Found Seismically Unqualified

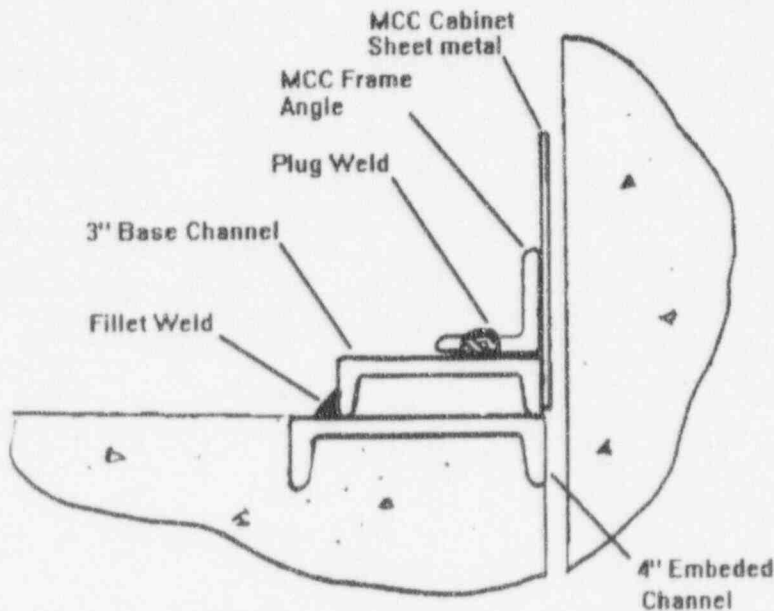
**DESIGN DETAIL**

The designed mounting system at the base of the MCC consists of two steel channels welded together by an intermittent (stitch) fillet weld. A four inch steel "C" channel with the open side facing downward is imbedded in the concrete base. A three inch steel "C" base channel is welded on top of the four inch channel with the fillet weld. The MCC frame angle is welded to the base channel and secures the MCC to the base structure as shown below.
