TRANSFORMER REPORT
ON
EVENTS AT NORTH ANNA POWER STATION

June 16, 1983

POWER TRANSFORMER DIVISION
WESTINGHOUSE ELECTRIC CORPORATION
GREENTREE, PA 15220

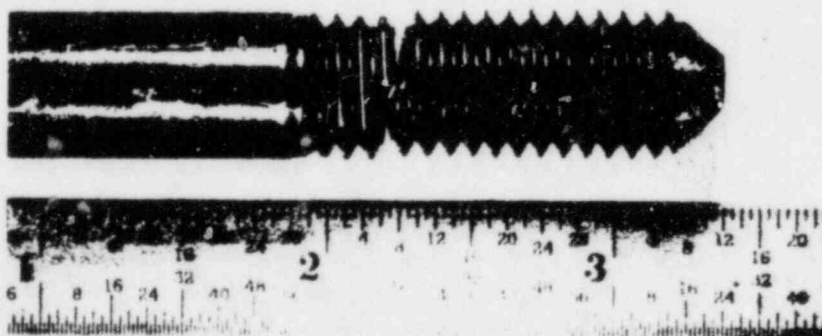
Mag. 1.5X

Figure 3. General view of the broken cap screw.

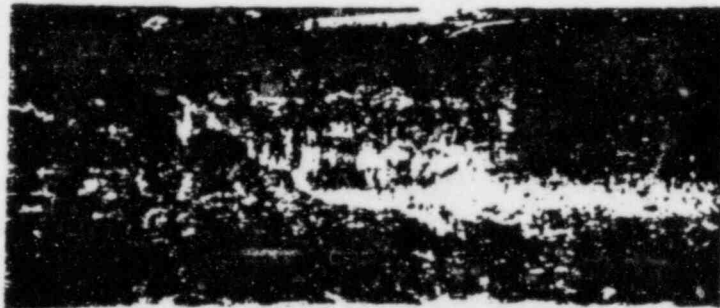
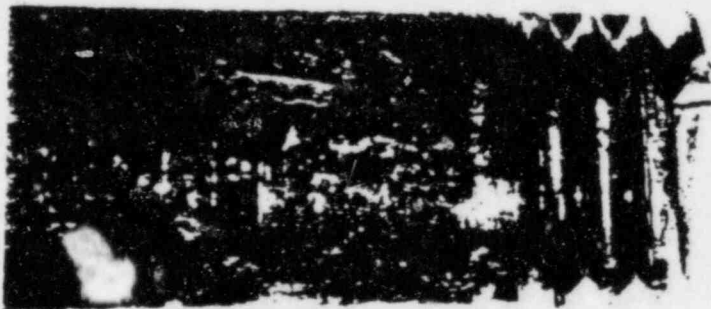
Figure 4. Details from Fig. 3. Note the wear marks under the head and in the middle of the screw. This side of the screw is located 180° from the main fracture origins (see Fig. 9). The indentations visible in the bottom photograph were produced in the hardness tests.

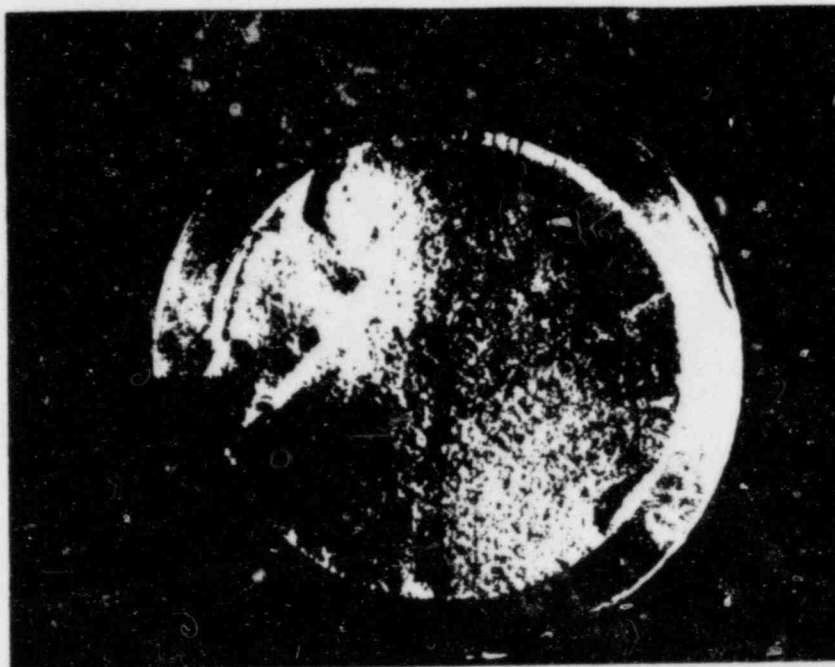
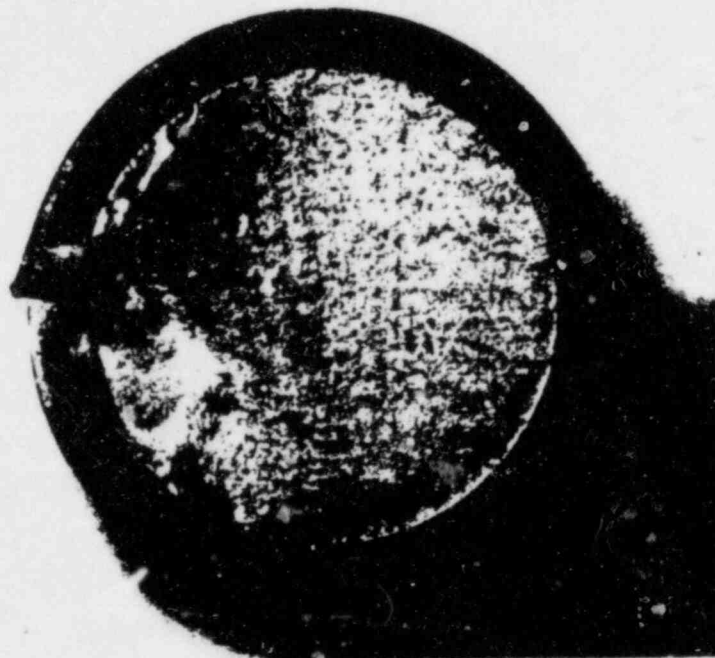
Figure 7. Fracture face on the head side (upper photograph) and on the thread side (lower photograph). Note the "beach marks" characteristic of fatigue.

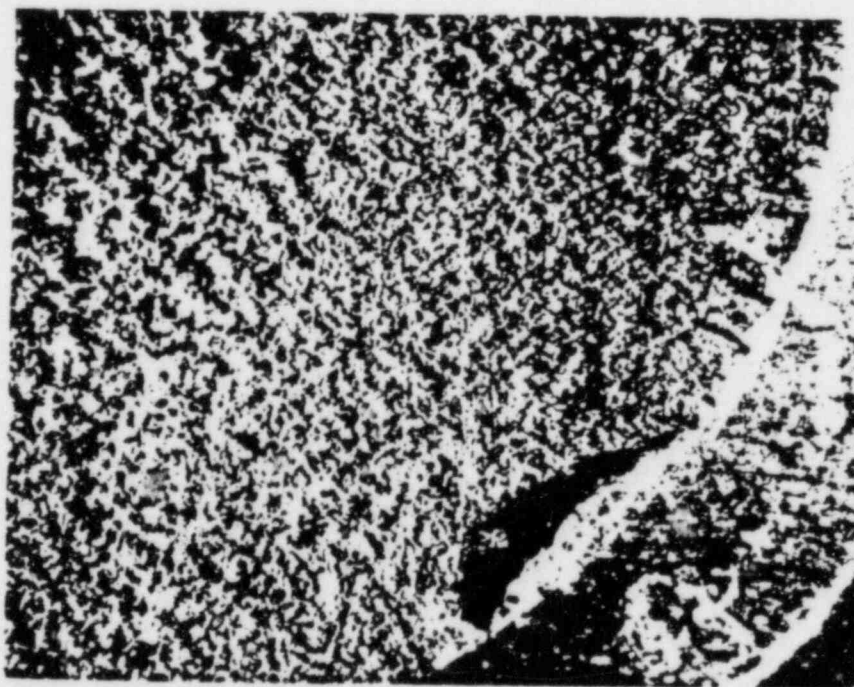
Figure 8. Details of the main origin areas of the fracture. The fracture had multiple origins located at the root of the thread visible on the right hand side of the photographs. Note also the beach marks.

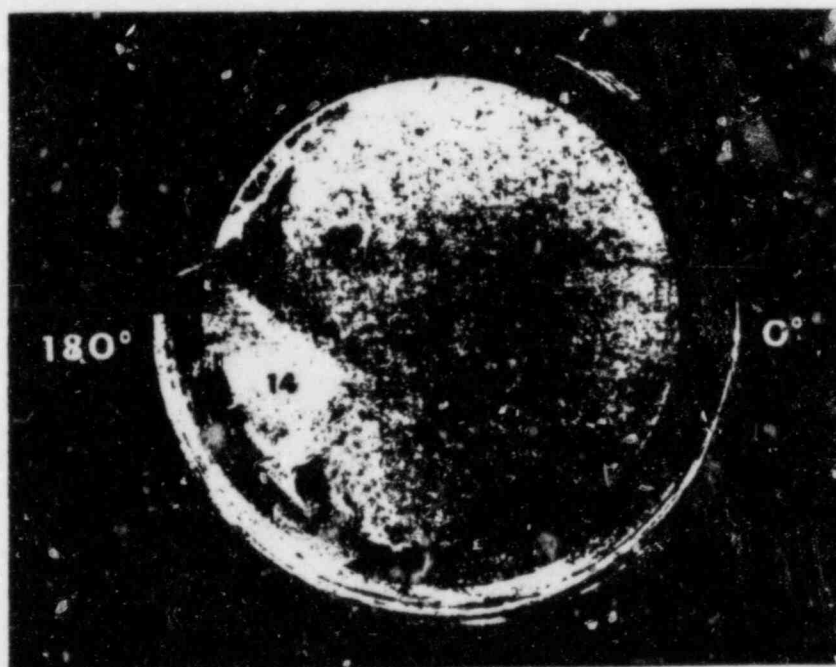
Figure 9. Fracture face on the thread side. The area numbers refer to the photograph numbers in the SEM fractography.

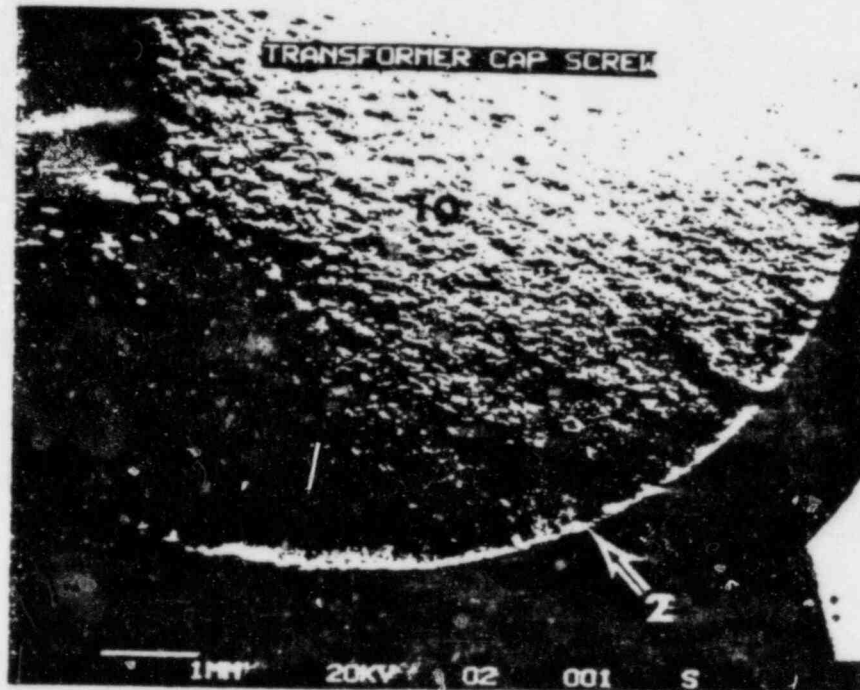
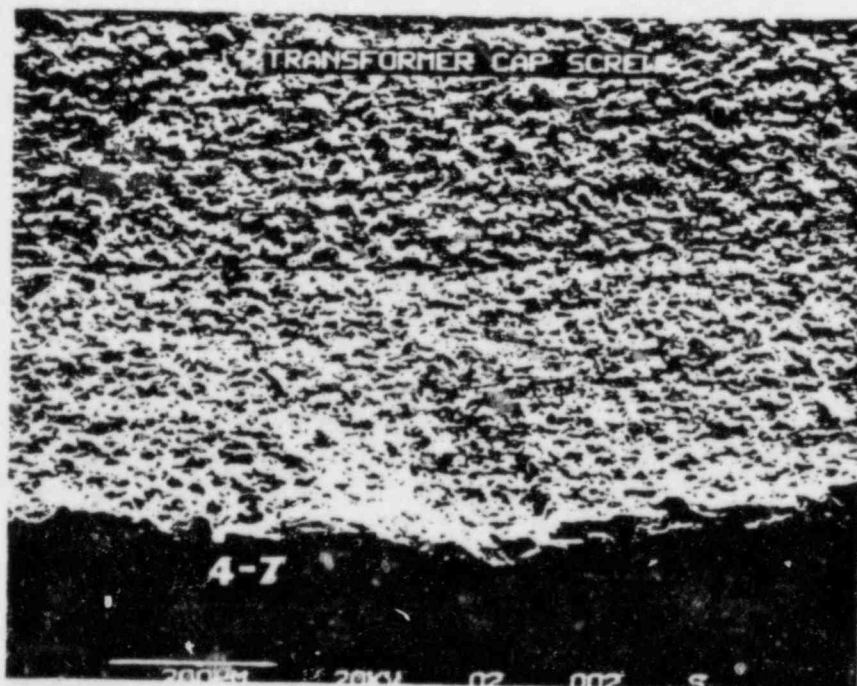
Figure 10. Area 1 from Fig. 9. Some of the primary fracture origins.

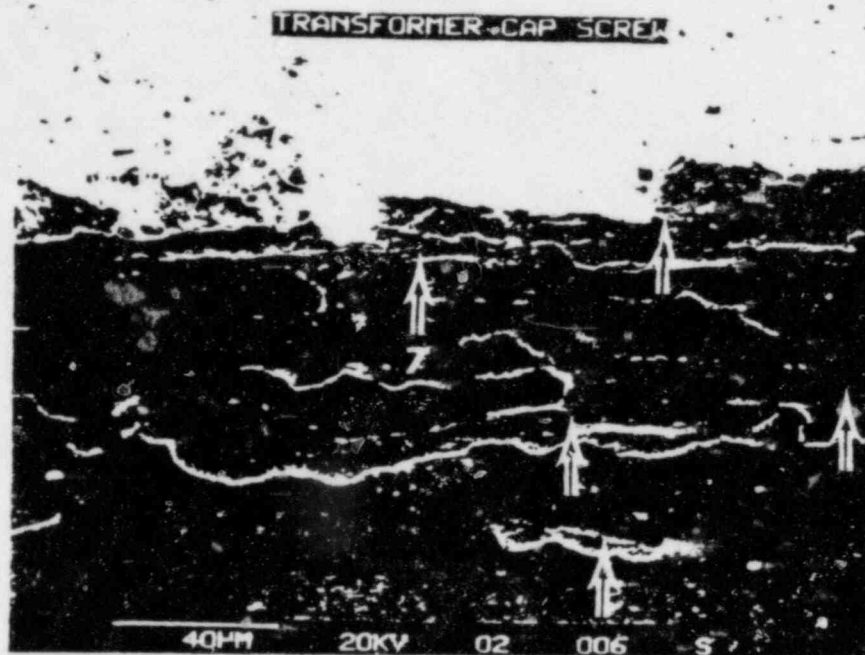
Figure 14. Bottom of the thread groove at the primary crack origins. Note the spalling of the oxide due to metal strain, and a number of small cracks, marked with arrows. The lower photograph (No. 7) shows one of the cracks at a higher magnification.

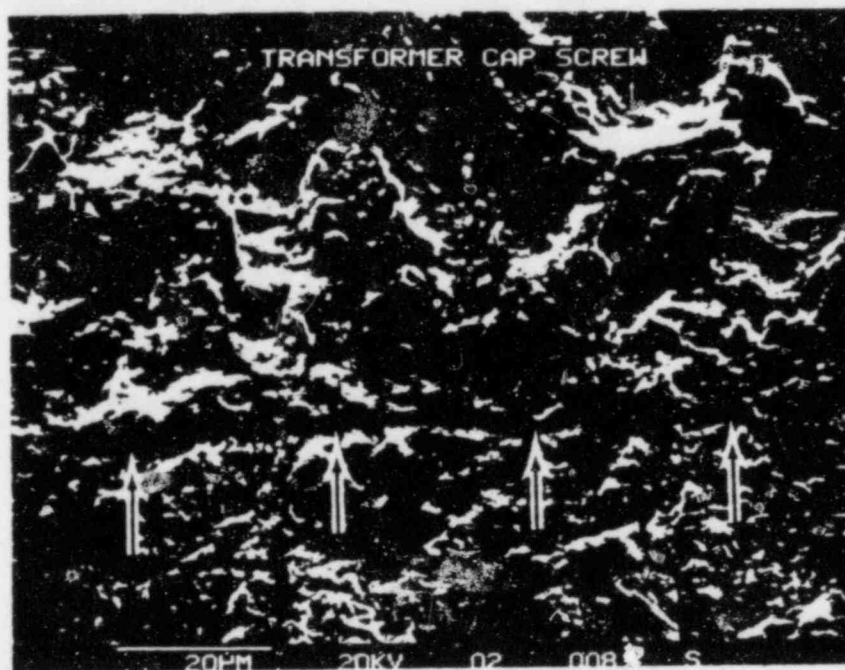
Figure 15. The first major beach mark of the fracture (marked No. 8 in Fig. 10). The crack probably stopped here for some time, and then resumed the propagation.

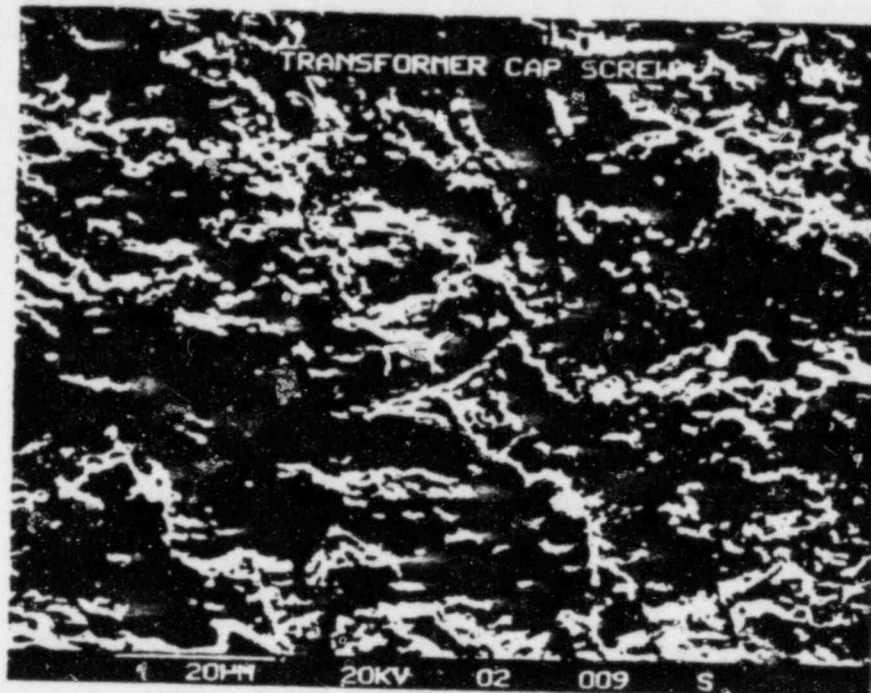
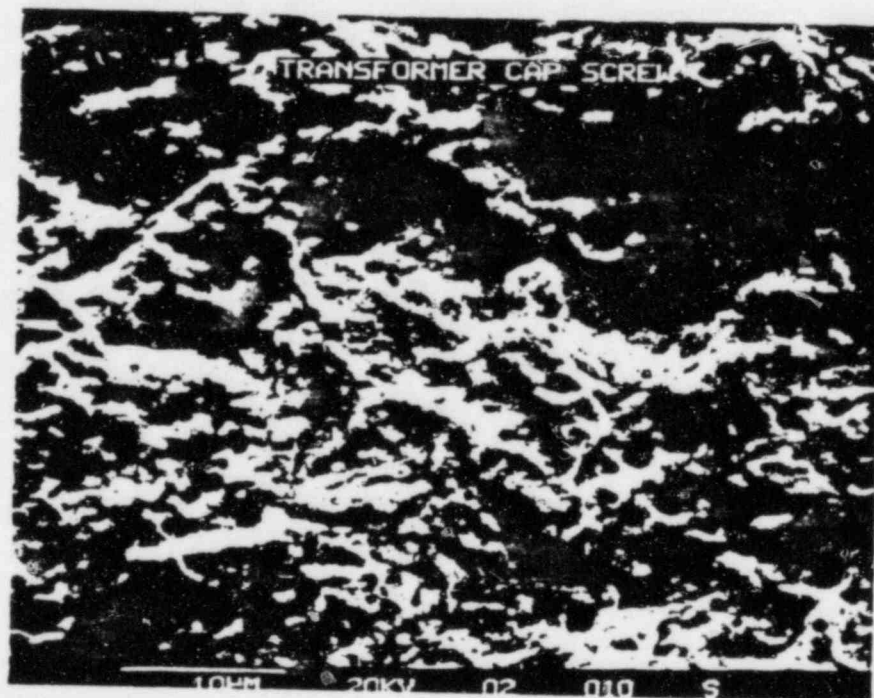
Figure 16. Fracture areas 9 and 10 from Figs. 9 and 10. Note the topography characteristic of fatigue at a moderately high stress intensity range.

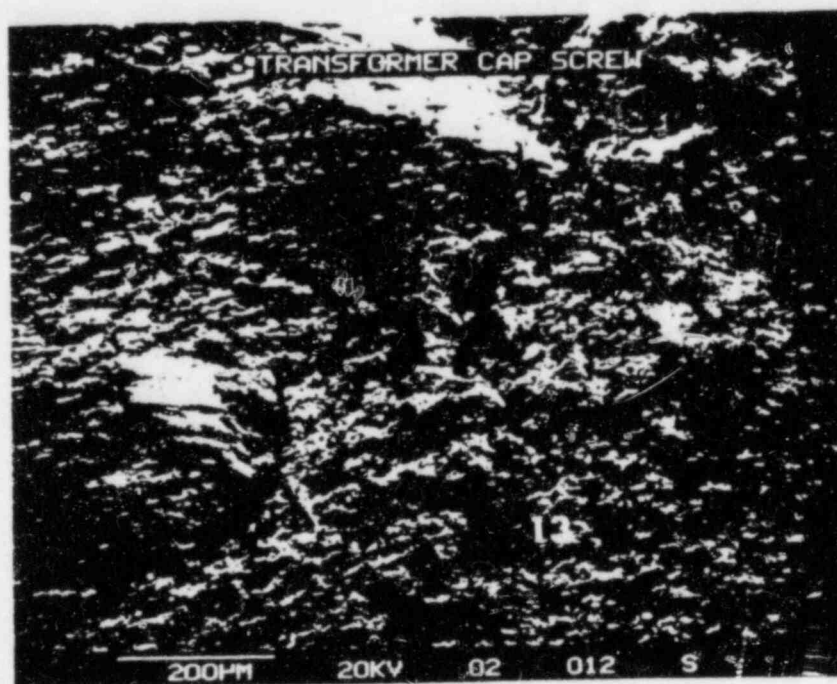
Figure 17. Fracture area 11 from Figs. 9 and 10. Note the side cracking characteristic of a high stress intensity fatigue fracture.

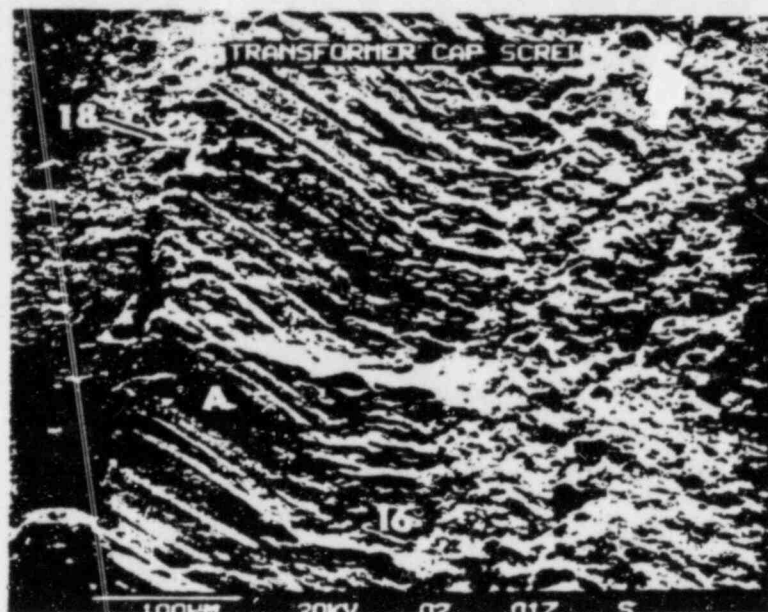
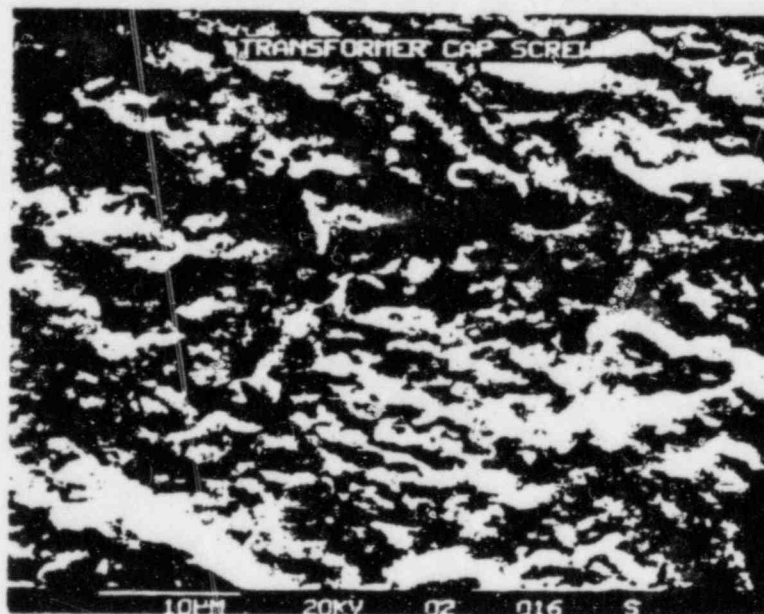
Figure 20. Fracture area 16 from Fig. 9. When the cap screw broke in the final overload, the area marked "A" was rubbed and smeared. However, small portions of this area, such as "B" in the photograph 16, which were left undamaged, show that this was originally a fatigue crack that started from the "180°" side (Fig. 9), but did not propagate as far as the crack which started from the "0°" side. The rubbing of area "A" must have produced enough heat to create oxide "C".

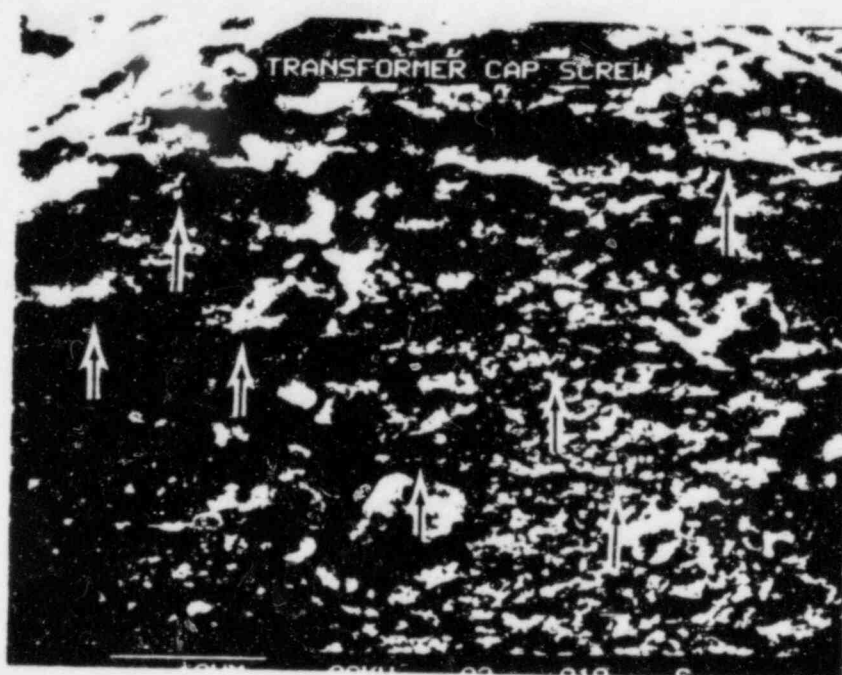
Figure 21. Appearance of the bottom of the thread when viewed in the direction of the arrow 18 in Fig. 20. Note the spalling of the oxide, indicating strain, and some small original fatigue cracks marked with arrows.
