EXAMINATION OF OTSG TUBES
B73-8 AND B112-19 FROM ANO-1
— FINAL REPORT —

RESEARCH AND DEVELOPMENT DIVISION
LYNCHBURG RESEARCH CENTER

SPONSORED BY
ARKANSAS POWER AND LIGHT

June 10, 1983

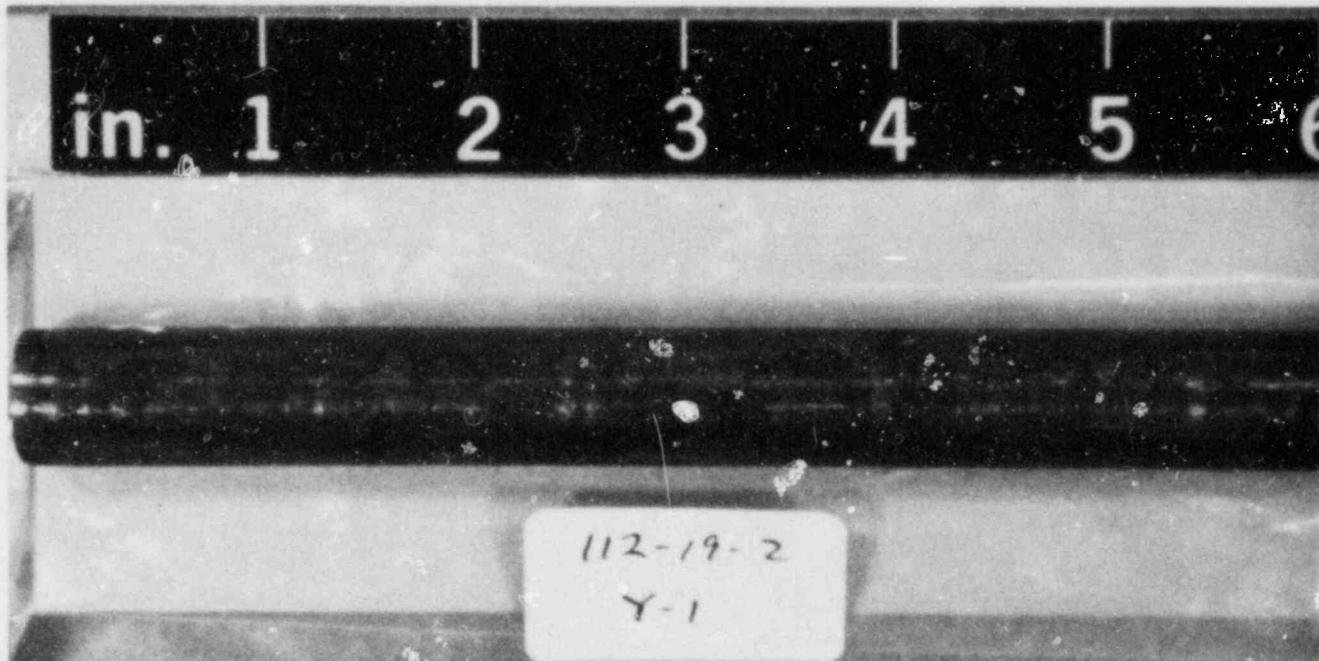
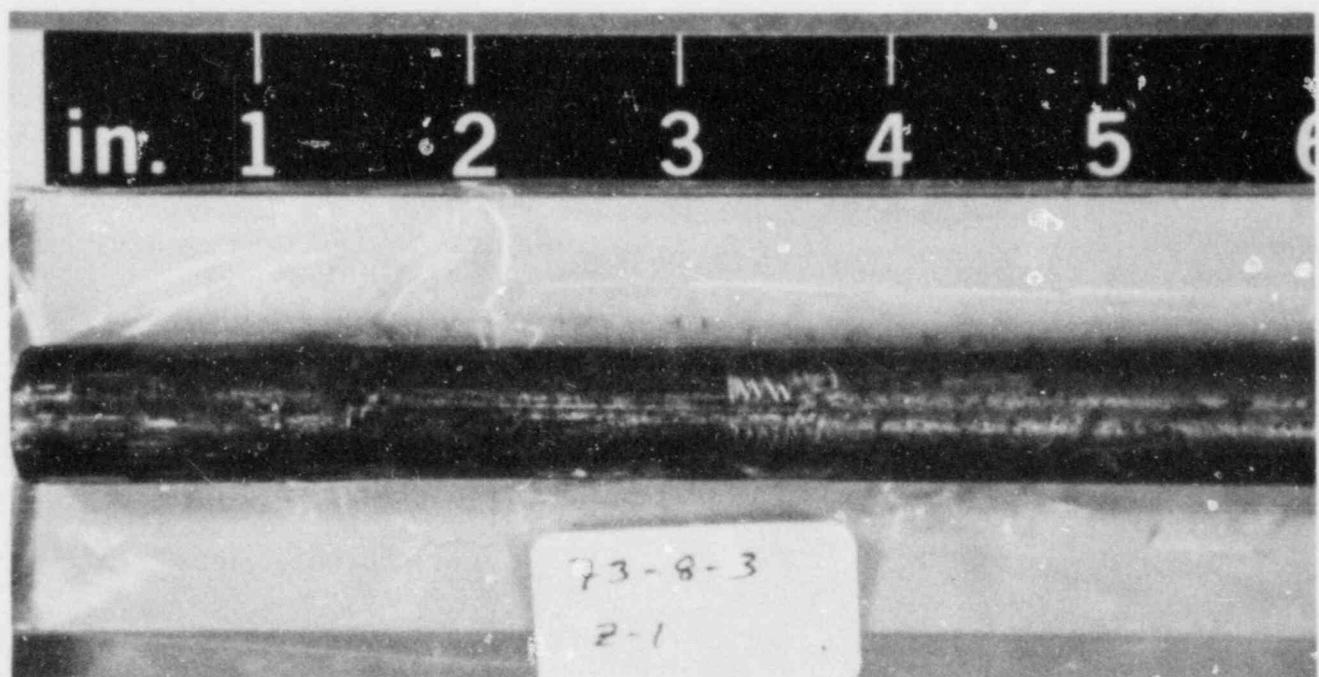
Figure 2-3. Typical OTSG Tube Characteristics

The most defined dry-out stains on both tubes were located at approximately midspan 16 and above. Very light and spotted stains were seen along the full lengths. The dry-out stains are thought to be due to the auxiliary feedwater flow, which enters the OTSG at an elevation near midspan 16. This is supported by the fact that the heaviest stained areas of these tubes were on surfaces in the direction of the auxiliary feedwater inlet nozzles.

Piece 2 Y-Axis
Dry-out Stains

Piece 3 Z-Axis
Tube Removal Marks

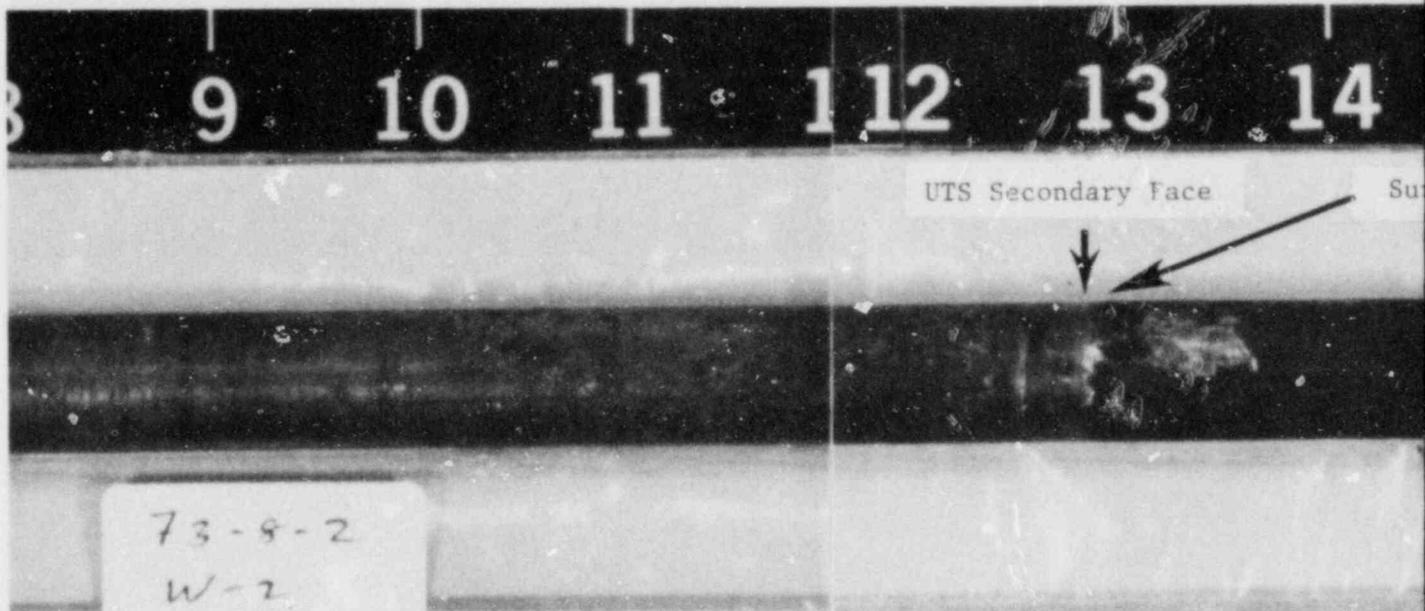
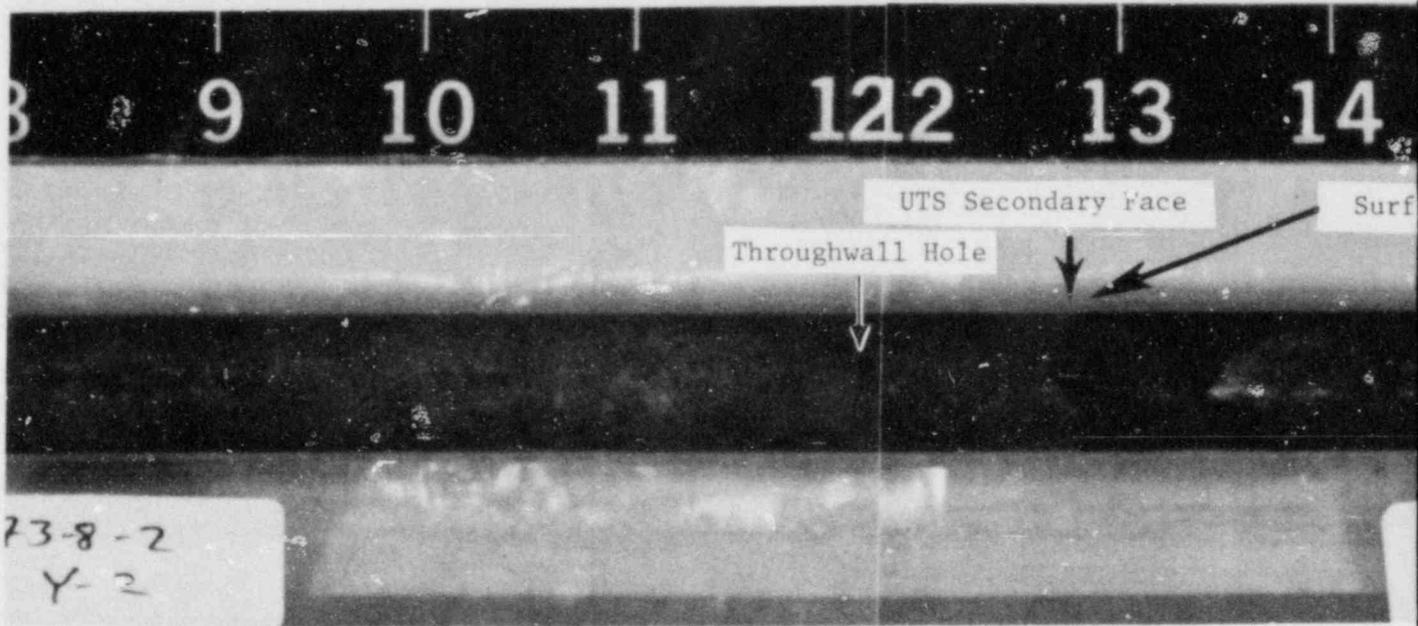
Figure 2-4. Tube B73-8 OD Surface Deposits Near UTS

Both tubes had unusually heavy black deposits near the UTS secondary face. Tube B73-8 had deposits extending from three inches within the UTS to a maximum of nine inches below the UTS secondary face. Figure 2-4 shows these deposits in different orientations. A through-wall hole is visible just above the UTS face on the Y-axis. It appears that the UTS crevice may have been tightly packed with deposits at the secondary face and were spalled during tube removal. This would help explain why the B73-8 required a breakaway force of 2,748 pounds during removal and why the through-wall cracks within the UTS (discussed later) did not leak during service.

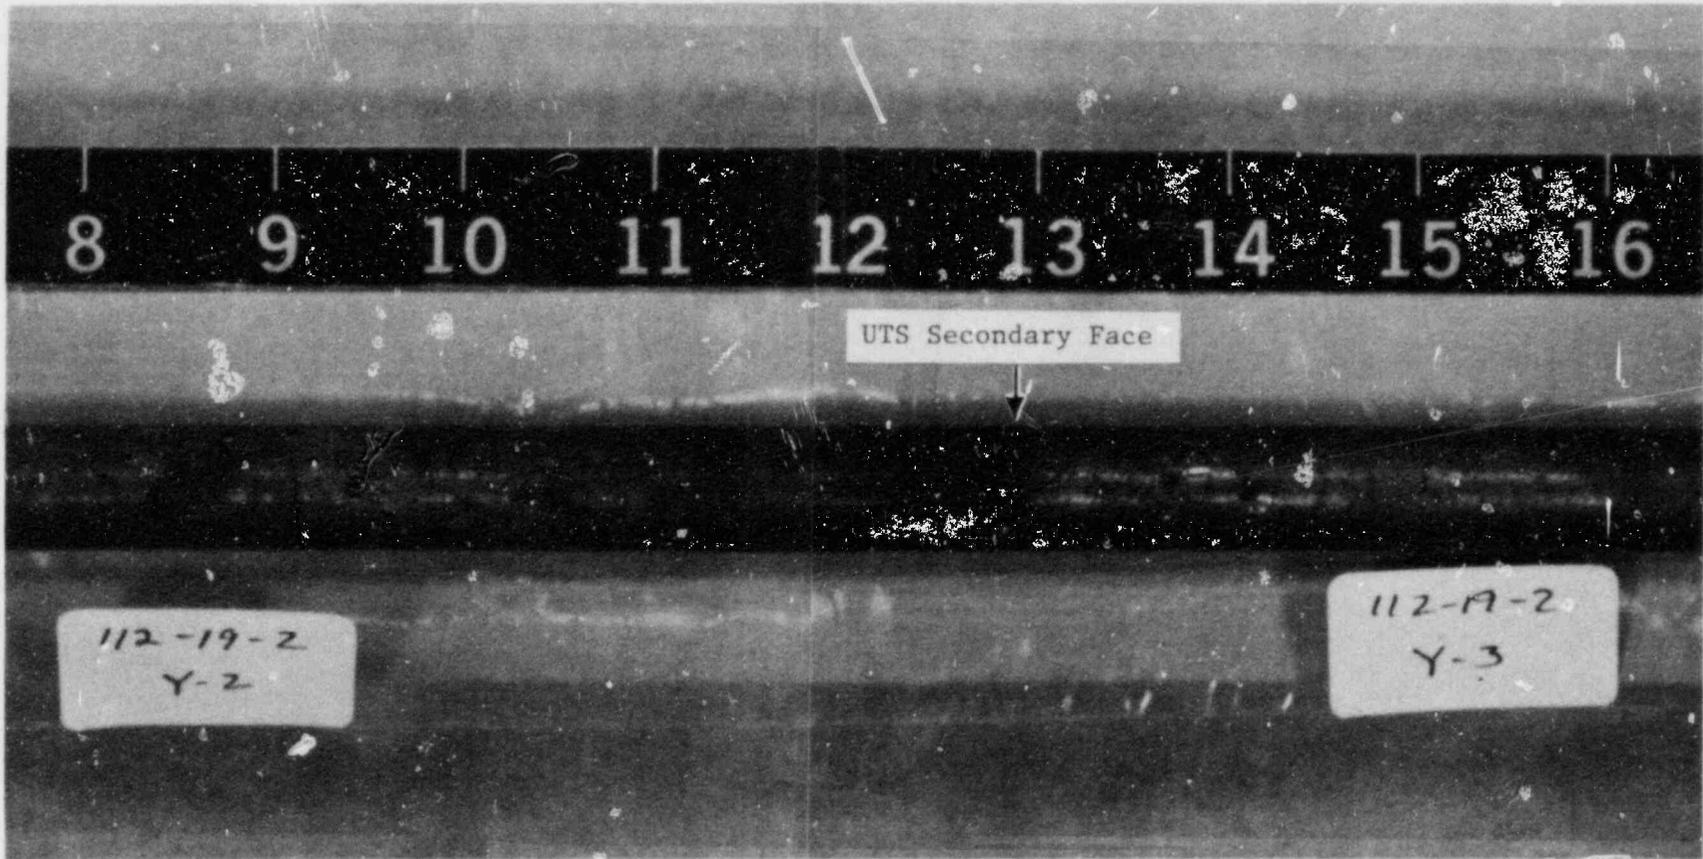
Figure 2-5. Tube B112-19 OD Surface Deposits Near UTS

The deposits on tube B112-19 were within four inches above the UTS secondary face and are shown in Figure 2-5. These deposits appeared relatively uniform in thickness and were not as heavy or spalled as were those on tube B73-8. The 15th tube support plate (TSP) region of tube B112-19 also appeared to have black deposits where the lands contacted the tube. These deposits are shown in Figure 2-6, and were not as heavy as those seen near the UTS face.

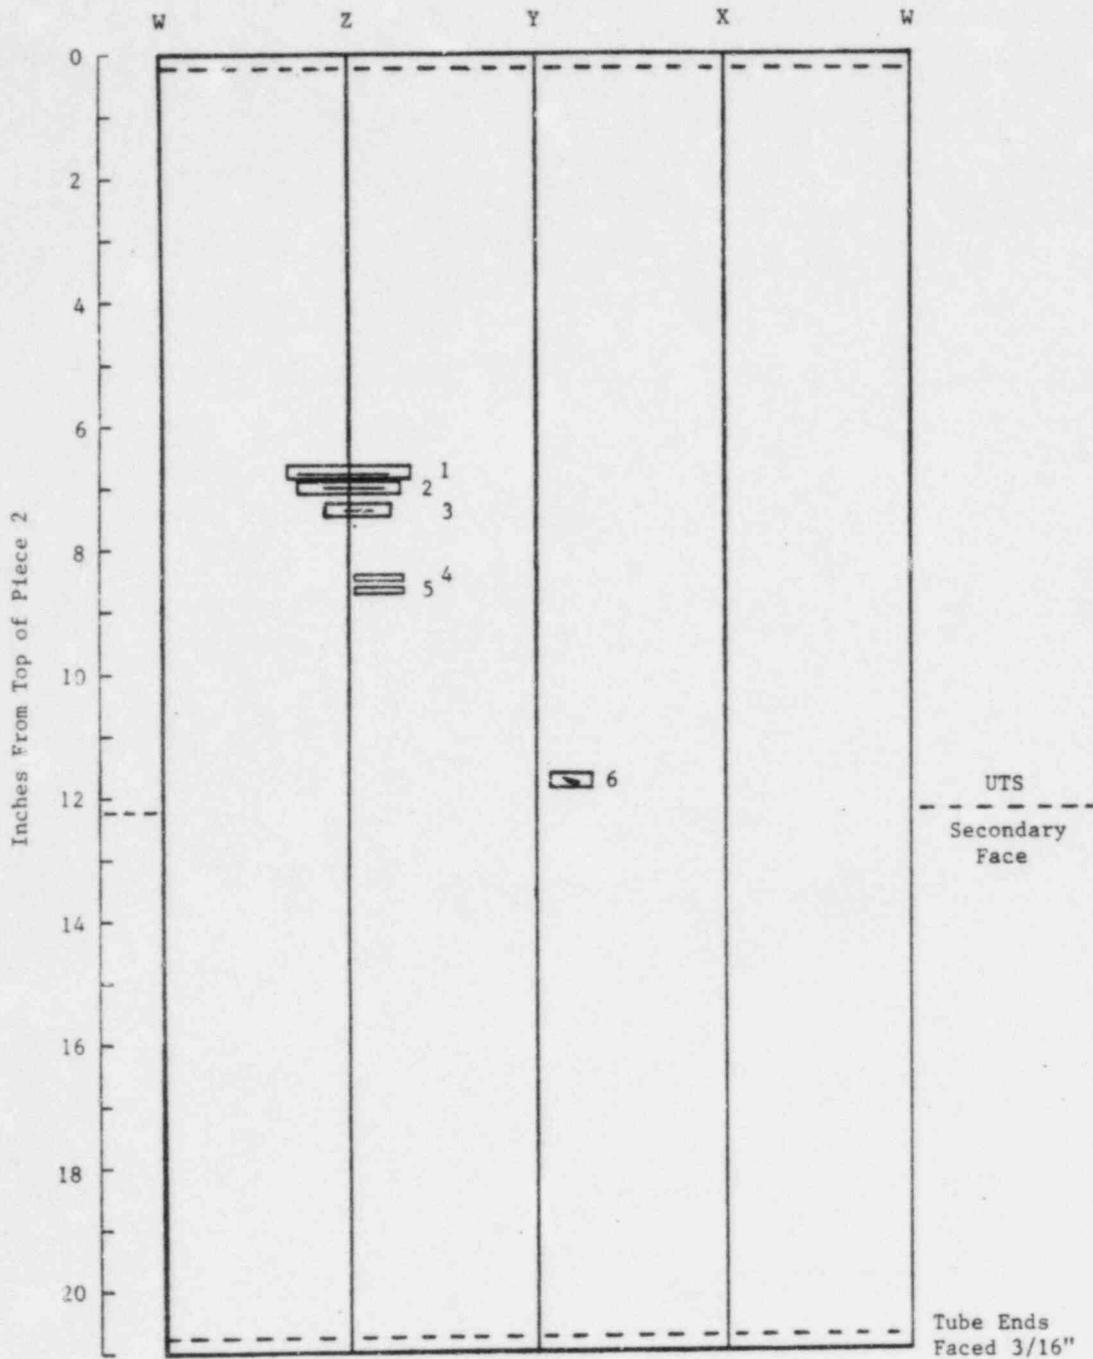
Figure 2-7. Location of Eddy Current Indications in Tube B73-8

Table 2-5 lists the defect indications seen during the site (ANO-1) and laboratory EC inspections. Figure 2-7 shows the locations of the EC indications with respect to the OTSG axes. A total of six laboratory defect indications were seen in tube B73-8 and were contained within a 6-inch region above the UTS secondary face. In all cases, the laboratory depth estimates were greater than those made at the site. This is commonly the case and has occurred with the UTS indications in other tube examinations. No depth estimate of the indication at 20.5 inches could be made in the laboratory due to a distorted signal (later determined to have been caused by two adjacent defects). The location of each defect indication was verified on the OD surface using a surface scanning absolute "pencil" probe. As listed in Table 2-5, each defect indication was designated as an examination area, with Area 1 being the uppermost indication.

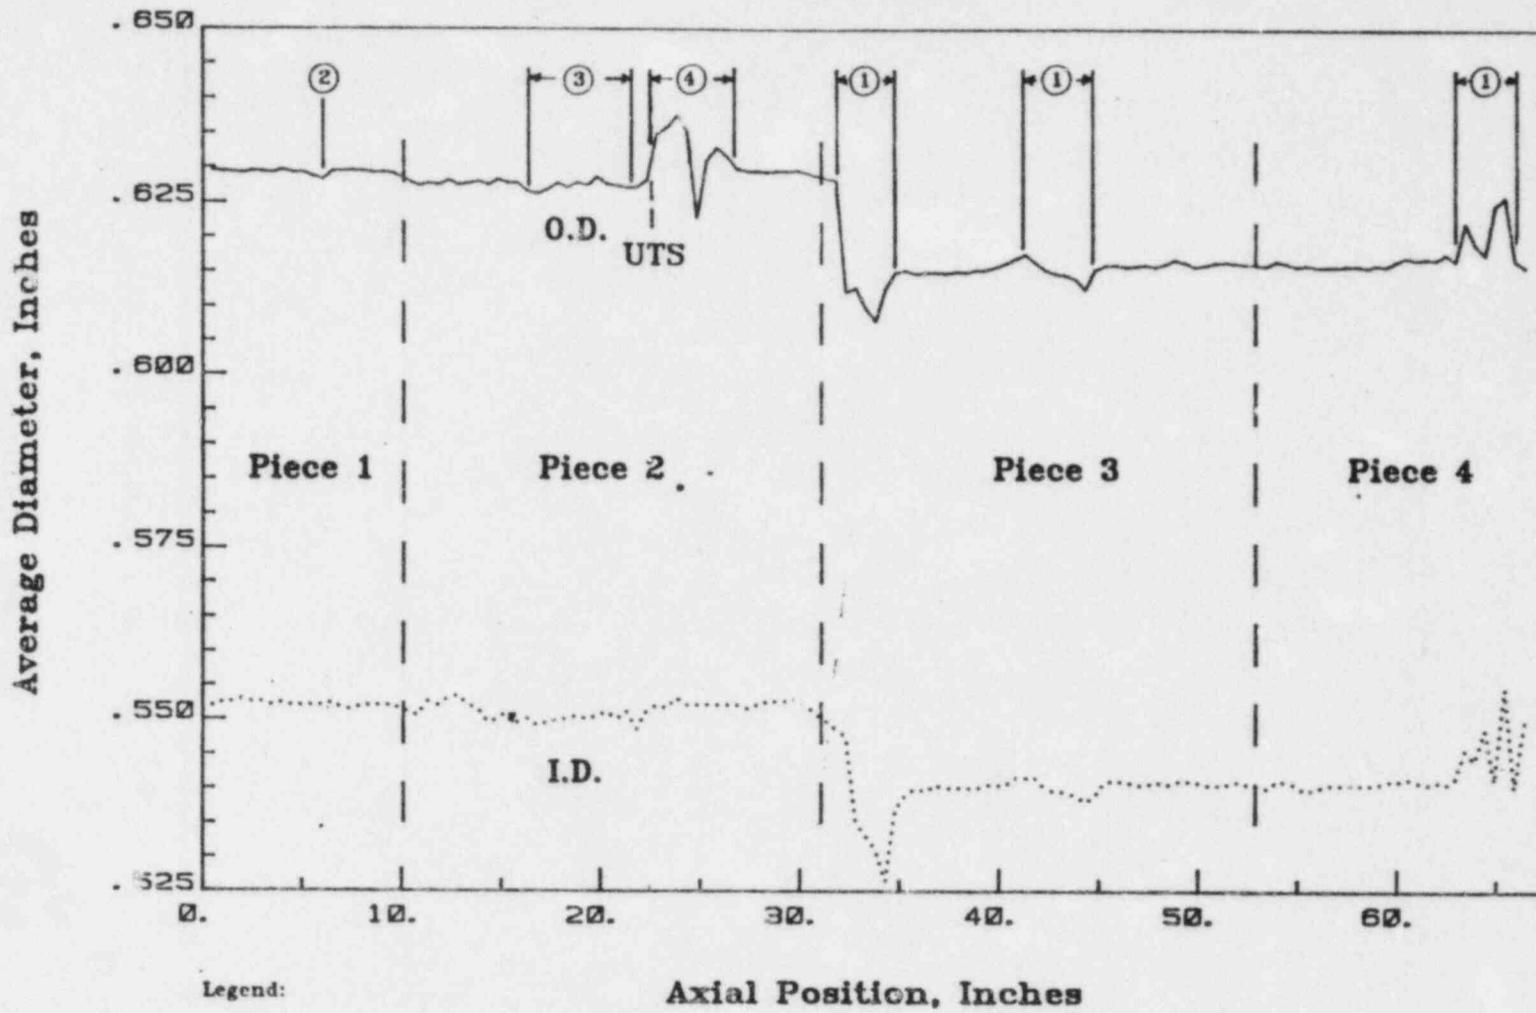
Figure 2-8. B73-8 Plot of Tube Diameter Versus Axial Position

Figure 2-8 shows the diameter data plotted versus tube axial position, with areas of previously observed anomalies noted. Areas of tube removal damage, surface deposits and eddy current indications corresponded to variations in tube diameters ranging from approximately 0.0005- to 0.020-inch. The most abrupt change occurred at approximately 32 to 35 inches from the top, where the OD and ID decreased from nominal 0.625- and 0.550-inch, respectively, to 0.615- and 0.540-inch. There is no apparent service-related explanation for this sudden 0.010-inch decrease in diameter. Although this tube required a very large tensile load to remove from the OTSG, the diameter uniformity of the lower portion implies that the diameter decrease may be a manufacturing artifact and not caused during tube removal.

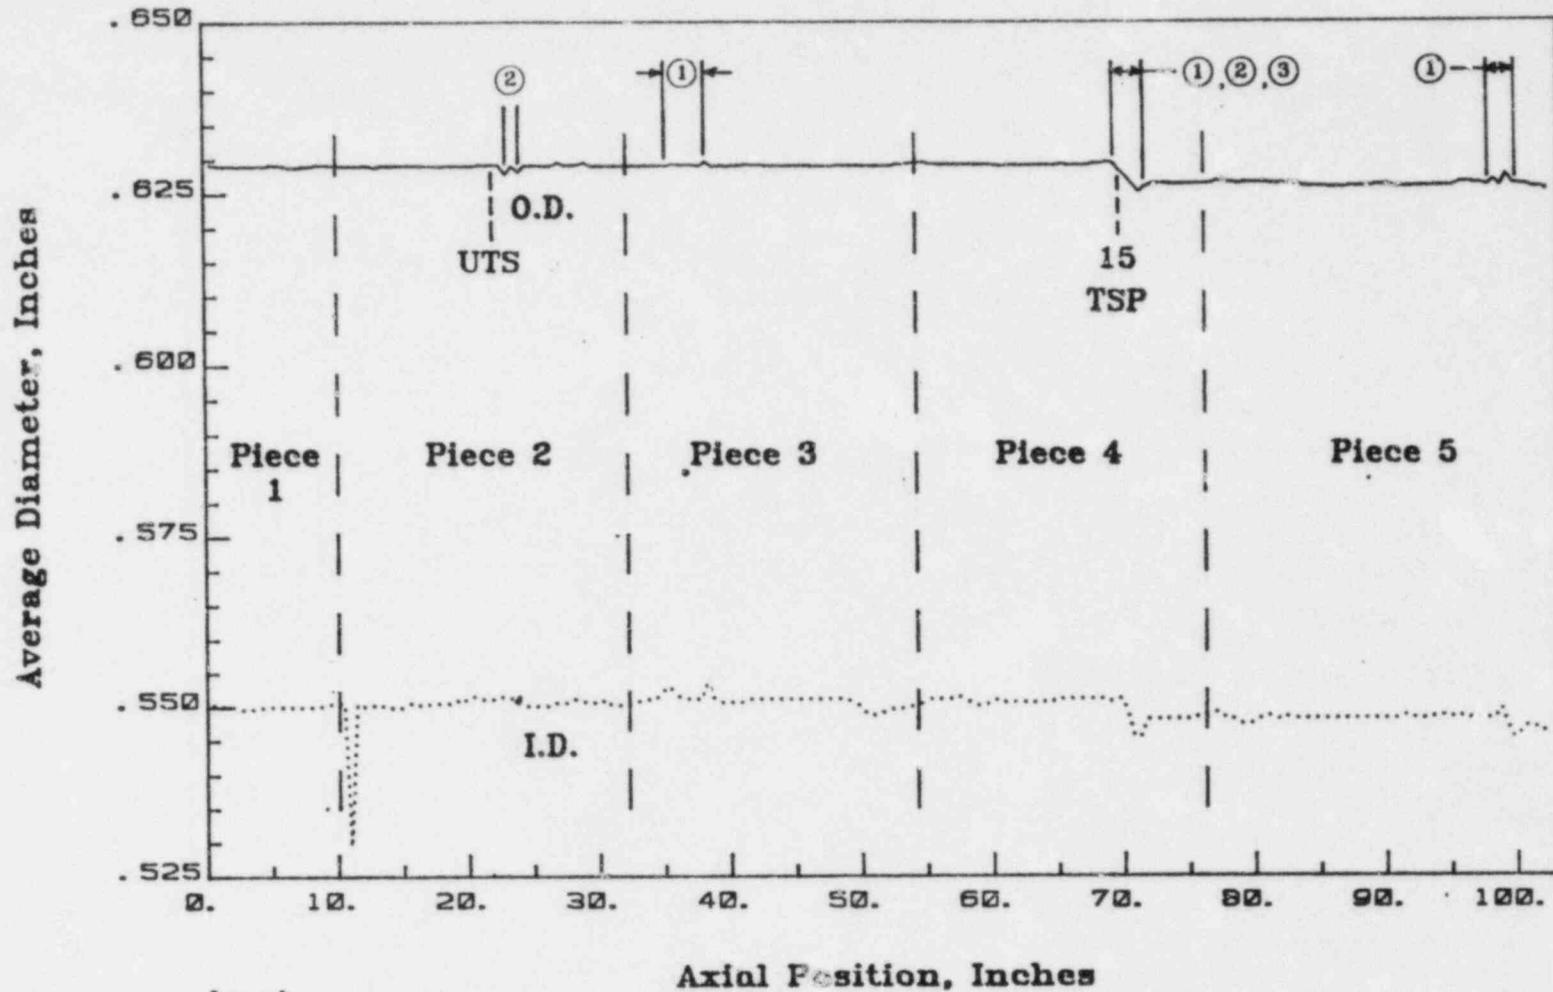
Figure 2-9. B112-19 Plot of Tube Diameter Versus Axial Position

The tube diameters were relatively uniform along the length as Figure 2-9 indicates. Small dent indications were observed during the laboratory EC inspection just below the UTS secondary face and near the 15th TSP. These locations corresponded to small irregularities in the diameter plots. In addition, a defect indication was observed during the site EC inspection and mechanical damage was visible during the macrovisual inspection just below the 15th TSP. The small diameter increases at 38 inches from the top were visible on the radiographs and appeared to be caused by the tube gripping tools used during the removal operation.

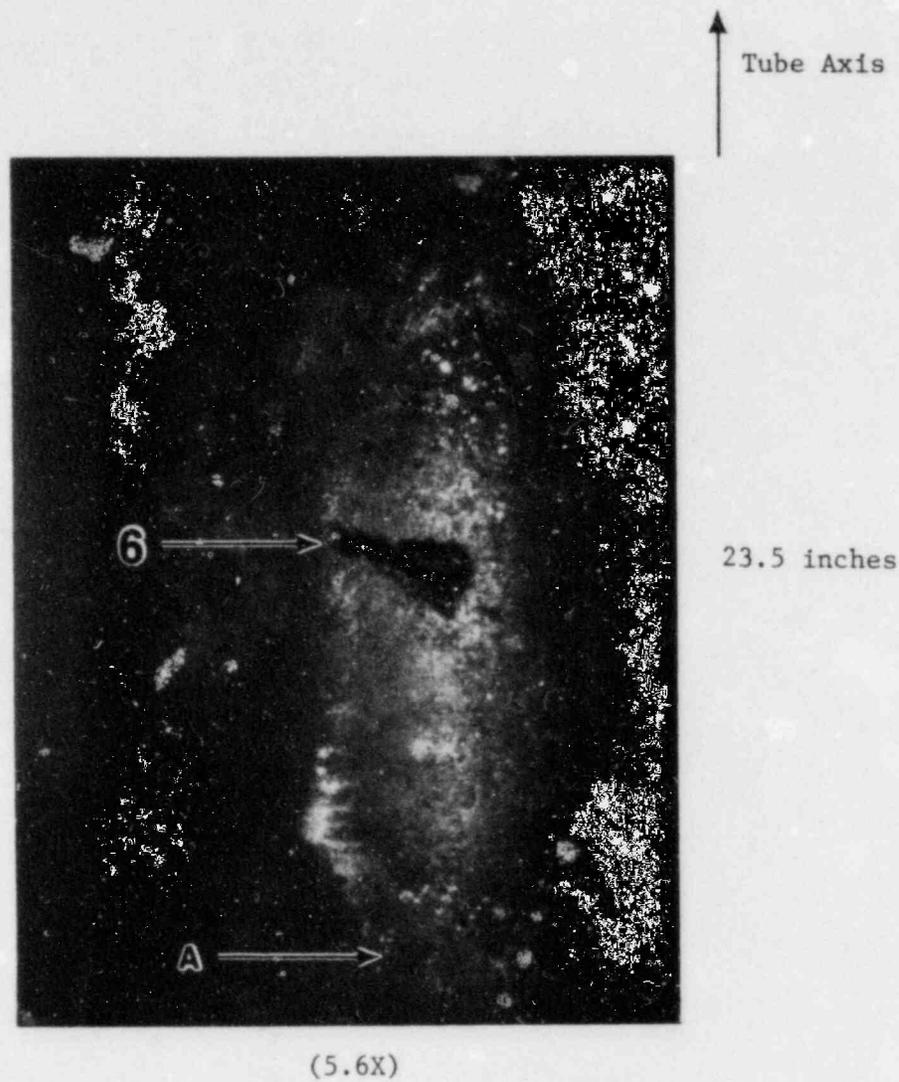
Figure 2-14. OD Surface of Tube B73-8 Defect Indication Areas

OD surface micrographs of defect indication areas are shown in Figures 2-11 through 2-14. The approximate extent of the indications was circled with black ink during the EC inspection. Heavy black OD surface deposits in these areas prevented an accurate confirmation of defect presence during the visual inspections. Areas 1, 2, and 3 did have circumferential crack-like features, but nothing anomalous was visible in Areas 4 and 5. A 100% through-wall hole was visible in Area 6, with unusually large axial extent on the OD surface, and is shown in Figure 2-14. Areas 7 to 12 were inspected using other techniques and not examined by stereo macroscopy.

A: Pitting and Wastage Attack

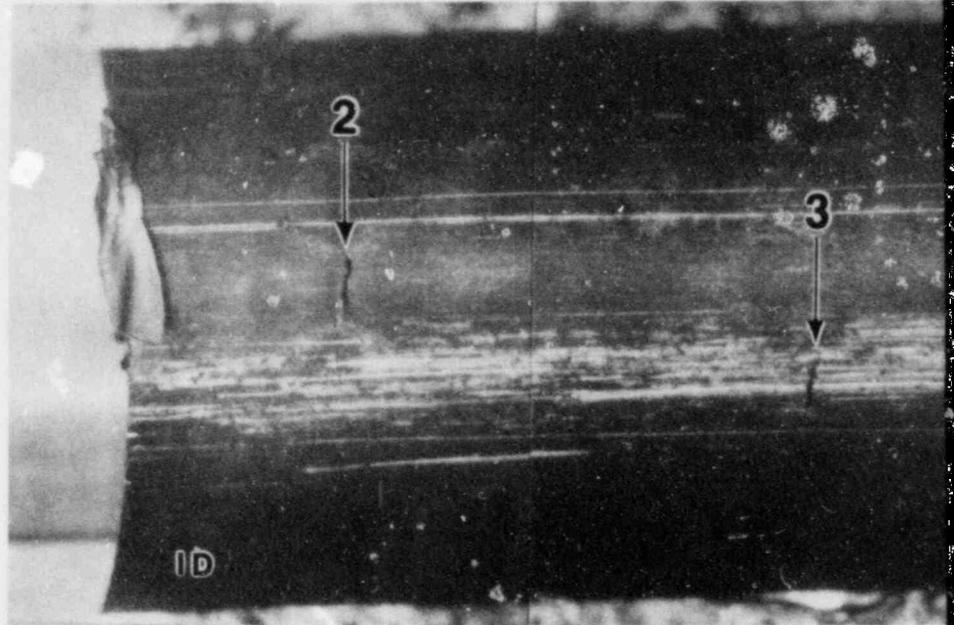
Figure 2-15. ID Surface of Tube B73-8
in Areas 2 and 3

Inspection of the ID surfaces revealed a circumferential crack in Areas 2 and 3. Figure 2-15 shows these cracks, which appear to have been "stretched" at the crack tips, thus opening them slightly in the axial direction. This probably occurred during tube removal, since large (approximately 2,700 pounds) axial forces were applied, and may have contributed to the larger depth estimates of the laboratory EC indications. The ID surface of the sample removed from Areas 4 and 5 appeared normal with no defects visible. The axial scrapes visible on the ID surface were caused by the insertion and removal of EC probes and tube removal devices and are typical for OTSG tubes removed from service.

Areas 2 & 3 (5.6X)

Area 2 (23X)

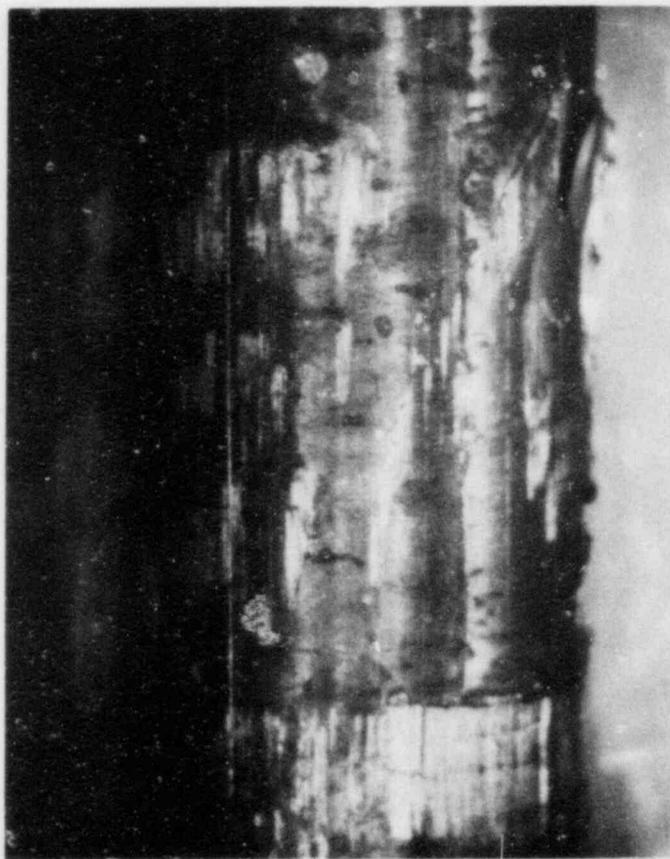
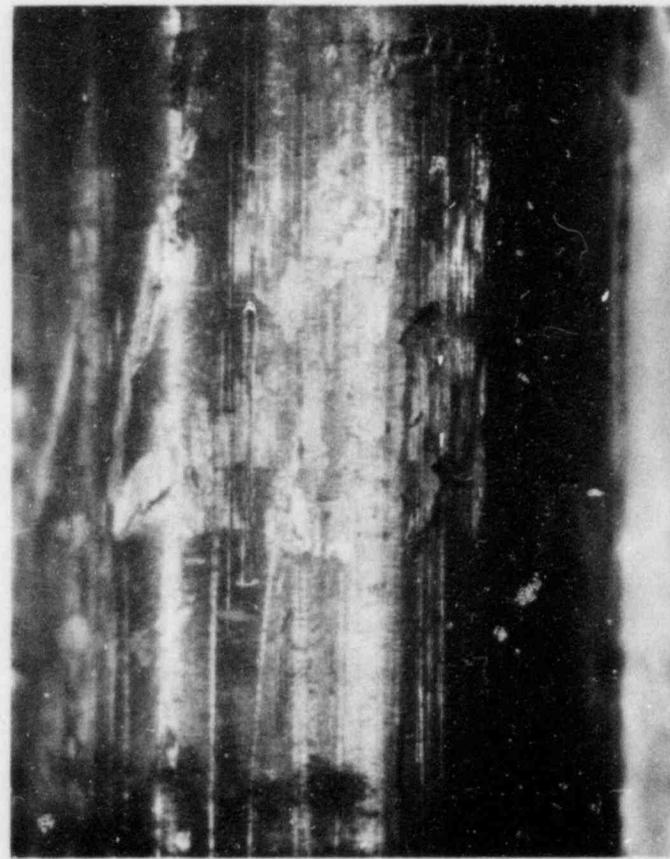
Figure 2-16. OD Surface of Tube B112-19 Defect Indication Area

The OD surface of Area 1 revealed a substantial amount of mechanical damage. This damage consisted of axially oriented scrapes and "plowed-up" metal and is shown in Figure 2-16. Since the overall OD surface was dark in this region and the damage was shiny, this implies that the damage was not service related. No obvious defects or cracks were visible on either the ID or OD surfaces of Area 1 which could be attributed to the site EC defect

OD Mechanical Damage
After Cleaning with
Inhibited HCl

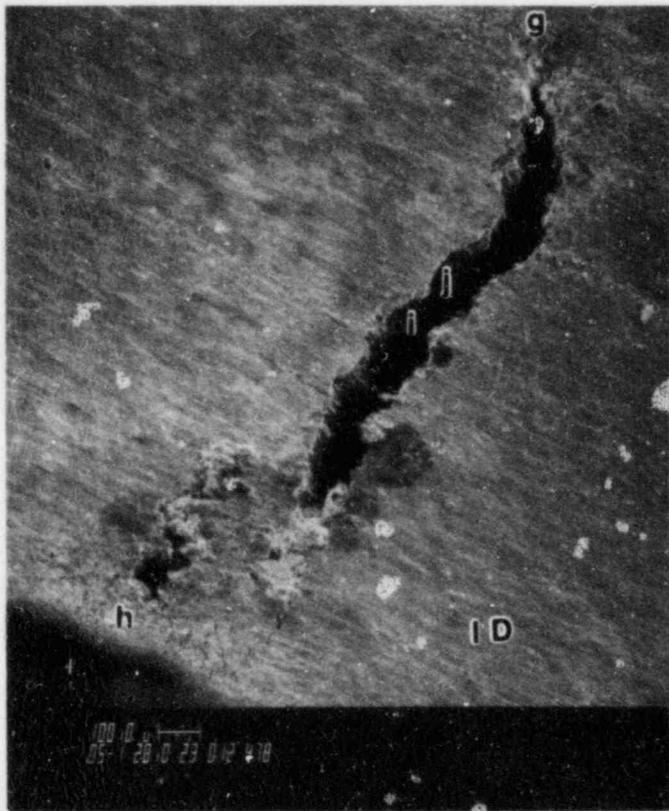
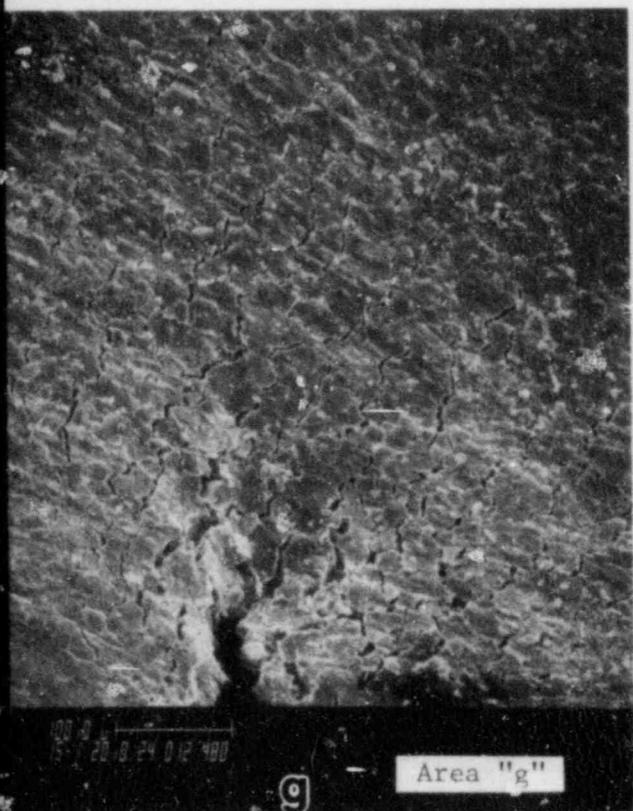
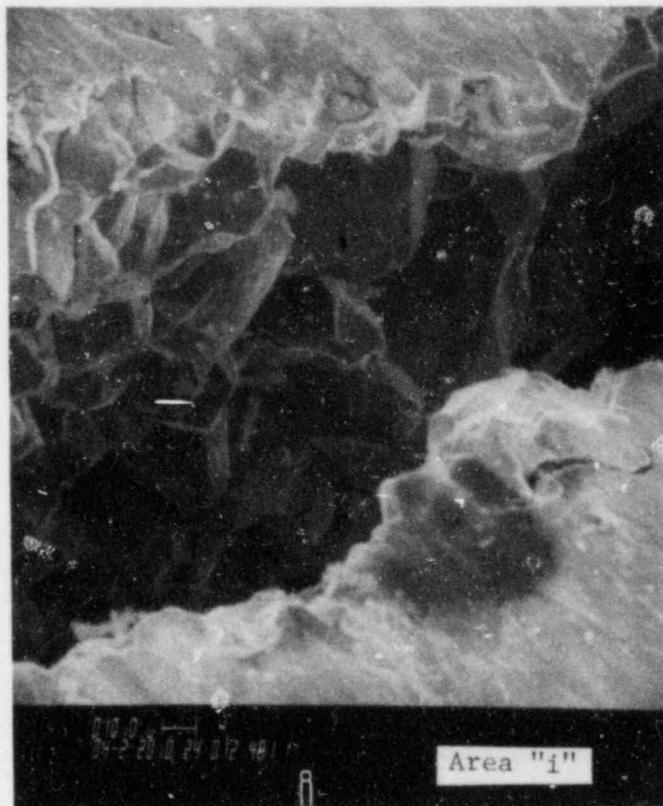
Figure 2-20. SEM Micrographs of Tube B73-8 Area 2

While examining the ID surfaces of Areas 2 and 3, the circumferential cracks seen during the macroscopic inspection were studied. Both cracks were intergranular in nature and relatively free of heavy deposits on the portion of the crack surfaces nearest the ID. Figures 2-20 and 2-21 show micrographs of these two cracks. Observations made during the macroscopic inspection were confirmed, in that the crack tips appear to have been "stretched". These observations support the theory that the cracks were "stretched" during the tube removal operation and, thus, may be a partial explanation as to why the laboratory defect indication depth estimates are slightly greater than those made from the site EC data.

ID Intergranular Circumferential Crack

Intergranular Crack Surface

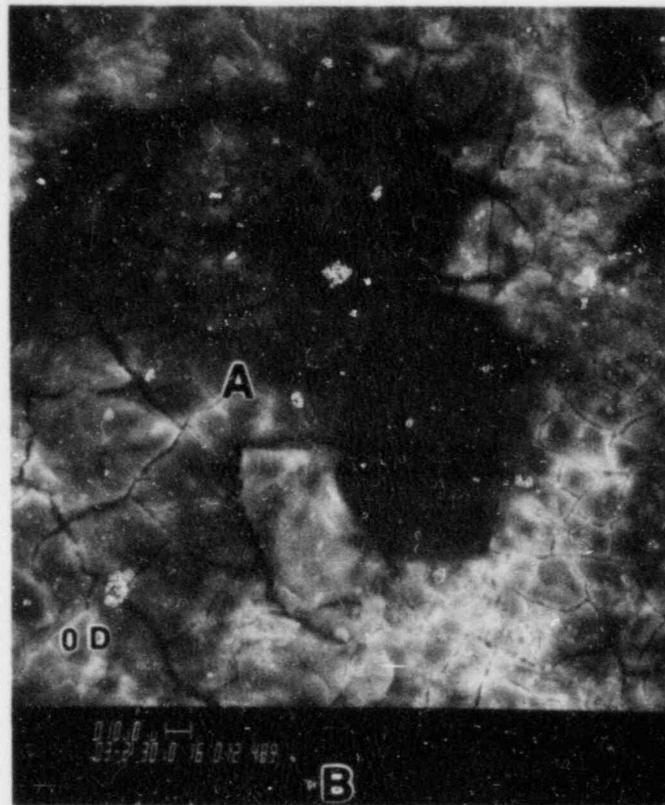
Figure 2-22. SEM Micrographs of Tube B73-8 Area 4

The OD surface of Areas 4 and 5 appeared very similar, with heavy deposits in both areas. A typical micrograph of deposits, which contained detectable sulfur using EDX, is shown in Figure 2-22. Area 5 did, however, have a circumferential crack-like feature visible under high magnification and is shown in Figure 2-23. An accurate depth estimate could not be made using the SEM, therefore it was not determined whether or not the cracking was limited to the surface deposits. The EDX spectrum in Figure 2-23 showed silicon and sulfur to be present in the deposit cracking in Area 5. The ID surface of Areas 4 and 5 appeared typical of OTSG tubes removed from service and a micrograph is also shown in Figure 2-23.

OD Surface Deposits

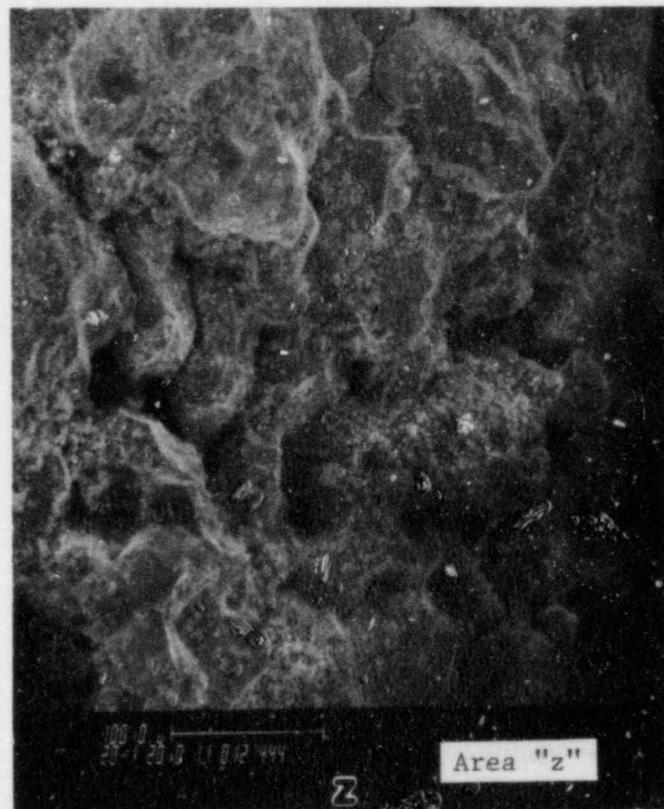
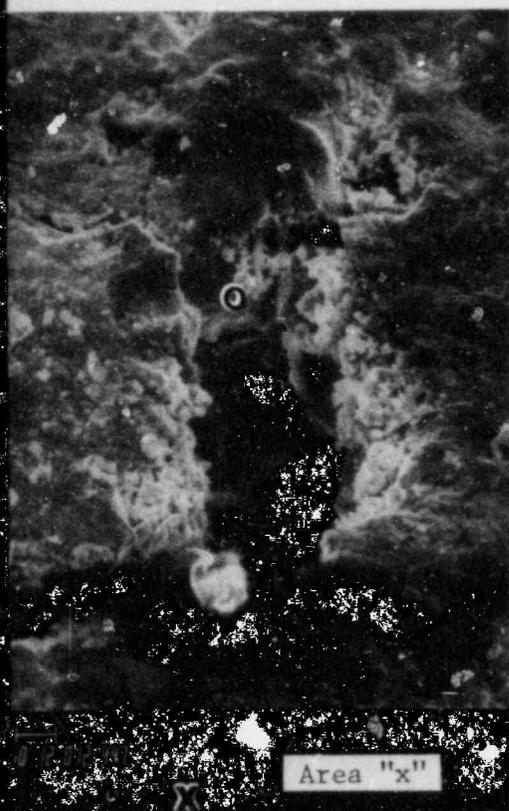
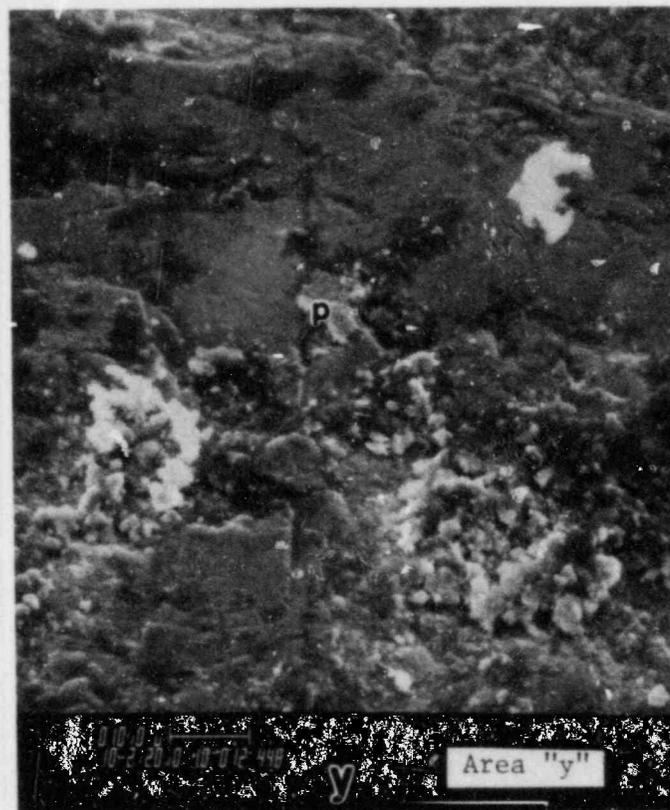
Figure 2-24. SEM Micrographs of Tube B73-8 Area 6

Area 6 of B73-8 contained the 100% through-wall circumferential hole seen during the macrovisual inspection. Micrographs of the OD surface are shown in Figures 2-24, which identify its intergranular nature. The IGA was rather extensive on the OD surface, which produced its hole-like appearance. The entire crack surface was covered with deposits, which indicates its exposure to a corrosive environment during OTSG service. The EDX spectrum from a portion of the crack surface revealed a trace amount of sulfur and large quantities of silicon, and is shown in Figure 2-24.

100% Through-Wall Circumferential Intergranular Hole

Crack Surface Deposits

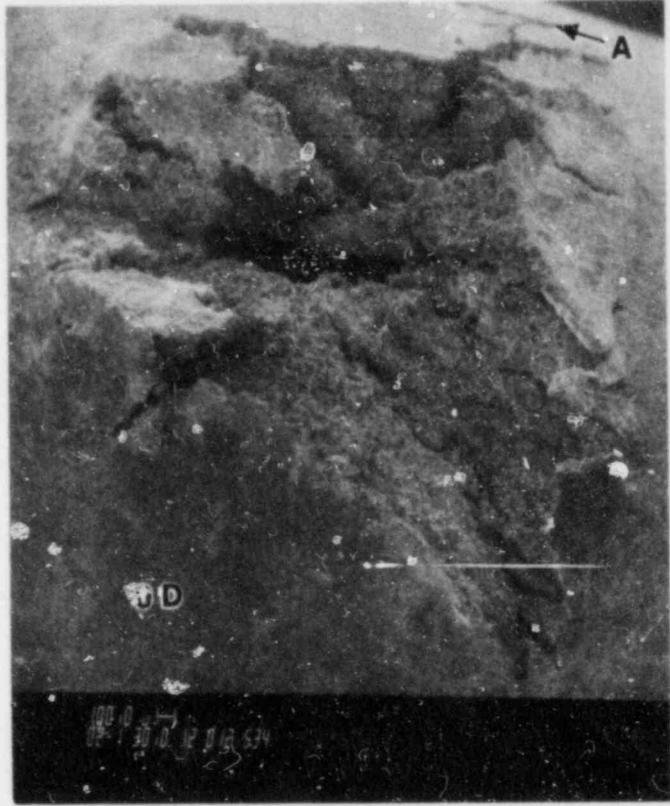
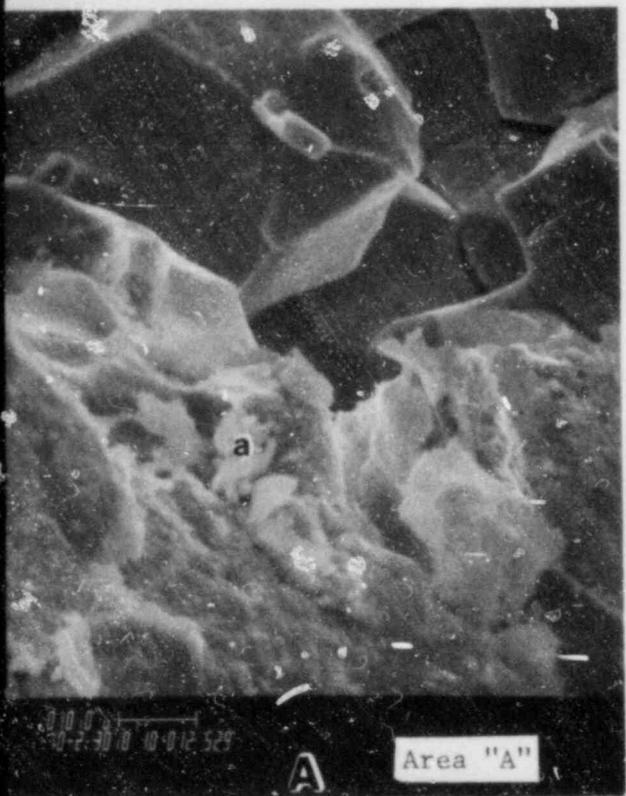
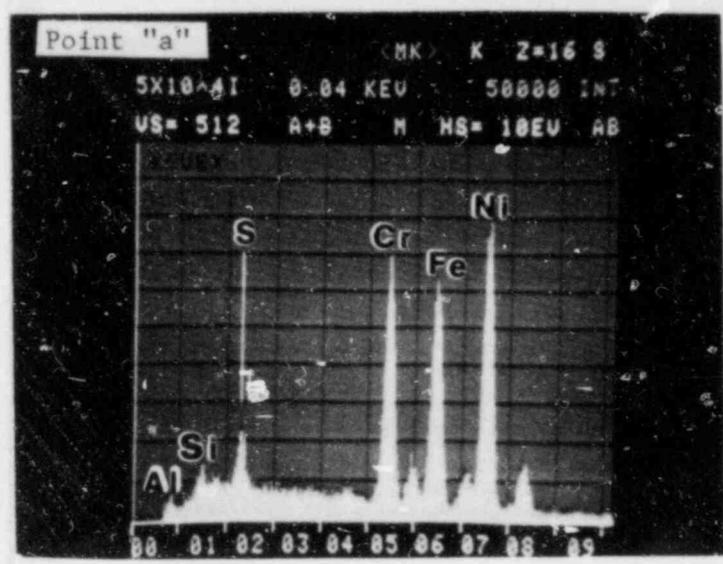
Figure 2-28. SEM Micrographs of Tube B73-8 Area 3 (After Bending)

The tube sample with the crack visible on the ID surface was circumferentially bend tested with the OD in tension and opened a 100% through-wall intergranular crack. As Figure 2-28 shows, the main crack was circumferentially oriented with "branching" in essentially all directions. Secondary OD surface cracking also was present and was linked with the main crack via IGA and secondary cracking. For the most part, the crack surface itself was relatively free of deposits except near the OD surface, where the deposits extended into the crack surface. The EDX spectrum obtained from the crack surface deposit showed a substantial amount (>2 wt %) of sulfur in addition to traces of aluminum and silicon.

Intergranular Circumferential Crack
with Extensive Branching

EDX Spectrum Showing Presence of Sulfur in Deposit

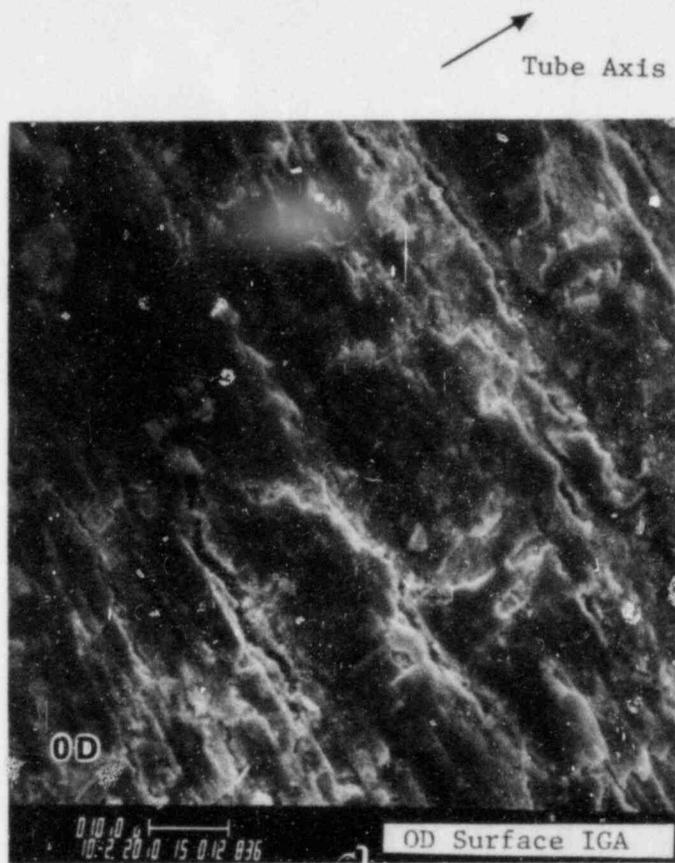
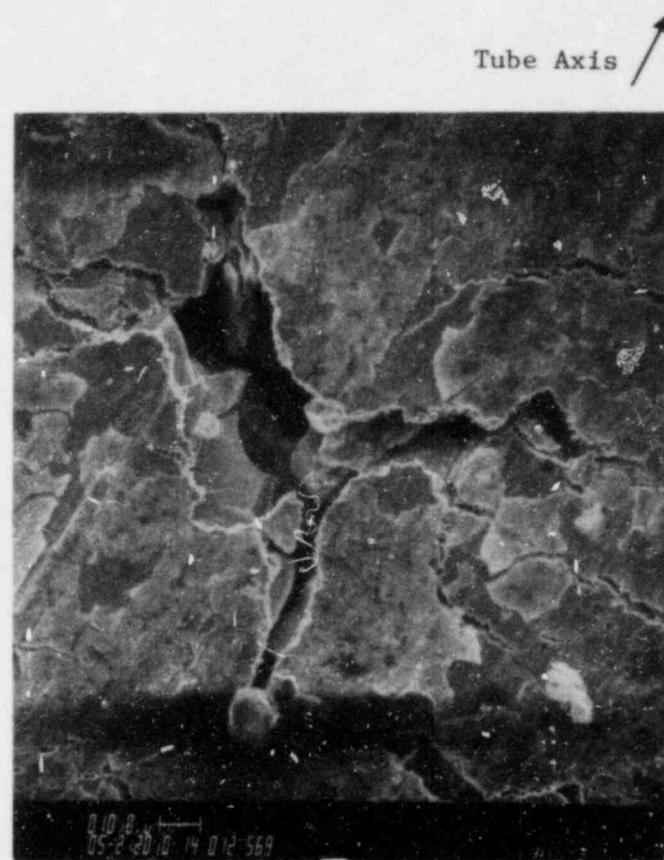
Figure 2-35. SEM Micrographs of Tube B112-19 Area 3 (After Bending)

In order to try to quantify the extent of the SIGA seen on the Areas 1 and 2 samples, strip samples from the 15th TSP region were circumferentially bent and examined. Figure 2-35 shows the OD SIGA which opened due to bending. The SIGA seemed more prevalent in the axial scrape marks where the additional surface stresses apparently opened the small cracking. To determine the penetration depth, metallography was performed.
