EXAMINATION OF OTSG TUBES
B73-8 AND B112-19 FROM ANO-1
— FINAL REPORT —

RESEARCH AND DEVELOPMENT DIVISION
LYNCHBURG RESEARCH CENTER

SPONSORED BY
ARKANSAS POWER AND LIGHT

June 10, 1983

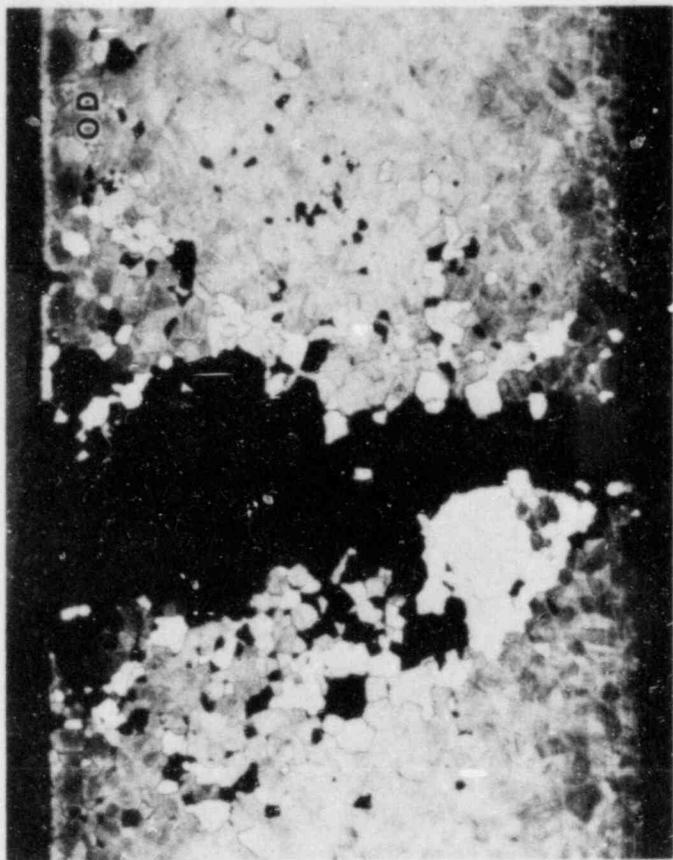
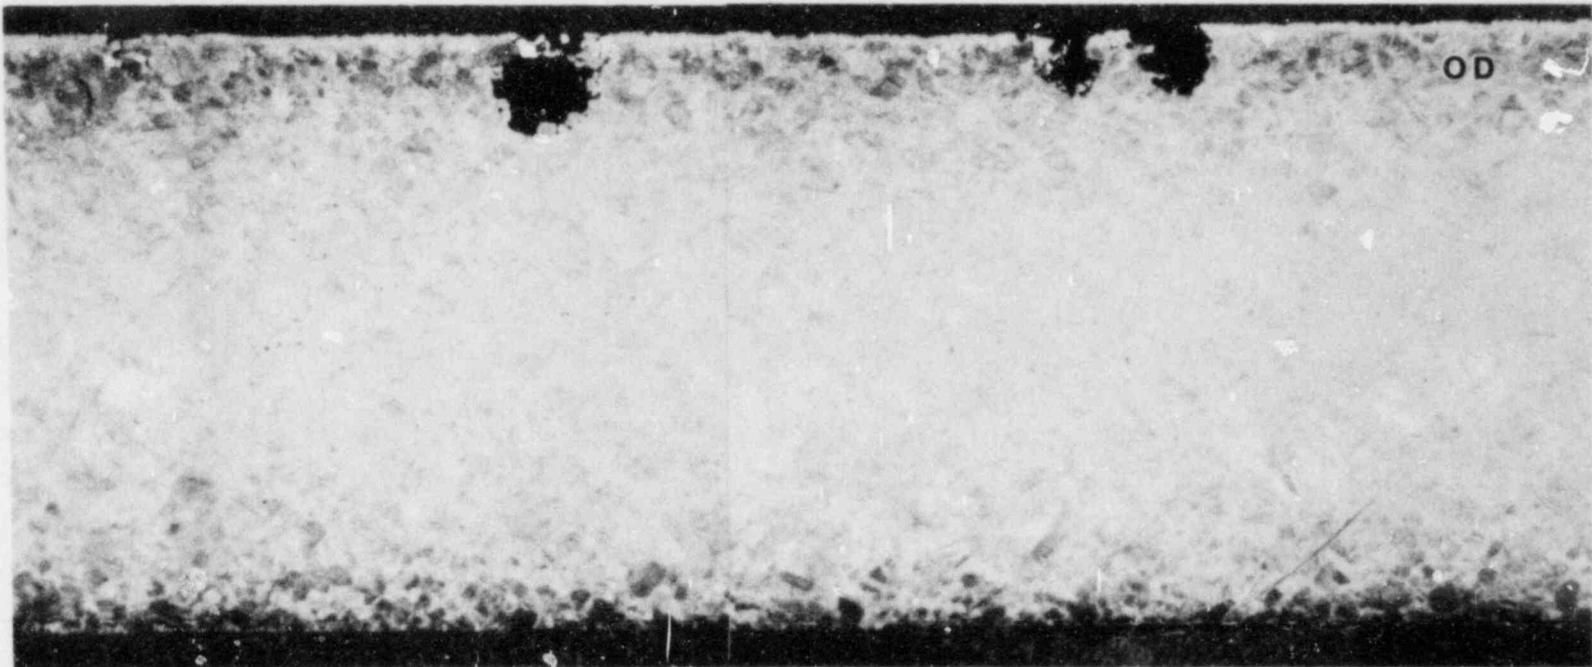
Longitudinal metallography was used to examine the crack seen on the ID surface during the visual inspections. As Figure 2-40 shows, the crack was 100% through-wall OD initiated and intergranular, with extensive IGA adjacent to the main crack. The OD surface deposits "filled" the crack, preventing its detection during the OD surface visual inspections.

Successive Longitudinal Grinding Steps Through
100% Throughwall Circumferential Crack

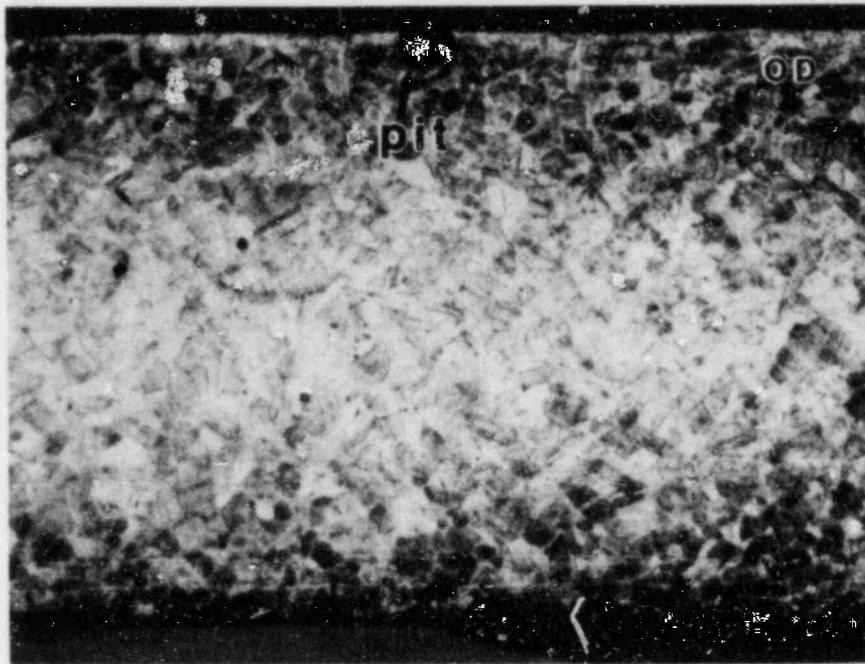
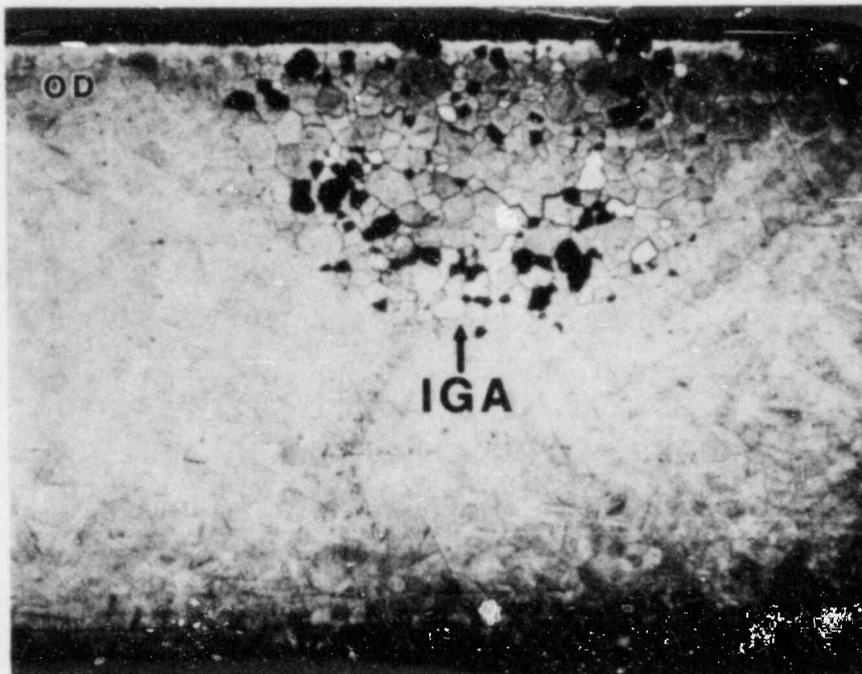
Figure 2-41. Micrographs of Tube B73-8 Area 2

One region of localized OD-initiated IGA approximately 50% through-wall and two regions of localized OD pitting were detected. These defects were also "filled" with surface deposits and were not detected during the OD surface visual inspections. Figure 2-41 shows micrographs of these defects.

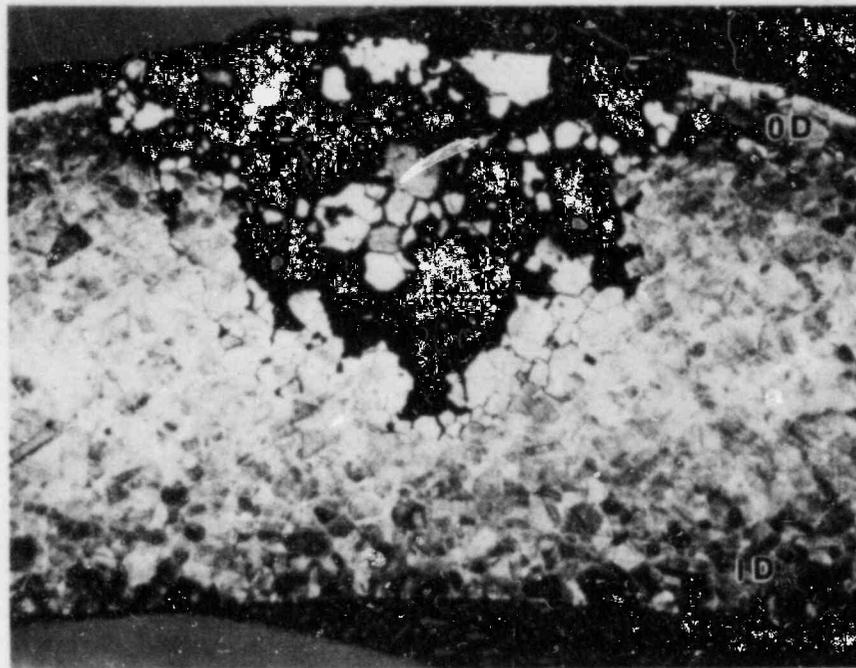
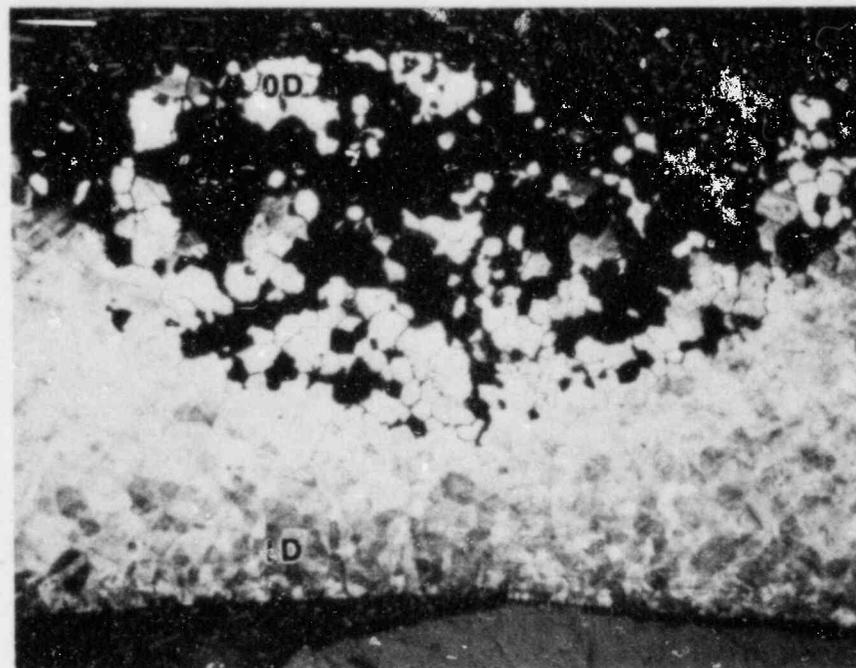
Figure 2-42. Micrographs of Tube B73-8 Area 4

To determine the cause of the EC defect indications at 20.5 inches, a sample from this area was metallographically examined. 70% and 60% through-wall OD-initiated circumferential cracks were found in Areas 4 and 5, respectively. The extensive IGA adjacent to both main cracks made their axial extent larger than that previously seen in Area 2. As Figures 2-42 and 2-43 show, these cracks were also filled with surface deposits, where grains had either deteriorated and "fallen out" or were chemically transformed into deposits. Two individual cracks possibly originated in Area 5, and became linked together via IGA.

70% Throughwall Intergranular
Circumferential Crack
(56.5X)

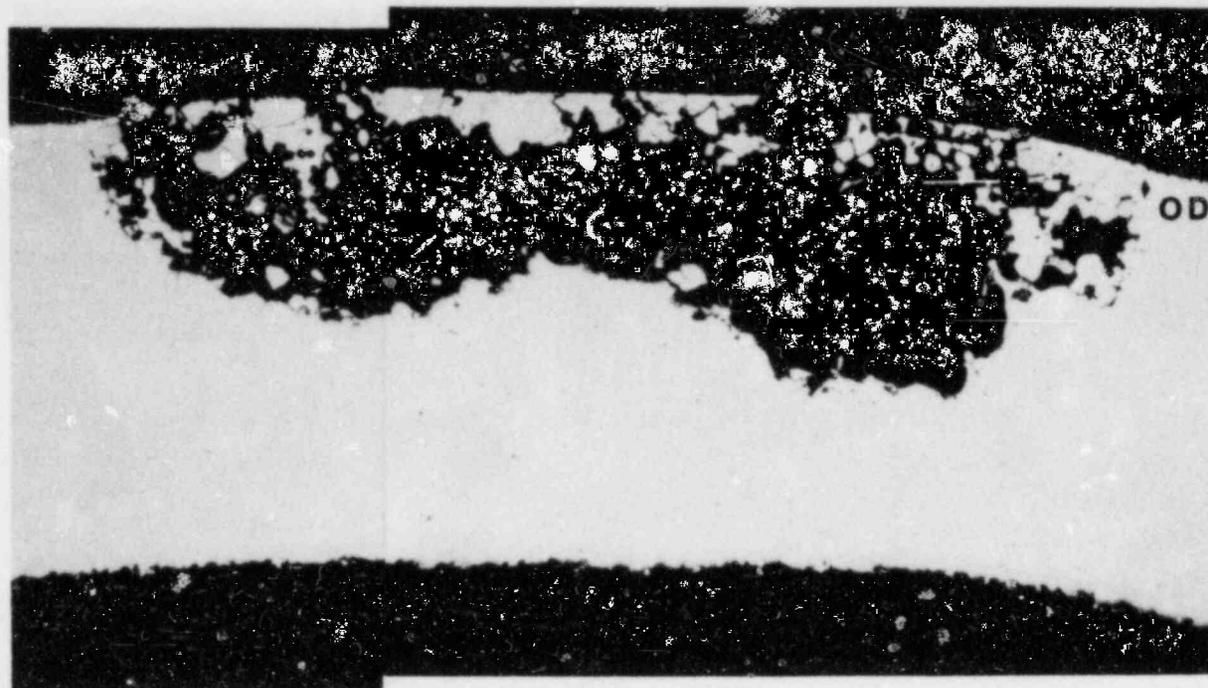
Figure 2-43. Micrographs of Tube B73-8 Area 5

60% Throughwall Intergranular
Circumferential Crack

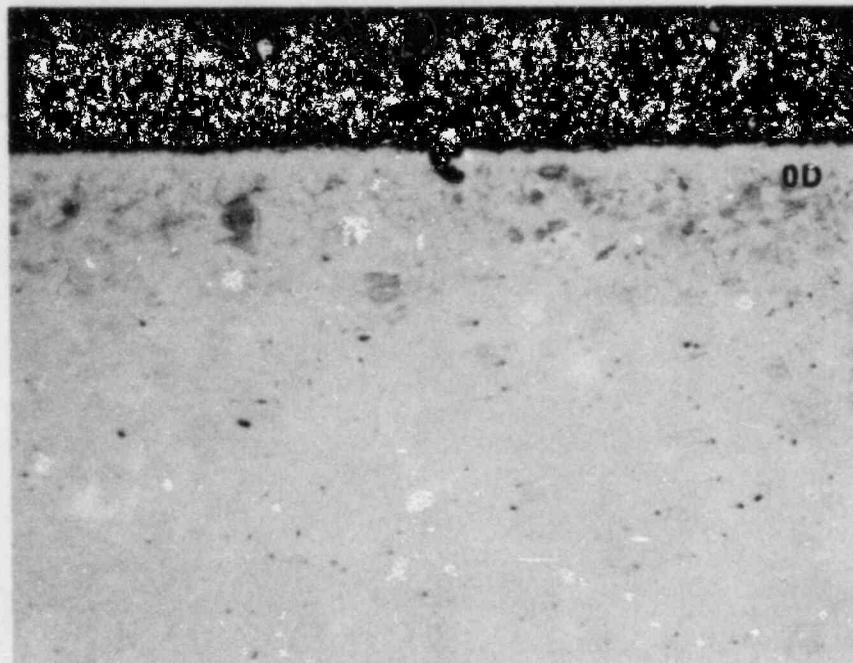
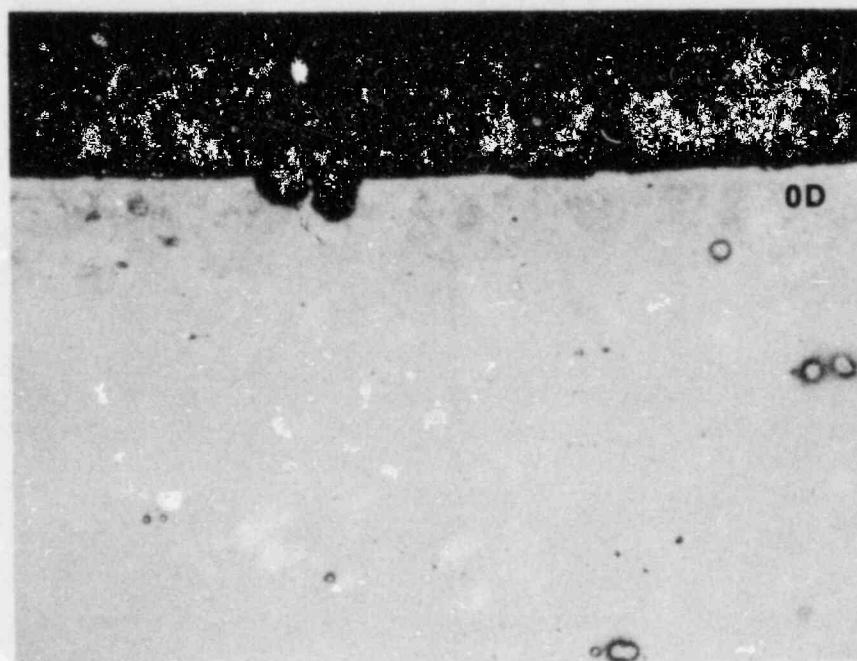
Figure 2-44. Micrographs of Tube B73-8 Area 7

OD Pitting
(50X)

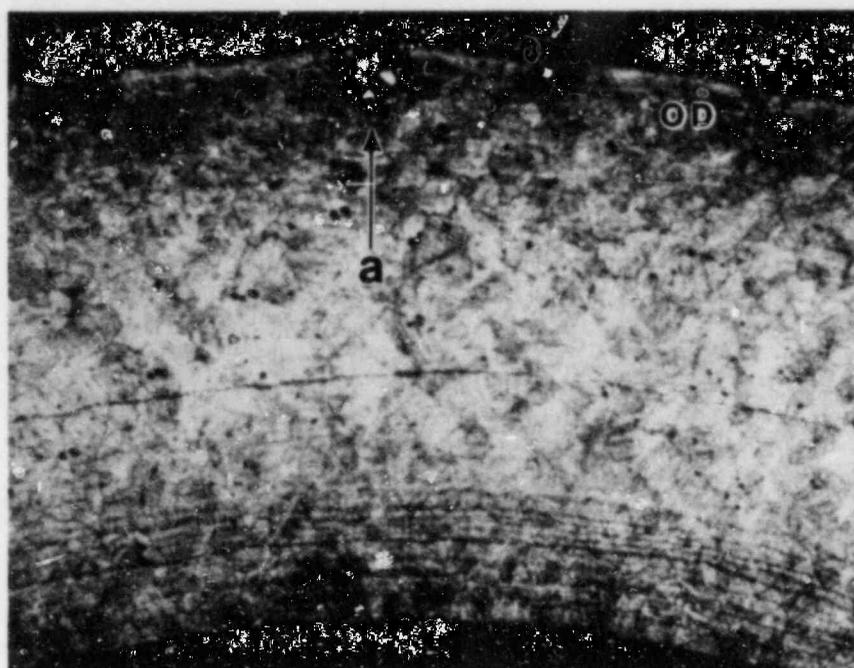
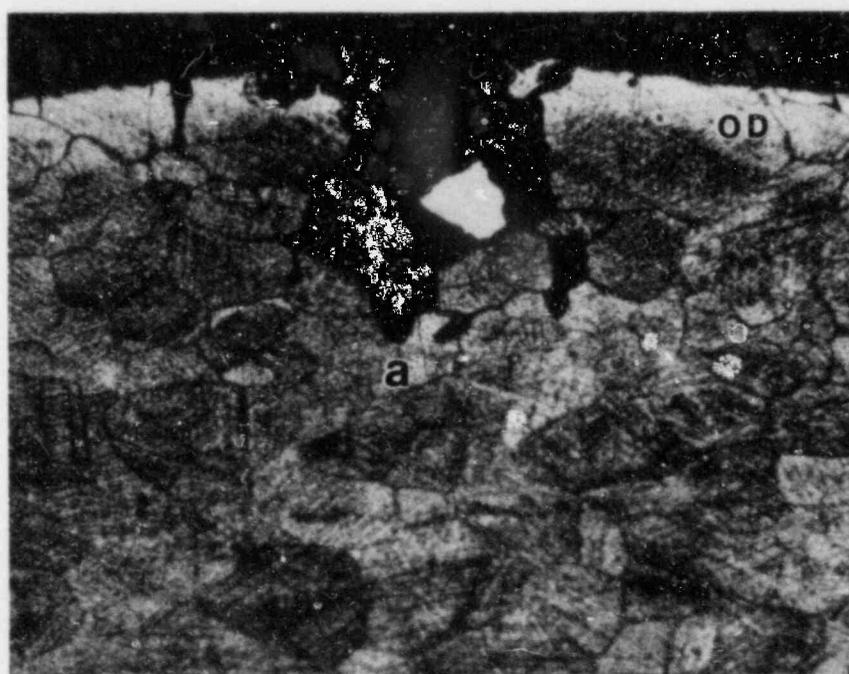
Figure 2-45. Micrographs of Tube B73-8 Area 8

The longitudinal grind-and-polish technique was used to determine the depth of the SIGA opened by bending and previously observed using SEM. The maximum depth observed was approximately 0.004-inch (about 10%), and is shown in Figure 2-45.

(75X)
OD Surface IGA

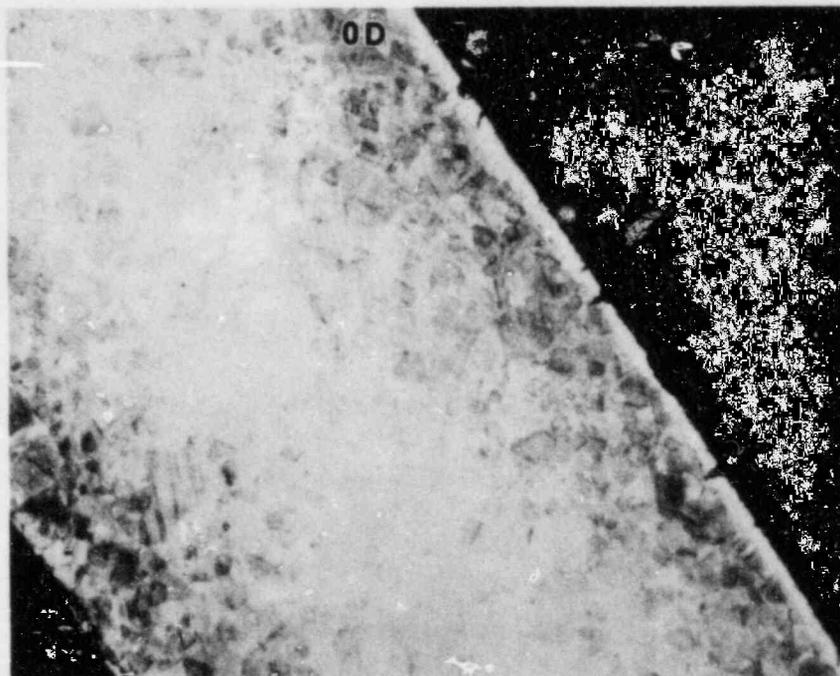
Figure 2-48. Micrographs of Tube B112-19 Areas 2 and 3

Metallography was performed on the bend samples from below and above Area 1 to determine the depth of the penetrations seen using SEM. Figure 2-48 shows typical micrographs of the penetrations found in these areas.

Area 3 (300X)
OD Surface IGA

Area 2 (75X)
