- I. LER NUMBER: LER/RO 83-20/01T-3
- II. LICENSEE NAME: Commonwealth Edison Company  
Quad Cities Nuclear Power Station
- III. FACILITY NAME: Unit Two
- IV. DOCKET NUMBER: 050-265
- V. EVENT DESCRIPTION:

QUAD-CITIES UNIT TWO

INDICATION DESCRIPTION & REPAIR

NJK-84-62

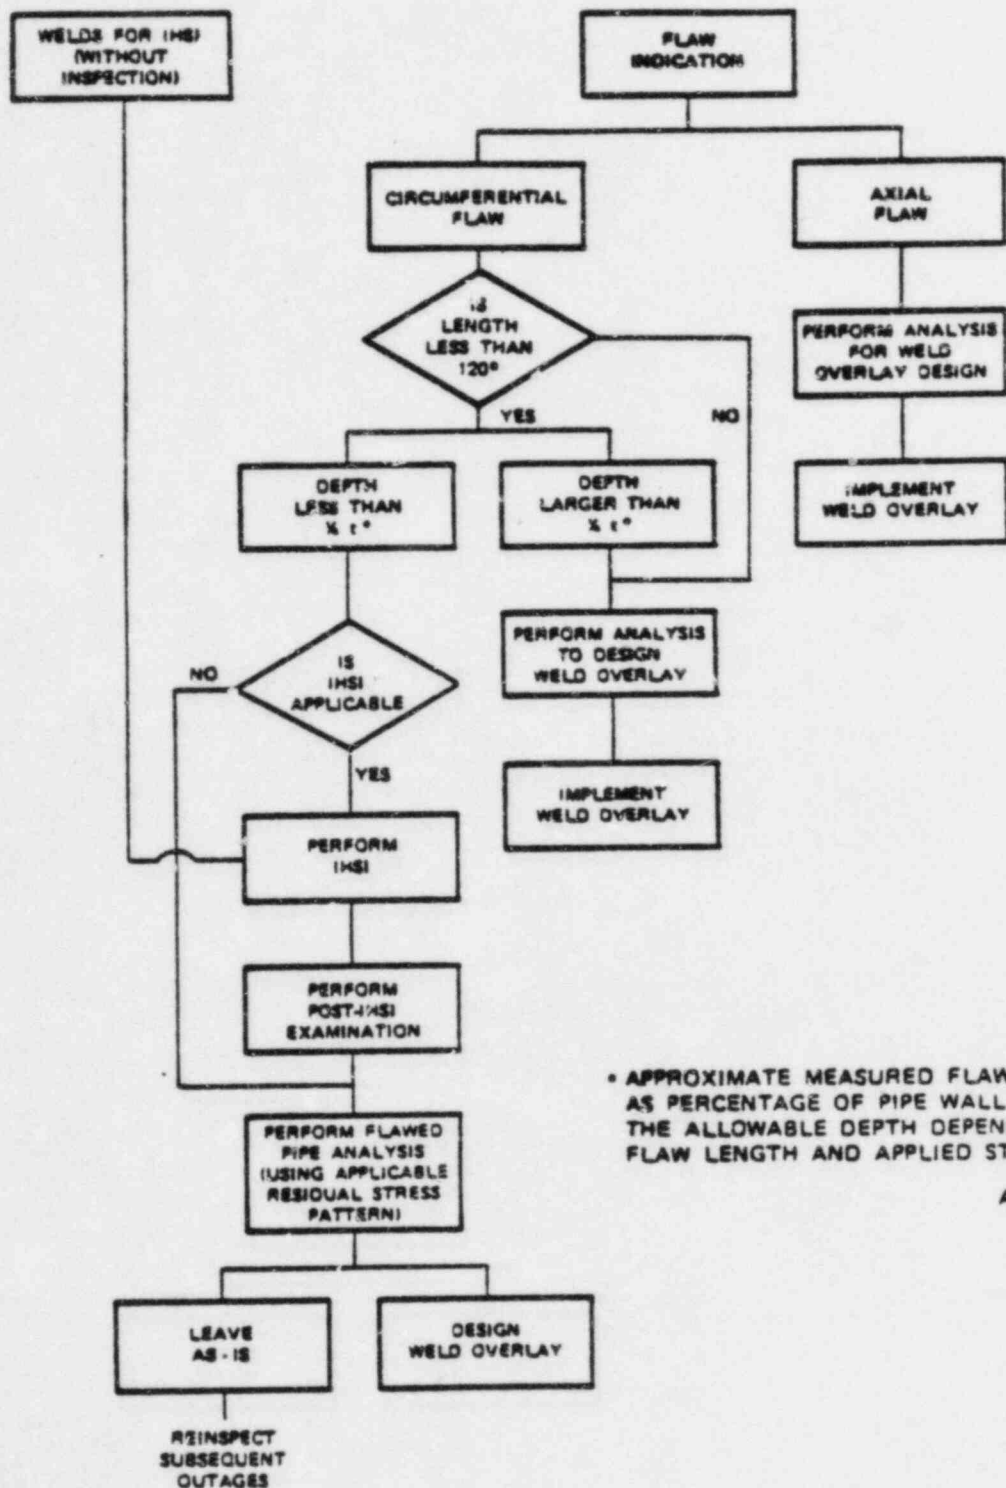
TYPICAL FLAW DISPOSITION SEQUENCE

The crack indication evaluation and repair criteria was performed by NUTECH Engineers, Inc. Indications were evaluated based upon indication depth, length, direction, and applied stresses. Induction Heat Stress Improvement (IHSI) was performed on many welds, both with and without crack indications in order to reduce weld residual stress. As a general rule, circumferential indications with a length greater than 120 degrees of the pipe circumference and/or a depth of greater than 25% of the pipe wall thickness were repaired by applying a weld overlay. All axial indications were repaired by weld overlay. All analyses were performed to the guidelines specified in the ASME Boiler and Pressure Vessel Code, Section XI, Paragraph IWB-3640, "Acceptance Criteria for Austenitic Steel Piping." See Attachment 2 for a typical evaluation sequence.
