GRAND GULF NUCLEAR STATION

UNIT 1

REPORT ON THE
DIVISION I, II and III
DIESEL GENERATORS

NUCLEAR PLANT ENGINEERING
OPERATIONAL ANALYSIS SECTION
DIVISION I, II, AND III DIESEL GENERATOR
OPERABILITY REPORT

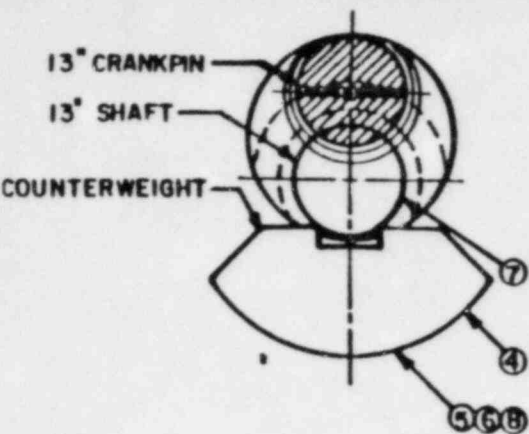
GGNS CONFIGURATION

continue to operate as designed. The need and schedule for inspection of the GGNS D/G crankshafts will be evaluated when the results of the analysis of the Shoreham crankshaft failure is available.
