FaAA83-10-16 PA07395

EMERGENCY DIESEL GENERATOR CONNECTING ROD BEARING FAILURE INVESTIGATION SHOREHAM NUCLEAR POWER STATION

Failure Analysis Associates 2225 East Bayshore Road Palo Alto, California 94303

October 31, 1983

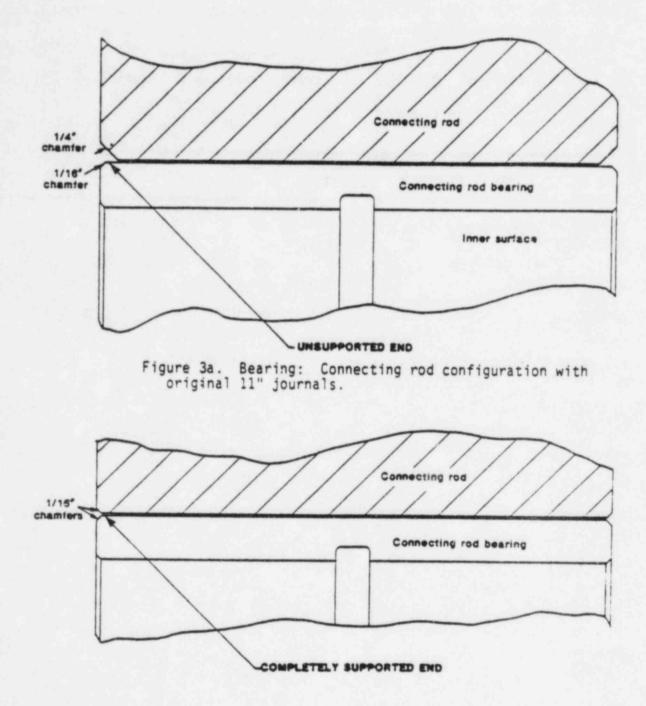
Figure 3b. Bearing: Connecting rod configuration with replacement 12" journals.

3. The new connecting rods have a small, 1/16 inch bore chamfer rather than the original 1/4 inch bore chamfer. As Figure 3-8 demonstrates by comparion with Figure 3-A, the cantilevered or overhung configuration of the original bearing is eliminated in the newer design.

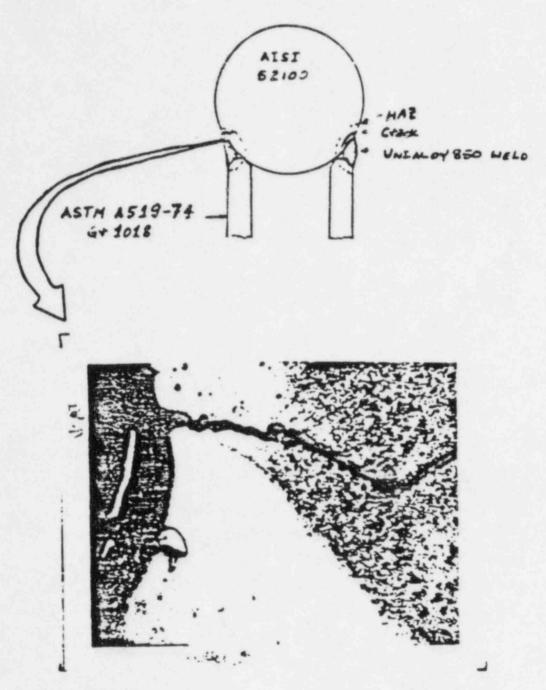
Figure 8: Micrograph of crack in Ball HAZ - Left Side

Shows austenitic weld and clean fusion line. Crack emanating from ball surface and is located in the acicular martensitic HAZ.
